# ANCHOR HOUSE MARINE SURVEYS

**Insurance Survey**

**Omega 828**

***'Blue Panther'***

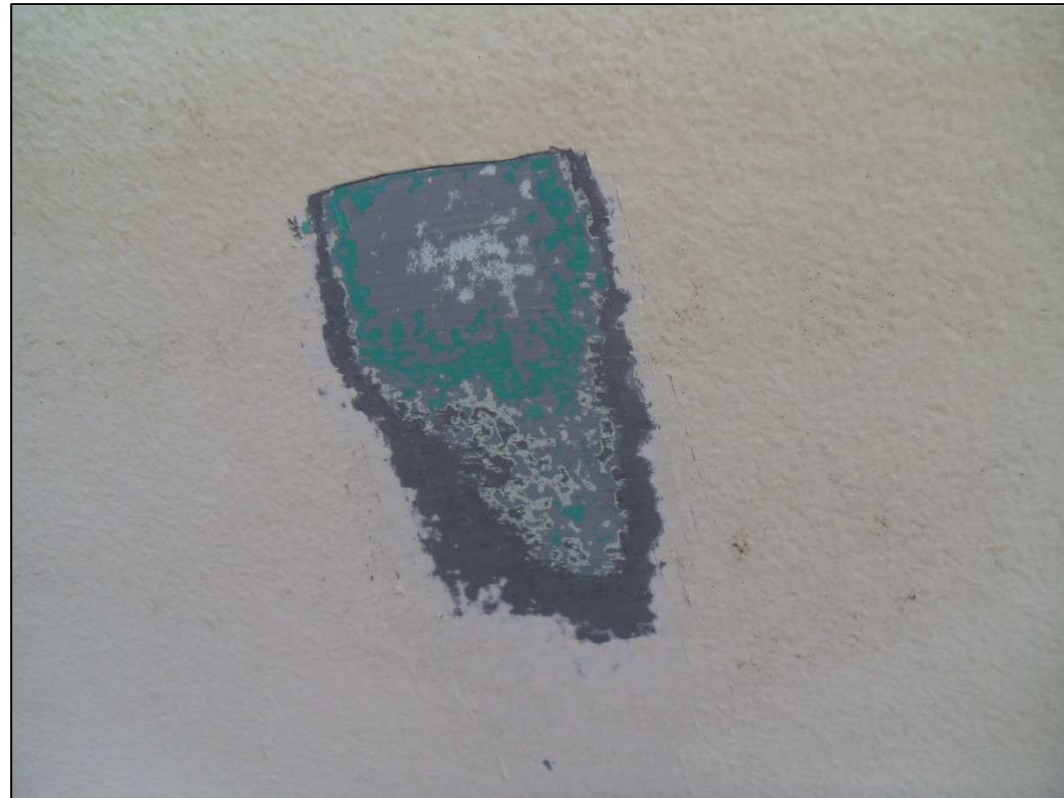
**Fig.1** – hull scraping showing the antifoul, primer and epoxy resin layers.

The antifoul is in white, mainly smooth appearance though there are some patches from previous block supports. This is painted over a grey primer and epoxy resin, like to be 'International' Gelshield going by the colours.

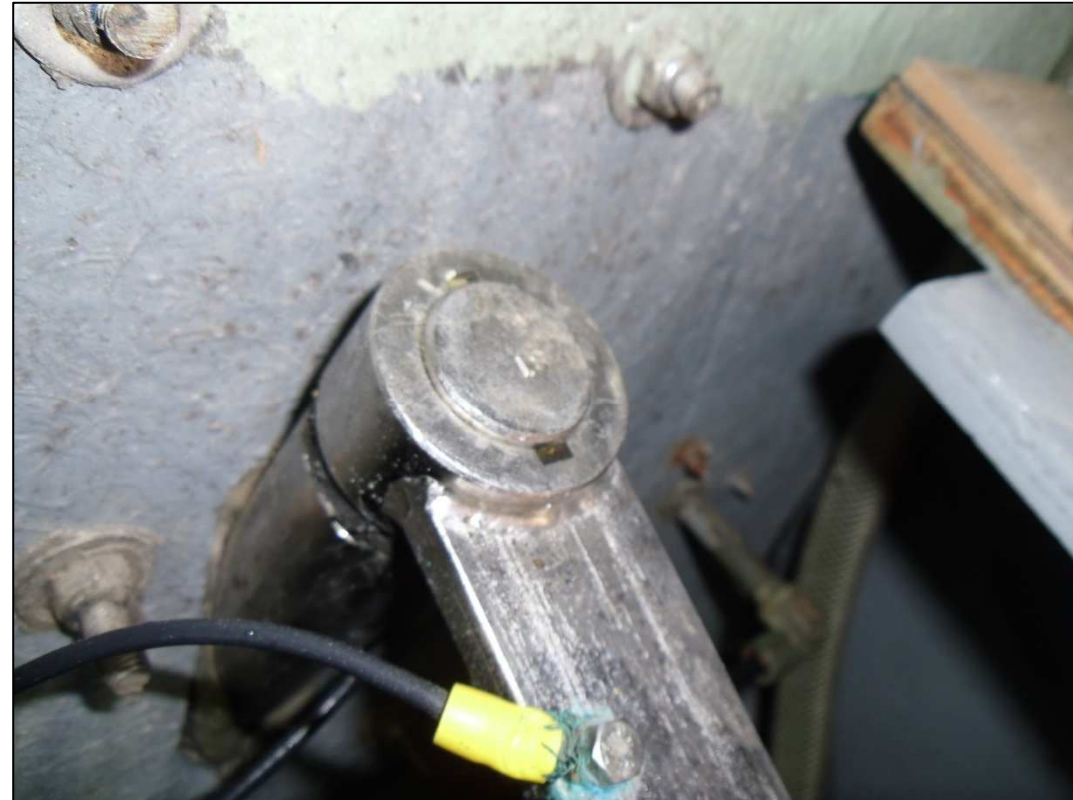
There are 2 x unsupported, stainless steel blade rudders securely fitted and in a good condition. The stocks are welded to the blades and where seen, all welds are serviceable, but the port rudder has dropped by about 1cm. Either that or the starboard rudder is not seated correctly.

**Fig.2** – port rudder has dropped 1cm or the starboard rudder is not seated correctly.

Service the rudders to ensure there is no dropping / slippage.

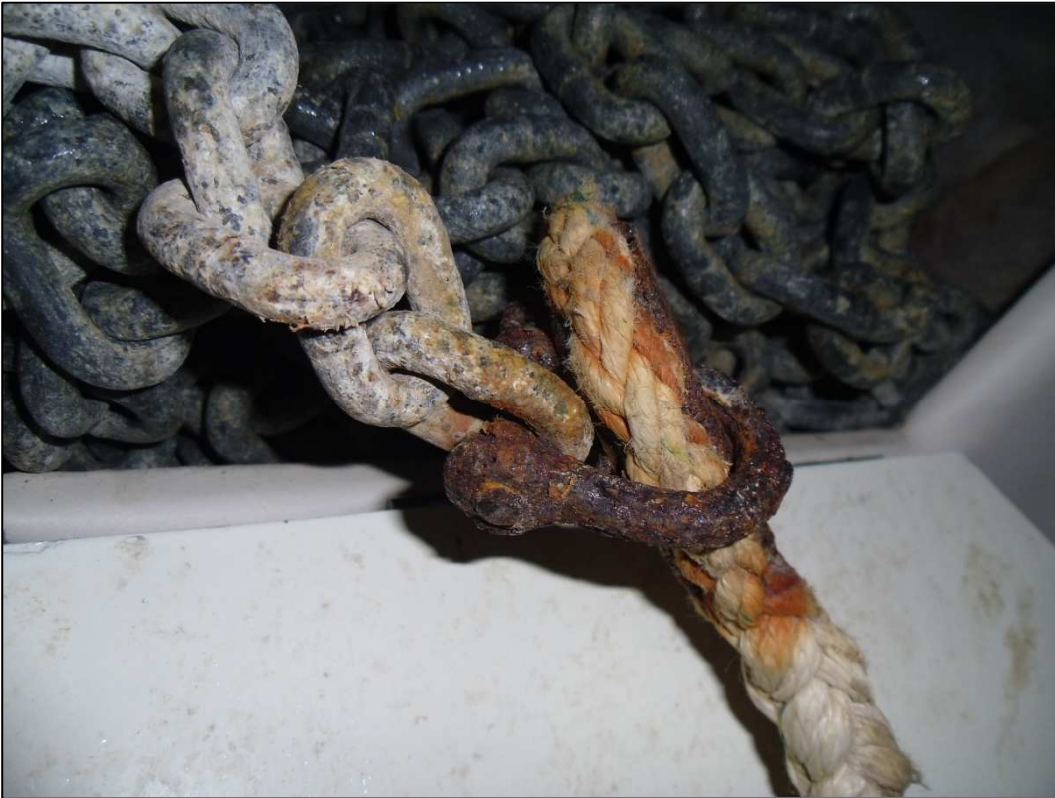
The main anchor cable is a length of 8mm galvanised steel chain in a serviceable condition – though this was not played out. There is a length of rope fitted to the chain bitter end though the connecting shackle is corroding and the rope end could not be seen fitted to a strong point.

**Fig.3** – chain bitter end to rope connecting shackle is corroding.

Ensure the rope is connected to a strong point and replace the shackle.

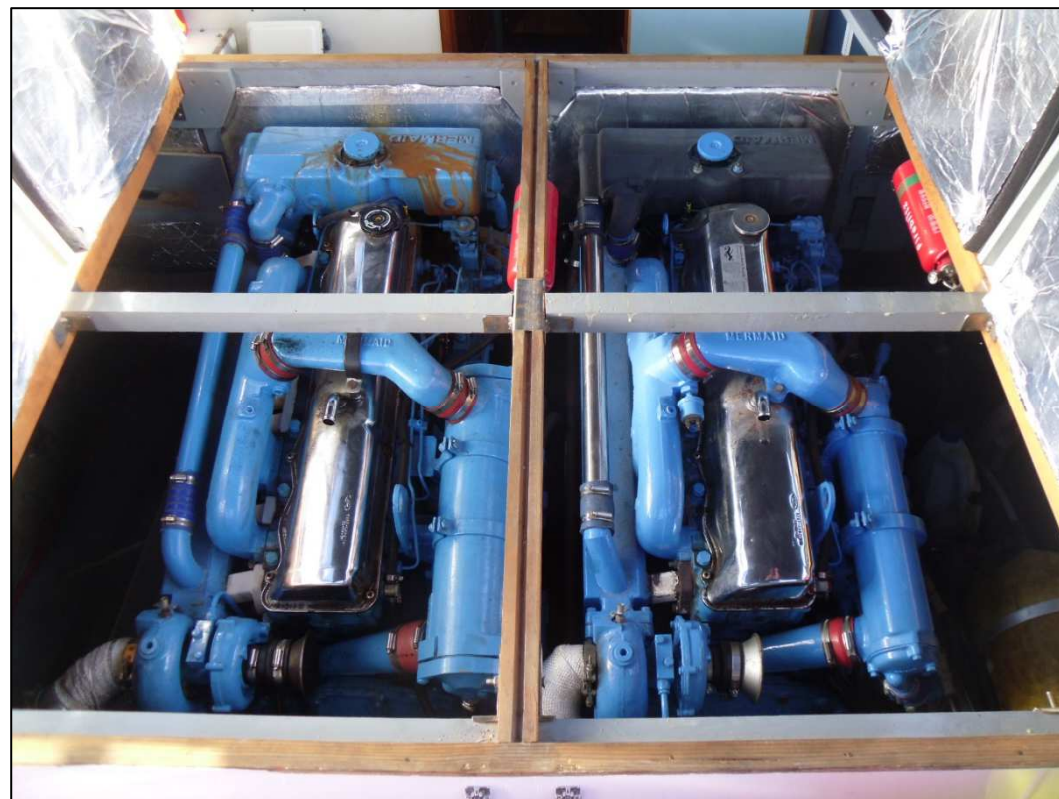
The engines are located under the cockpit deck hatches and these are in overall good cosmetic condition with no clear signs of any obvious corrosion or leak issues. The engine details are:

**Fig.4 – Mermaid Marine Majestic 6-cylinder turbocharged diesel engines.**
