ANCHOR HOUSE MARINE SURVEYS

Full Condition Survey Report

Berthon 8 Tonne Gauntlet

'Nausikaa'

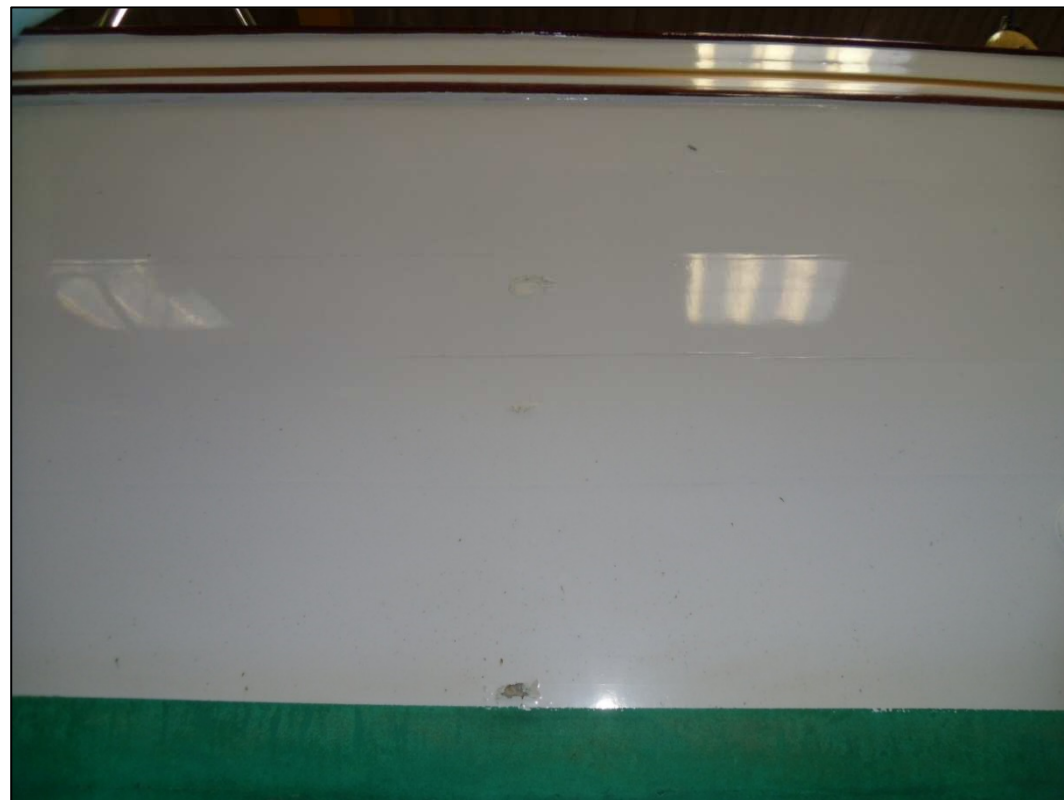
This is in white painted, carvel laid teak planking with a gold painted cove line above the varnished teak fender. The topside is generally clean but there are some minor areas of paint bubbling / detachment as well as some light caulking line protrusion in the paintwork along the yacht's length but there are no signs of any major damage or repair. There are no fore and aft sling tags fitted.

This is in white painted, carvel laid teak planking with a gold painted cove line above the varnished teak fender. The topside is generally clean but there are some areas of paint bubbling / detachment aft of midships as well as some light caulking line protrusion in the paintwork along the yacht's length but there are no signs of any major damage or repair. There are no fore and aft sling tags fitted.

Fig.1 – some light defects and plank caulking line protrusion in the paintwork.

Repair the topside defects.

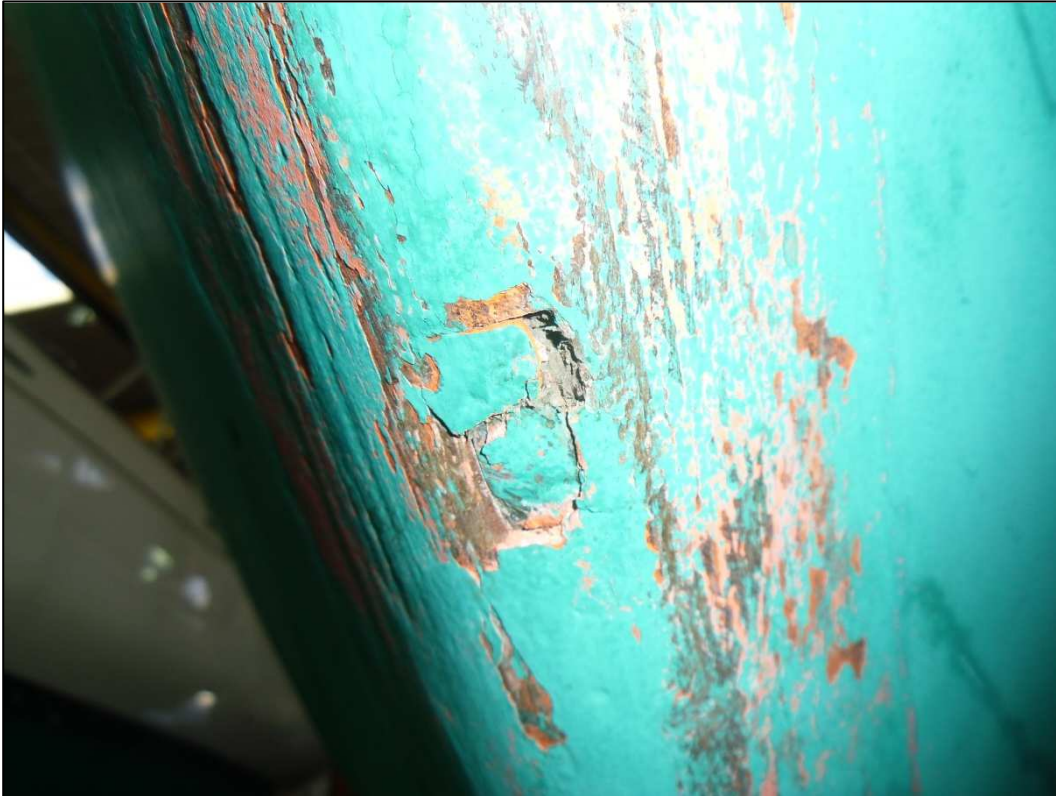
There are some minor chips and scuffs in the paintwork above the waterline but no signs of any major damage or repair. Below the waterline there is some heavy wear / rubbing, scuffing marks as well as some apparent circular impressions noted with surface wood damage, which may be in way of the connecting bolts. The damp seam / caulking lines can be lightly seen in the antifoul but there are no signs of any obvious internal issues.

Fig.2 – small area of damage to the bow stem below the waterline.

Repair the areas of wear along the stem / forefoot.

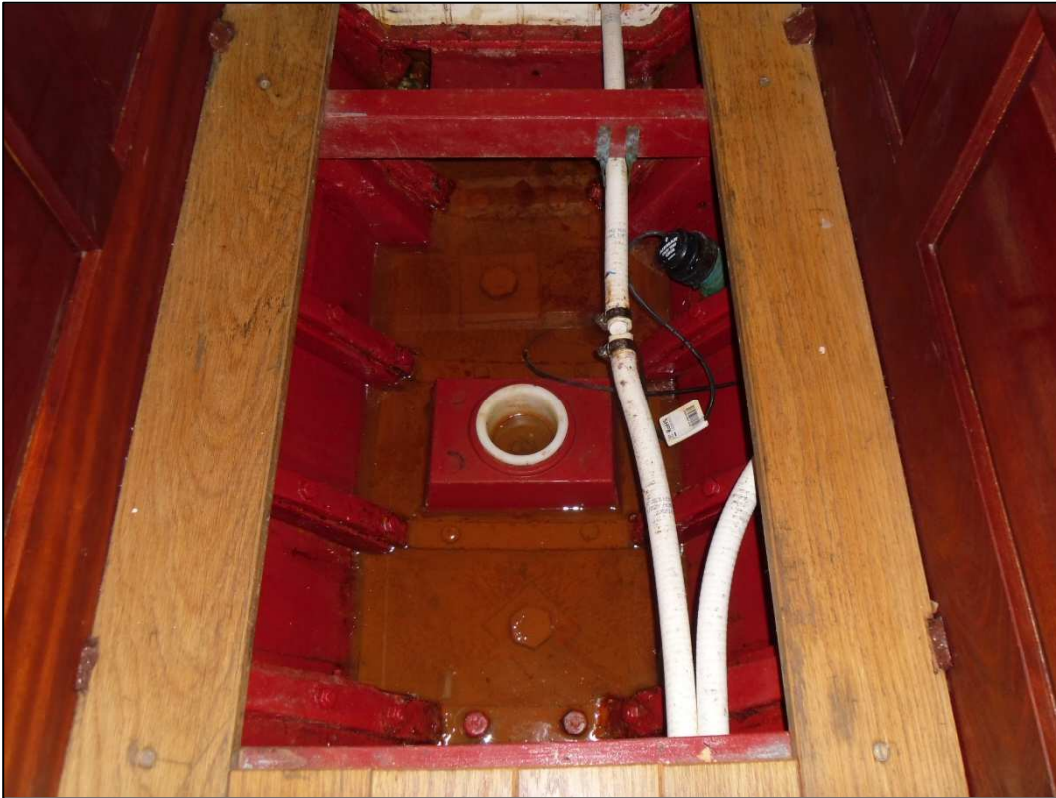
The lead ballast keel is in a serviceable condition with no signs of any obvious movement at the keelson to keel joint. The ballast keel to rudder post bronze or copper cover piece is serviceable with no clear signs of any dezincification where inspected though there is some light tear damage on the bottom face. There are various signs of light cracking of the coatings along the join with the hull but there are no signs of any weeping from the join along its length. Internally, the keelson is painted in red bilge paint or similar and all bolts where seen are generally serviceable and returning a good sound when hammer tested. However, the bilge is covered with around 1" of sea water with the forward keel bolts submerged which will need to be removed.

Fig.3 – sea water in the bilge forward covering the keel bolts and iron floors.

Remove all bilge water, clean out and allow to dry. Repair the torn copper / bronze sheathing.

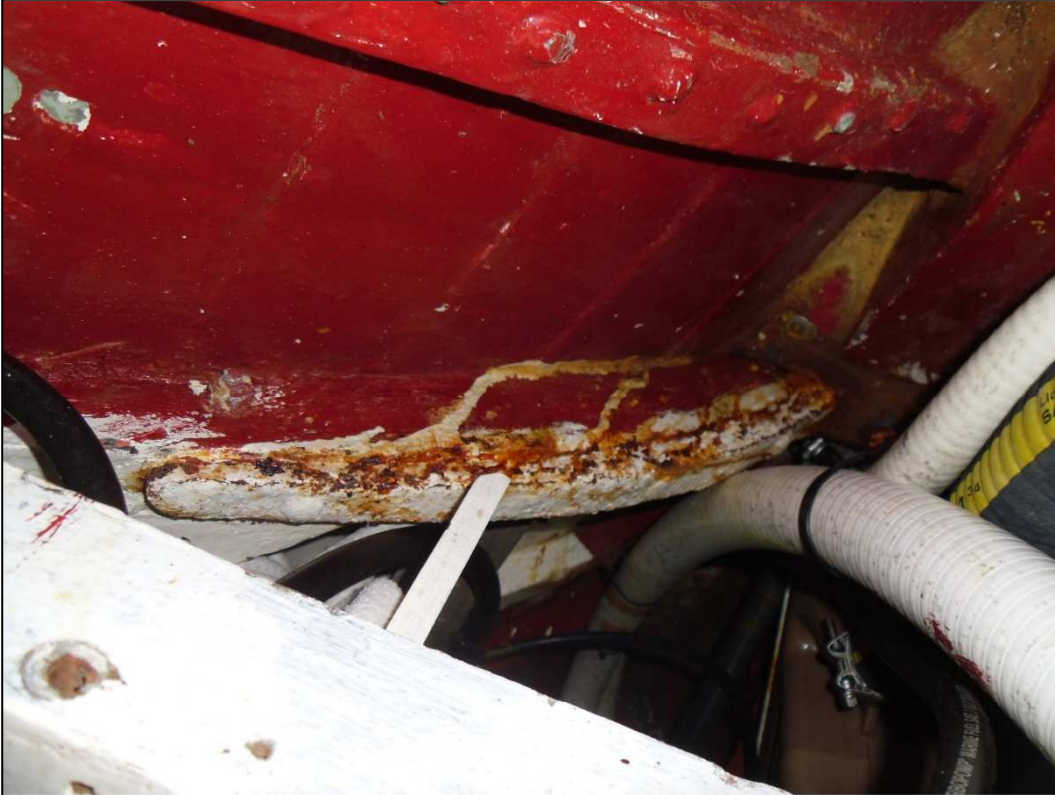
These are securely fitted to the hull frames and elm keelson via bronze bolts and coated in red bilge paint but in the bilge where the sea water is, there is surface corrosion noted particularly to the submerged sections. In the cockpit and aft, these are showing a fair bit of corrosion and weeping though access is difficult to properly inspect.

Fig.4 – signs of corrosion and weeping from the lazarette iron floors.

Clean off all corrosion from the floors and knees where seen and repaint.

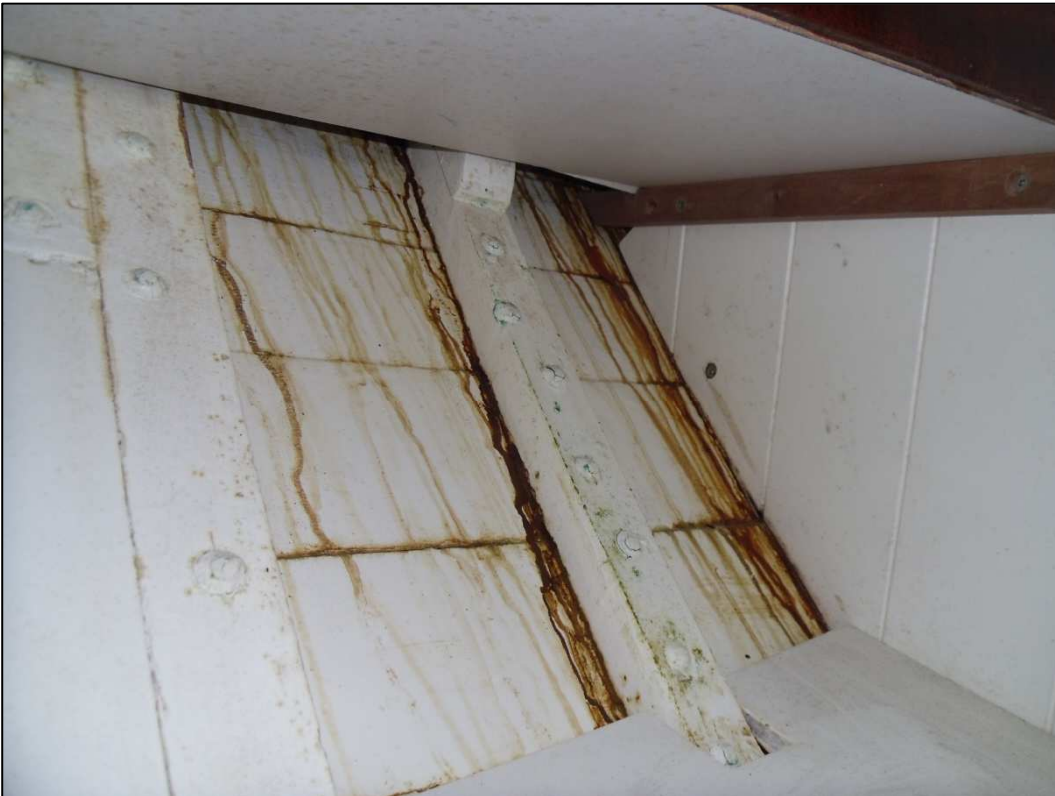
Fig.5 – example of weeping from the structure / planking.

Resolve all areas of weeping.

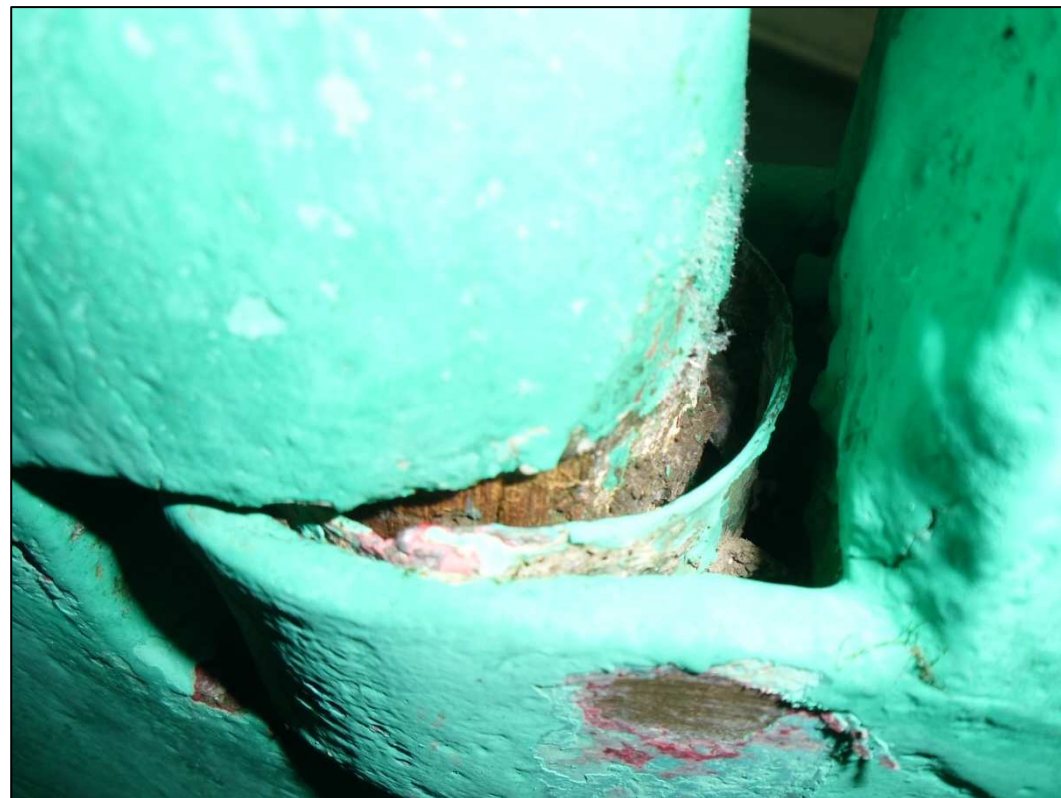
Fig.6 – rudder gudgeon inner sleeve has detached and is corroding.

There is medium to heavy play in the bronze base bearing and centre gudgeon hinge. The gudgeon hinge is securely fitted but the inner lining has detached and is corroding and the 'wooden stock' section appears quite worn, though visibility was limited.

Monitor the bearing and replace once it worsens.

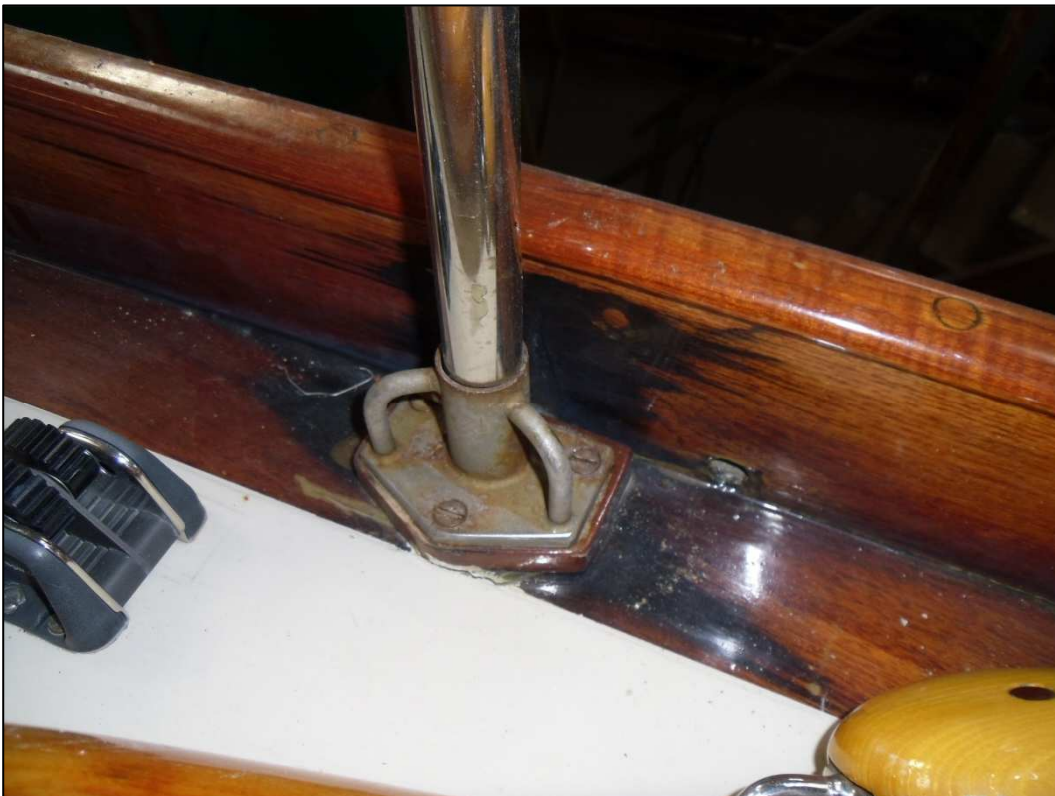
Fig.7 – starboard side gate aft stanchion is loose at the deck join.

- There are 6 x stainless steel tube stanchions incorporating side gates securely pinned to galvanised steel deck mounts which in turn are screwed to varnished teak blocks fitted to the margin boards. The starboard aft gate mounting block is loose and both side gate forward stanchion support arms are loose where they join the margin board.
- There are upper and lower cord guardwires fitted to the pushpit and pulpit by cord.

Repair the loose stanchion and tighten the side gate supports.

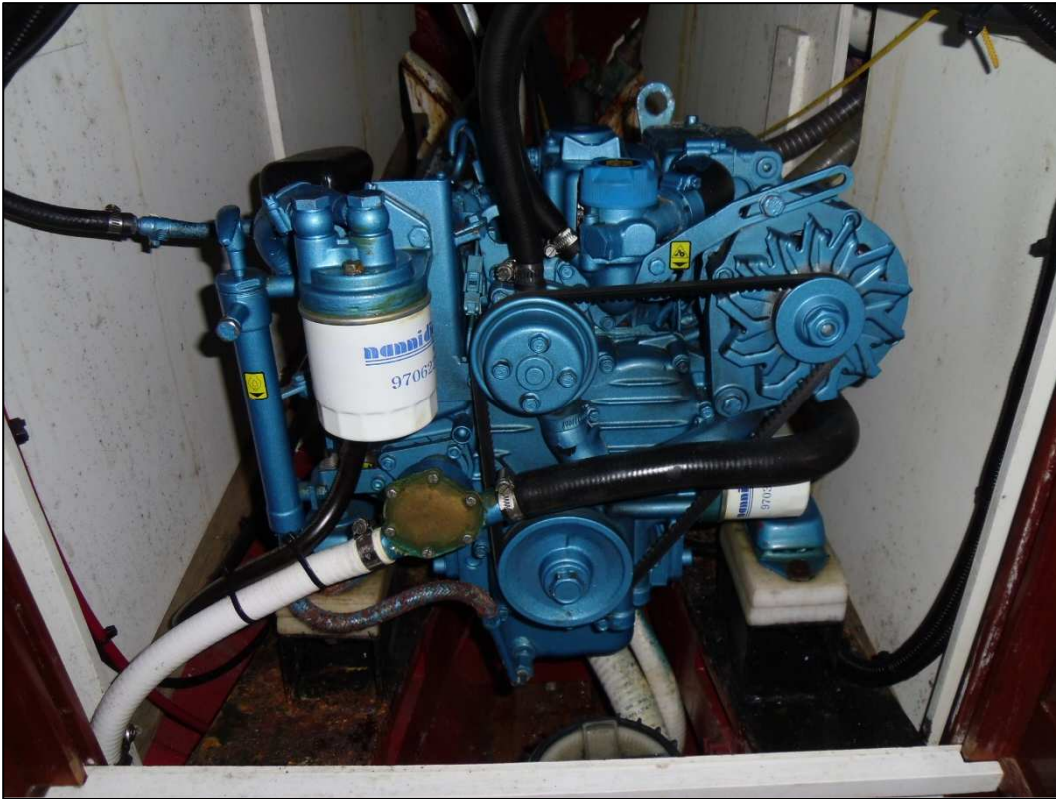
The engine is in good cosmetic condition overall and is in a condition proportionate to being serviced and maintained regularly. However, the oil extraction flexible hose has surface corrosion. The engine identification plate could not be read. The engine details are:

Fig.8 – Nanni N2.14 2-cylinder diesel engine.
