ANCHOR HOUSE MARINE SURVEYS

Full Condition Survey Report

Hanse 315

'Spindrift'

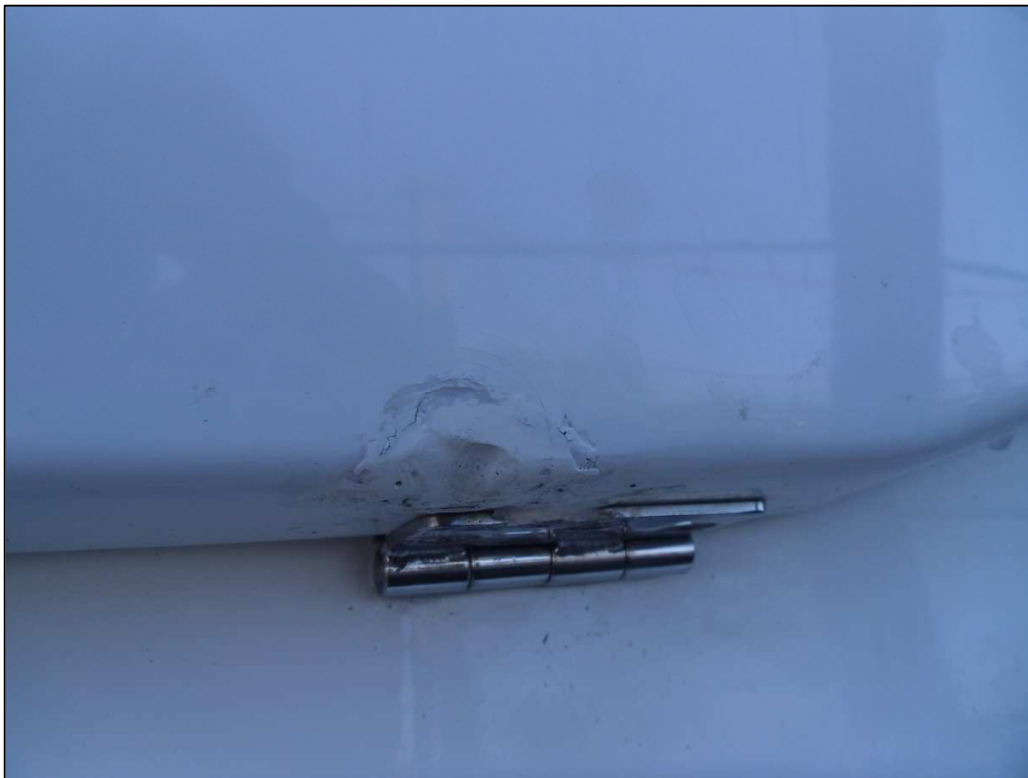
This is in white GRP and in a sound condition overall. This has a hinged bathing platform securely fitted with twin dyneema cord stays. The platform is laid with teak deck panels in a serviceable condition, but there is a small area of gel damage to the hinge and surrounding gelcoat on the starboard side and both securing locks are loose.

Fig.1 – damage to platform starboard hinge plate and surrounding gelcoat.

Recommendation

Repair the hinge and gel damage.

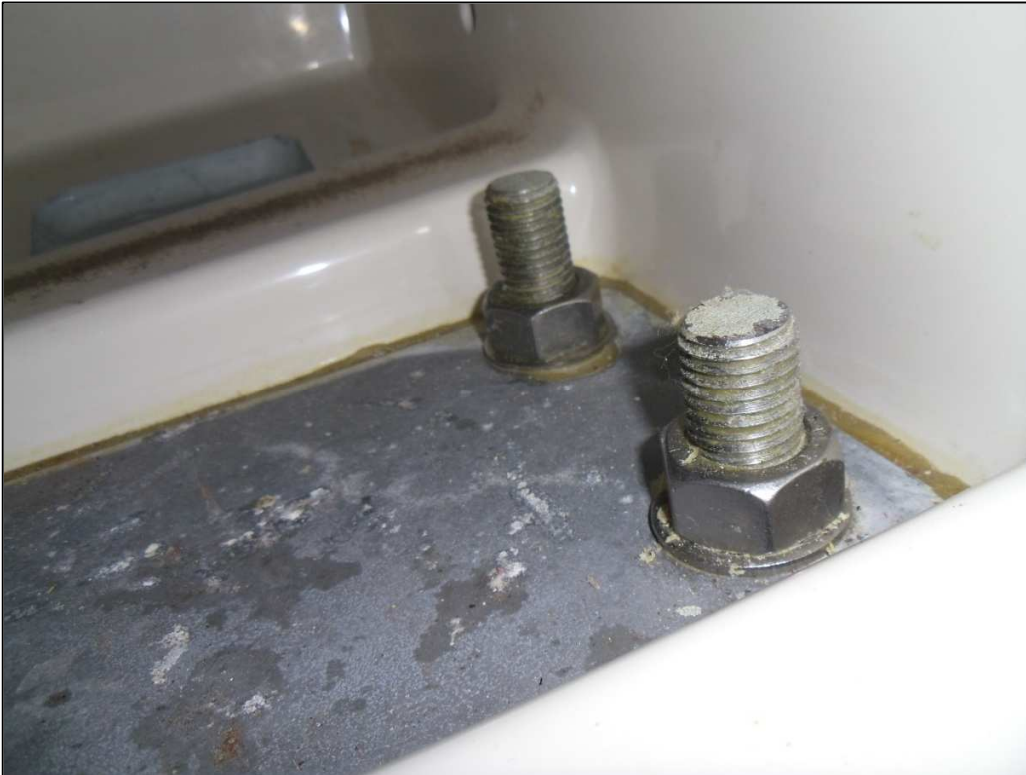
The keel is an iron fin and partial bulb type in a sound condition and is securely bolted through the hull. The keel to hull join is serviceable, with no signs of any cracking or rust weeping etc, though the join itself has been painted over. Internally, the stainless steel keel bolts and fixings are all in a clean and serviceable condition and the surrounding bilge is dry, with all bolts returning a good hammer sound.

Fig.2 – section of keel bolts showing their condition which is the same for all.

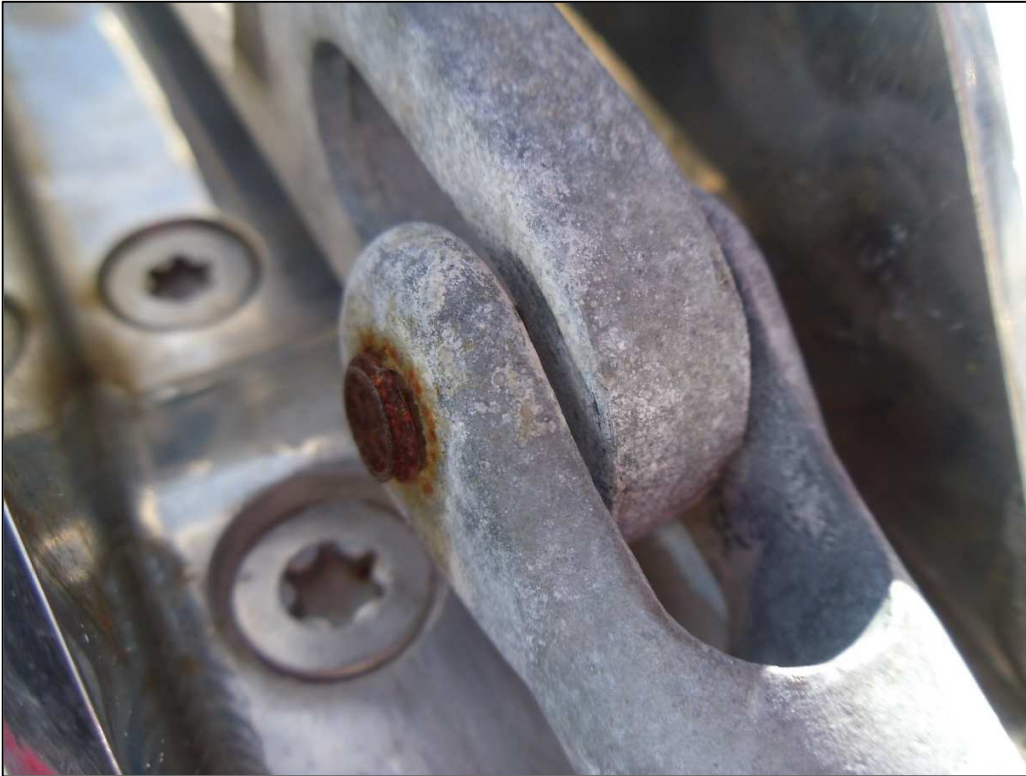
Fig.3 – anchor to chain connection fitting is showing corrosion.

<p><i>Fore Hatch:</i> There is a 'Lewmar' square, aft hinged, tinted acrylic pane which seals over a raised white painted, aluminium coaming topped with a serviceable seal. This has 2 x internally lockable handles with 2 x rotary locking stays and there is a vent in the centre of the glazing. Both handles are very tight to turn and there is a small leak through the inner frame, coming from the port forward corner piece.</p> <p><i>Additional Hatches:</i></p> <ul style="list-style-type: none">• There is a second 'Lewmar' hatch identical to the fore hatch aft of the mast with the exception of it being forward hinged.• Securely fitted outboard of the main hatch are 2 x 'Lewmar' rectangular hatches, with outboard friction hinges, serviceable seals and glazing, non-locking handles and these are in a serviceable condition. <p><i>Windows:</i></p> <ul style="list-style-type: none">• There are 4 x 'Lewmar' side windows consisting of tempered glass panes securely bonded over openings in the coach roof sides, two per side. The external seals are serviceable and internally, they have plastic trim and there were no signs of any leaks.• There is a glazing pane securely bonded over the saloon forward end, aft of the forehatch. Internally, there were no signs of any leaks.• Located in each of the hatch side mouldings are tinted glazing panels bonded to the moulding. Internally, there were no signs of any leaks. <p><i>Portlights:</i> There is a 'Lewmar' portlight located in the aft cabin looking out into the cockpit consisting of an anodised aluminium frame with internal plastic trim. This has clean acrylic glazing, a clean seal and rotary securing handles, though the base of the trim is very dirty which may indicate a possible light leak.</p> <p><i>Hatch Covers:</i> All hatches have internal sun blinds fitted and these are in a serviceable condition.</p> <p>Hand Rails and Stanchions</p> <p><i>Pulpit and Pushpit:</i> There are stainless steel tube pulpit and pushpit installations securely fitted with no signs of any major stress cracking at the deck joins.</p> <p><i>Stanchions:</i> There are 6 x stainless steel tube, tapered stanchions securely fitted into sockets at the deck edge.</p> <p><i>Guardwires:</i> There are 1 x 19 stainless steel upper and lower guardwires tensioned by bottlescrew tensioners fore and aft. These are all securely fitted and pinned, though the starboard aft upper connection is not pinned and all are slightly slack, more so on the port side.</p> <p><i>Handrails:</i></p> <ul style="list-style-type: none">• There are 2 x teak handles securely fitted either side of the main hatch heading down the steps.• There are 2 x stainless steel tube handrails securely fitted outboard on the coach roof. <p>Ground Tackle and Mooring Arrangements</p> <p><i>Anchor:</i> There is a 'Lewmar' 10kg, galvanised steel delta anchor fitted in the stem head in a serviceable condition. There is a galvanised steel link connecting to the chain, but the end connections are showing corrosion, particularly the forward one.</p>	<p>Recommendation Source the leak and resolve.</p> <p>Recommendation Ensure all connections are pinned and all guardwires are taught.</p> <p>Recommendation Replace the link with a stainless steel swivel shackle.</p>

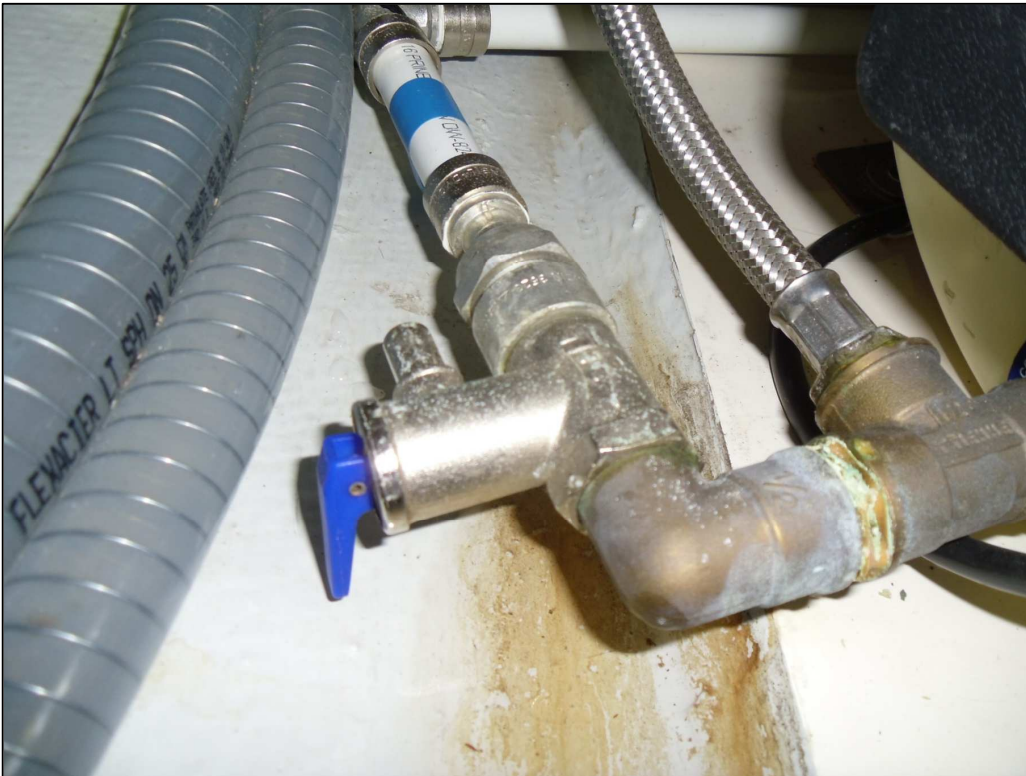
Fig.4 – leak from the pressure relief valve or elbow connection to the T piece.

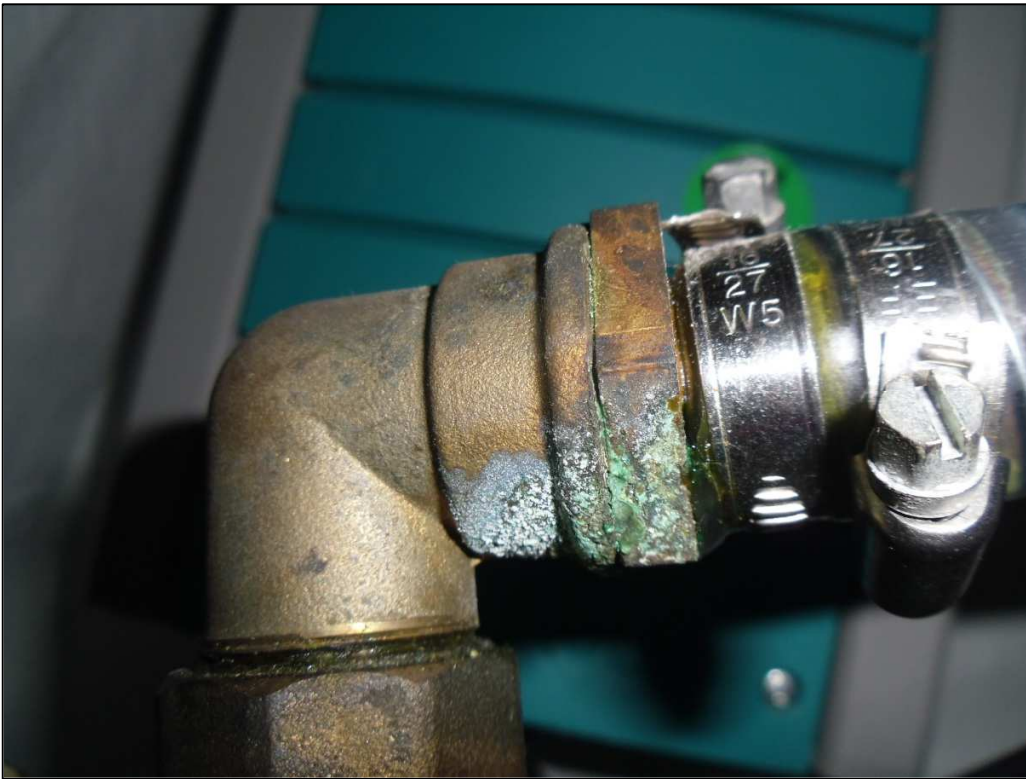
- The toilet inlet is a brass bodied ball valve seacock located under the saloon seating aft. No 'CR' marks were noted. This operated satisfactorily and is in a serviceable condition, but with evidence of a possible leak from the hose to elbow join. This is double clipped to clear, wire reinforced hose, which is double clipped to the pump, and then to the toilet bowl.

Fig.5 – corrosion / leak from the toilet inlet seacock to hose join.

Recommendation

Service the seacock to remove any possible leak.

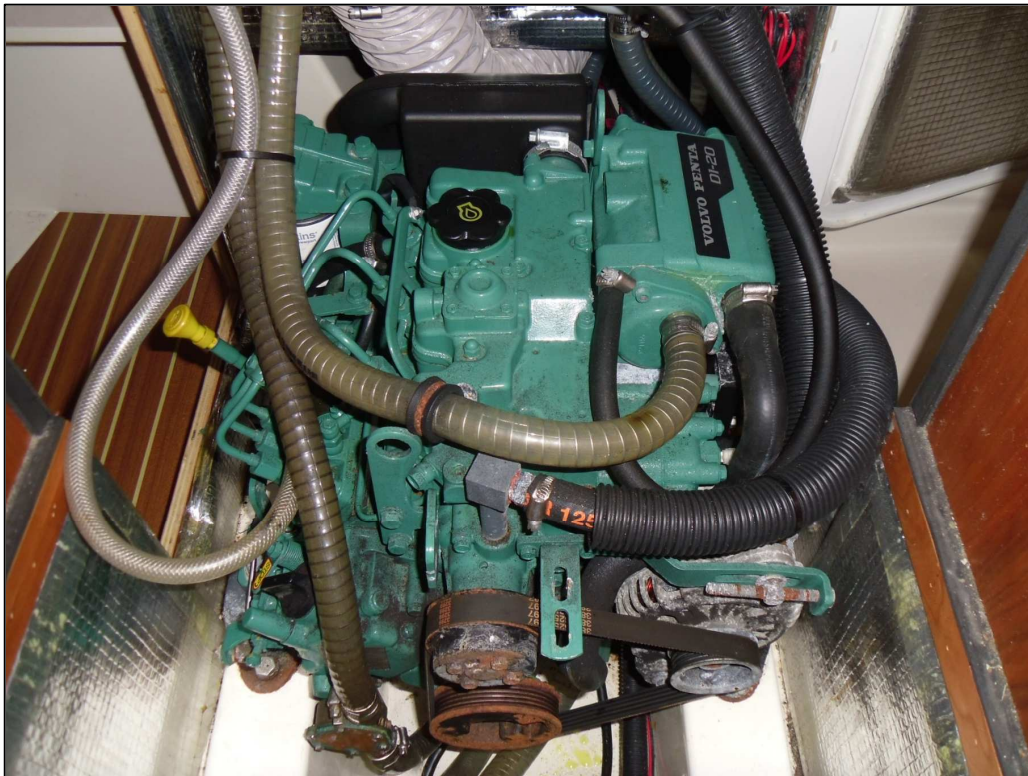
The engine is in a serviceable cosmetic condition and the compartment is lined in insulation panels. But there is a coolant leak issue and the front case, areas of the block and various ancillaries have surface corrosion noted. It is therefore recommended to have the engine and gearbox fully inspected and serviced by a competent 'Volvo Penta' specialist. The main specifications are:

Fig.6 – Volvo Penta D1-20 3-cylinder diesel engine.

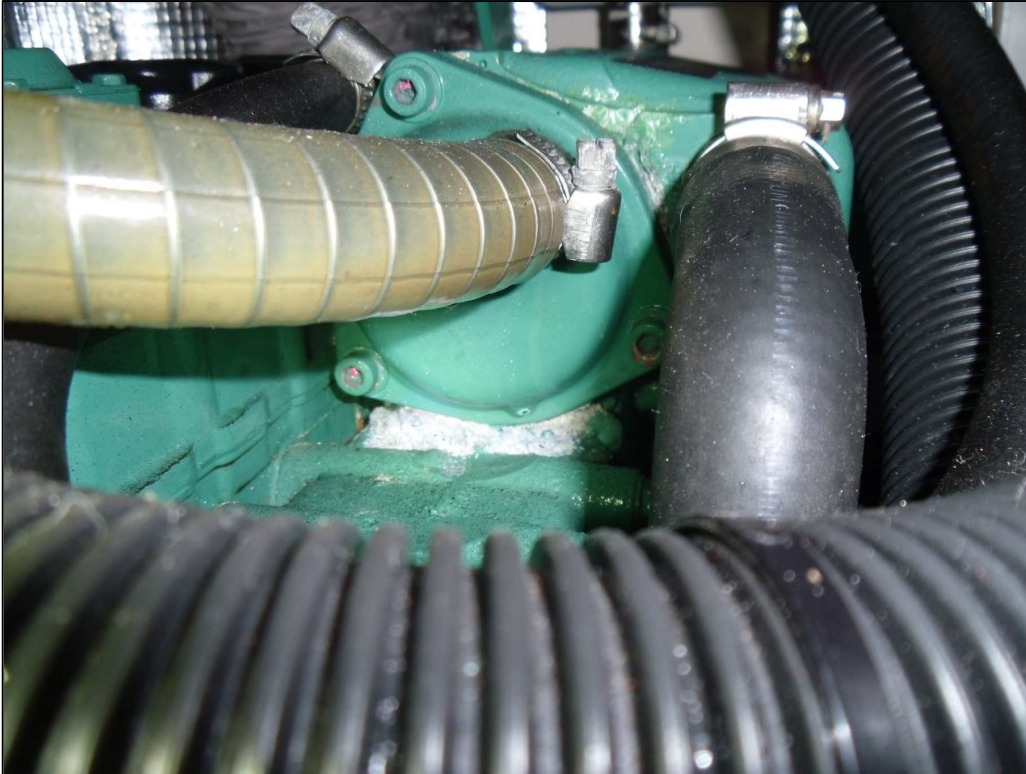
The engine is cooled directly by seawater supplied by an engine driven impeller type pump. The pump is in a serviceable condition overall, but the circulation and crankshaft pulleys have all over surface corrosion. There is clearly a leak from the forward cap of the heat exchanger and is the likely source of the various corrosion issues. The antifreeze coolant protects to -20°C and is mainly clear.

Fig.7 – evidence of a long standing leak from the heat exchanger forward end cap.

Urgent Recommendation

Replace the heat exchanger end cap seals. The unit itself may require desalting.
