# ANCHOR HOUSE MARINE SURVEYS

## **Insurance Survey Report**

**Carver 30**

18<sup>th</sup> February 2019

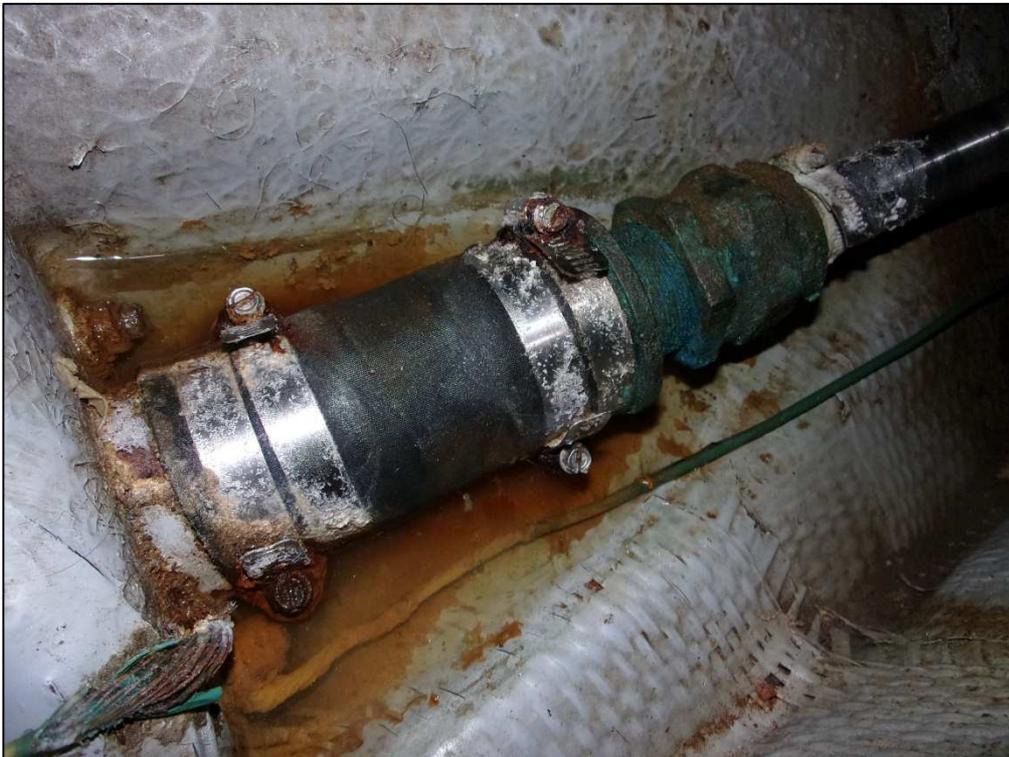
The stuffing box type stern glands are showing surface corrosion all over the bodies with the fixings showing strong surface corrosion. There is salt water surrounding both installation and both will need a complete overhaul.

**Fig.1** – stern glands showing corrosion to stiffing box and fixings.

**Urgent Recommendation**

Service both glands and remove all standing water.

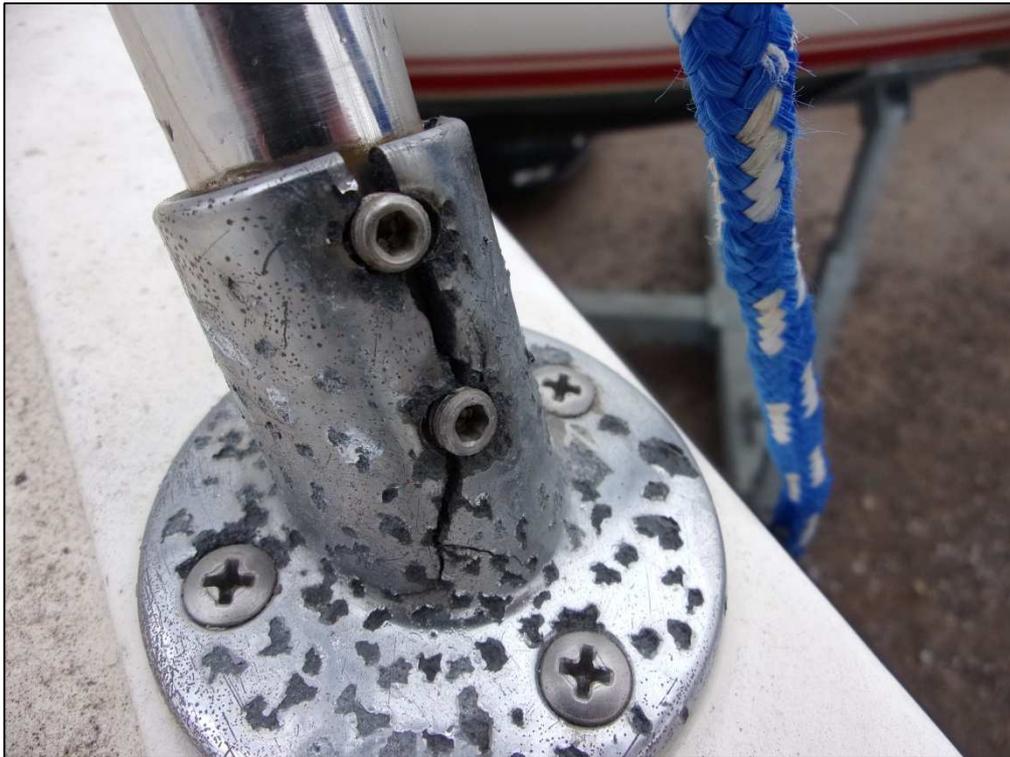
There are 22mm diameter stainless steel tube pushpit / fore deck railings and pushpit / cockpit railings incorporating stanchions. Many of the foredeck railing stanchions are either broken or cracked and the cockpit railings are loose especially on the port side and can be lifted free in areas due to missing pins.

**Fig.2** – cracked forward railing mounting bracket.

Replace all broken and split stanchion supports and replace any missing or broken railing pins.

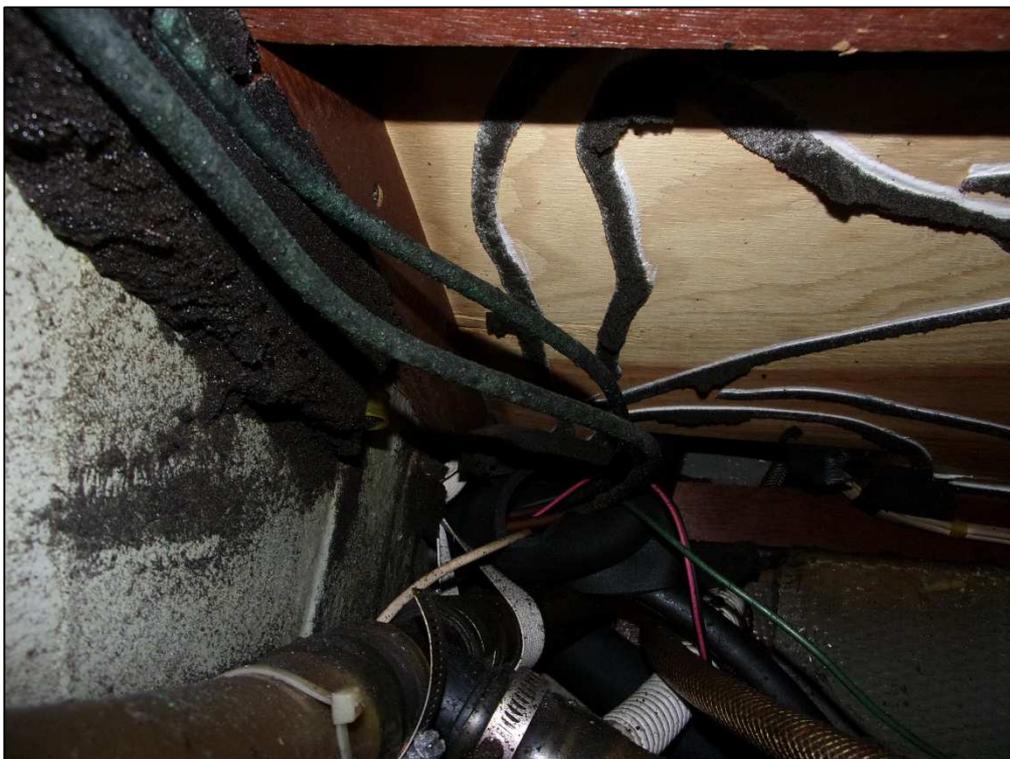
The copper pipework from the tank is showing areas of surface corrosion outboard both sides in the engine compartment. The flexible hoses to the engines are ISO 7840 compliant and no leaks were noted.

**Fig.3** – copper fuel pipes with surface corrosion.

Clean up all corrosion on the fuel pipes and / or replace with ISO 7840 flexible.

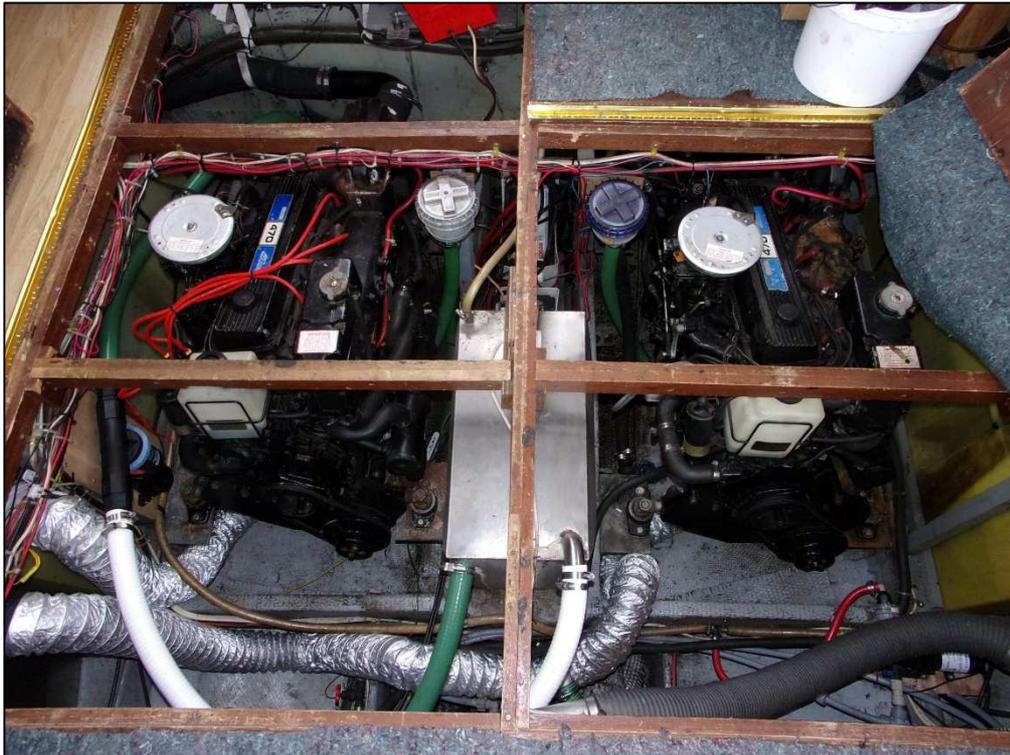
The engines are in overall average cosmetic condition though there is heavy surface corrosion around the exhaust manifold and riser joints and these should be cleaned up, protected and monitored for any worsening. Despite the engines being regularly serviced by the owner, it is still recommended to have a competent 'Mercury' specialist fully inspect and service the engines at the next service ashore to ensure their longevity.

**Fig.4** – Mercury MIE 470 4-cylinder petrol engines.

Have the engines fully inspected and serviced by a competent 'Mercury Marine' specialist.

Clean off all surface corrosion and protect with 'Tectyl' or similar.
