## **Full Condition Survey Report**

### **Hallberg Rassy Rasmus 35**

Hamble Point Marina, Hanble, UK

Monday 21<sup>st</sup> and Tuesday 22<sup>nd</sup> January 2019

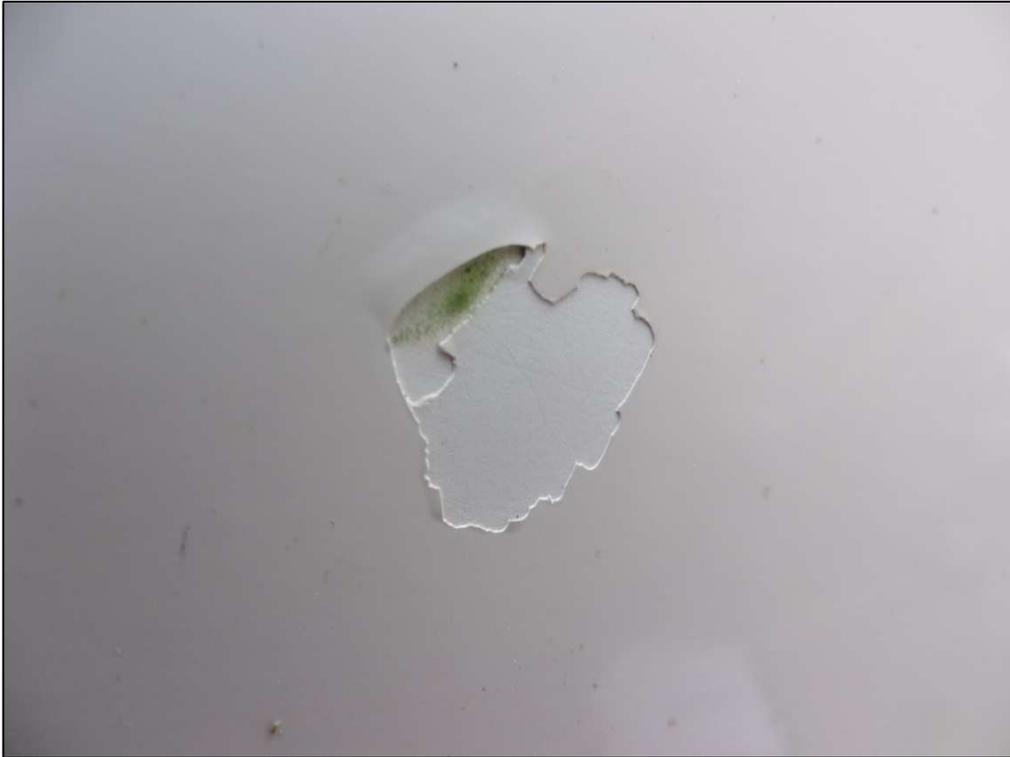
This is in white painted GRP with a slight knuckle above a navy blue cove stripe, a teak topped toe rail and a navy blue antifoul waterline stripe. The topside is generally clean but there are areas of small paint chips aft and some rub marks forward but there are no signs of any major damage or repair. The teak toe rail has rub marks in areas, is outwardly proud at the join forward and there are areas of poor sealant / gaps in the sealant on the underside. There are no fore and aft sling tags present.

This is in white painted GRP with a slight knuckle above a navy blue cove stripe, a teak topped toe rail and a navy blue antifoul waterline stripe. There are areas of small paint chips aft, an area of scrapes at midships at the waterline, a long scrape forward of midships and a scratch aft of forward but there are no signs of any major damage or repair. The teak toe rail has rub marks in areas, is outwardly proud at the join forward and there are areas of poor sealant / gaps in the sealant on the underside. There are no fore and aft sling tags present.

**Fig.1** – topside paint peeling / chips.

Repair the topside defects.

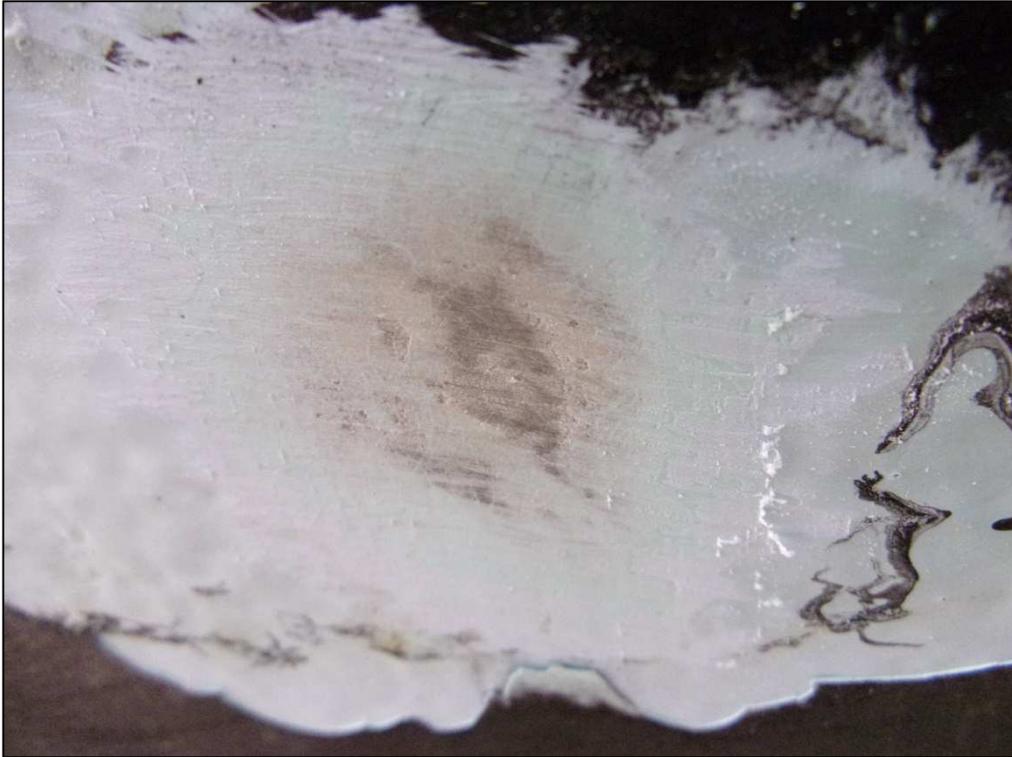
The antifoul is in black, smooth in appearance and adhering generally well though it is flaking and detaching in areas. The hull has been faired and primed and whilst there are coatings between the fairing and antifoul, these need to be confirmed as they are not the usual 'International' Gelshield colours.

**Fig.2** – hull coatings make up layers.

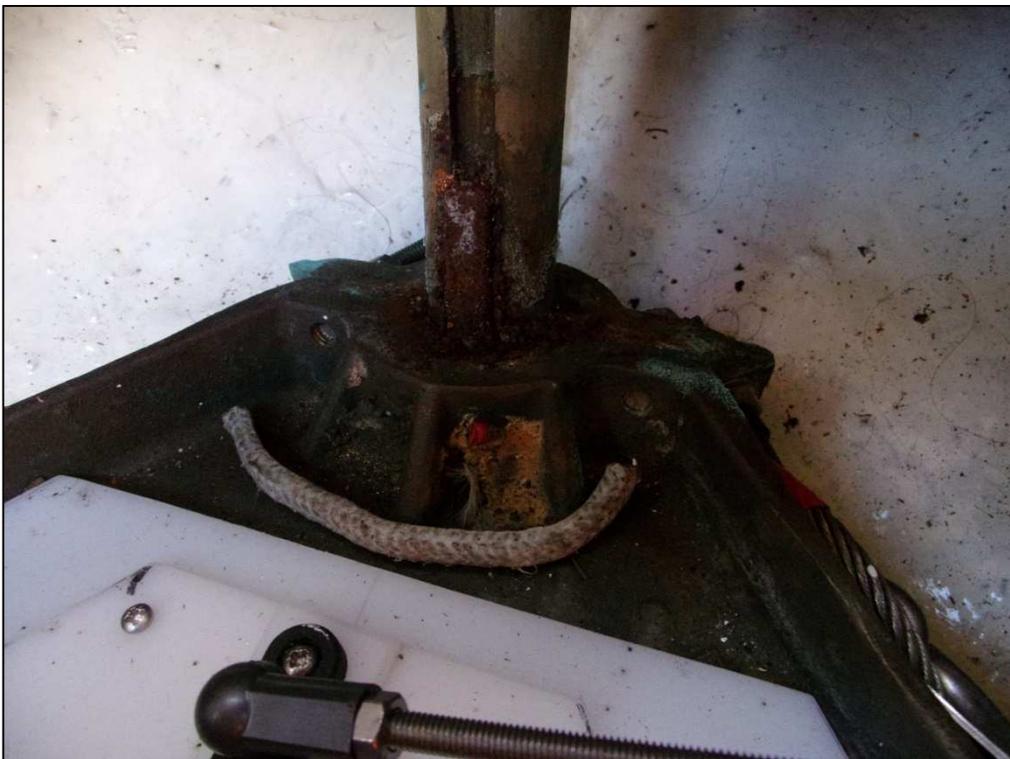
**Fig.3** – quadrant to stock join showing strong corrosion.

This is in 35mm bronze and continues through the aft end of the aft cabin and up to the stern deck. The join with the quadrant located under the aft cabin bunk is showing strong surface corrosion and the quadrant has play present.

Clean off the corrosion and inspect the connection and key.

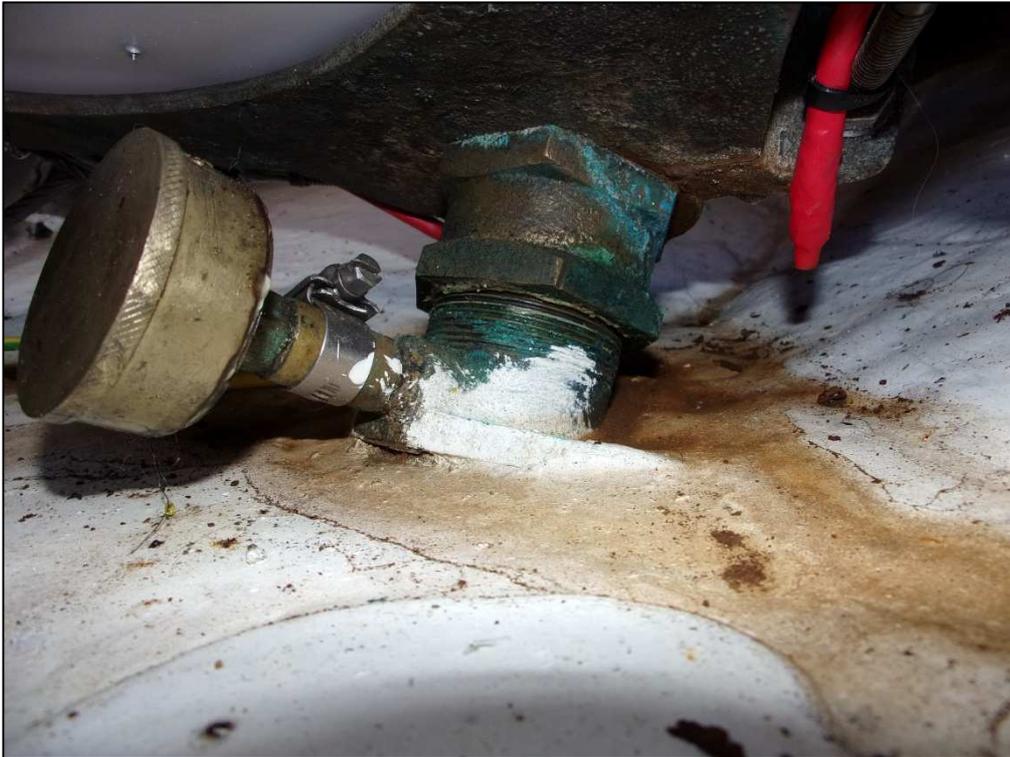
This is a bronze packing type with independent greaser reservoir and this is showing signs of corrosion with evidence of a long term leak along with areas of standing salt water present. There is evidence of numerous previous leak runs all heading towards the stern bilge.

**Fig.4** – leaking rudder trunk gland.

Investigate the cause of the gland leak and repair / repack as necessary.

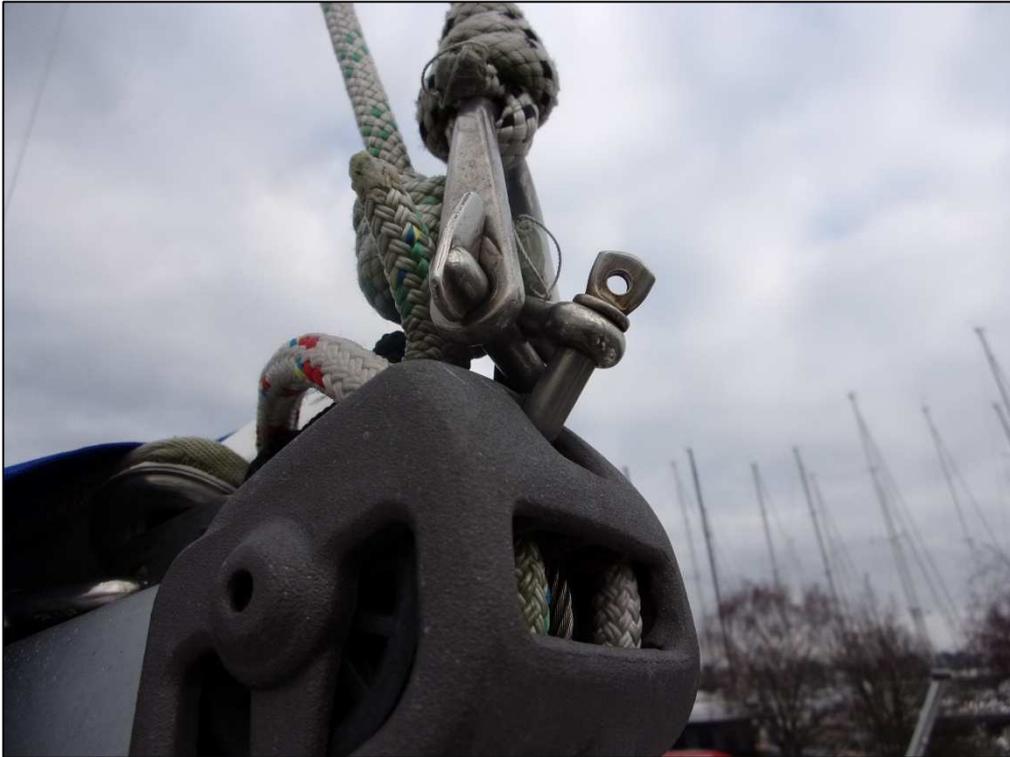
- The anodised aluminium booms are sound and secure. The mast mounting brackets are secure, pinned and in good serviceable condition but the topping lift shackle pins are not secured against accidental unscrewing.
- The main mast 'Selden' rodkicker is in a serviceable condition with a serviceable bracket though the shackle pin is not secured against accidental unscrewing.

**Fig.5** – example of rigging shackle pin not wired against accidental unscrewing.

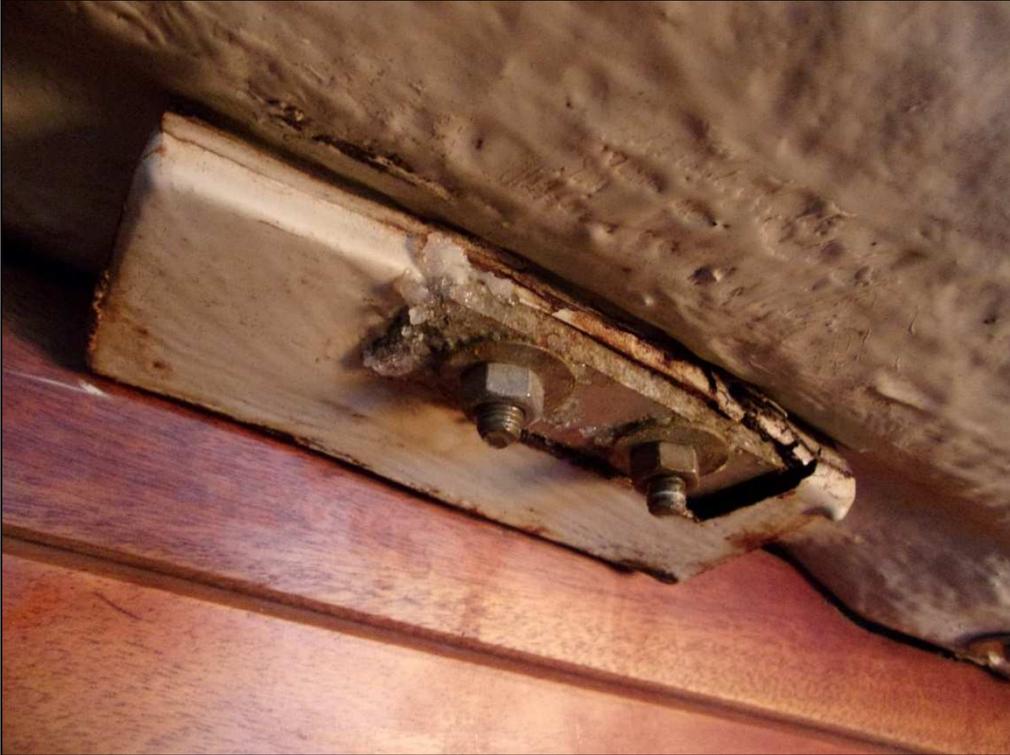
- The reinforcements for the main mast shrouds are in stainless steel and secured to strong frames inside the saloon.
- The reinforcements for the main mast aft stay and mizzen mast shrouds are showing signs of surface corrosion and some of the internal support blocks are beginning to collapse.
- The forestay is secured via a chain plate to the top of the bow stem and is sound and secure with no evidence of any movement.

**Fig.6** – combination mizzen mast shroud and main mast aft stay reinforcement.

Inspect and service the reinforcements and support blocks.

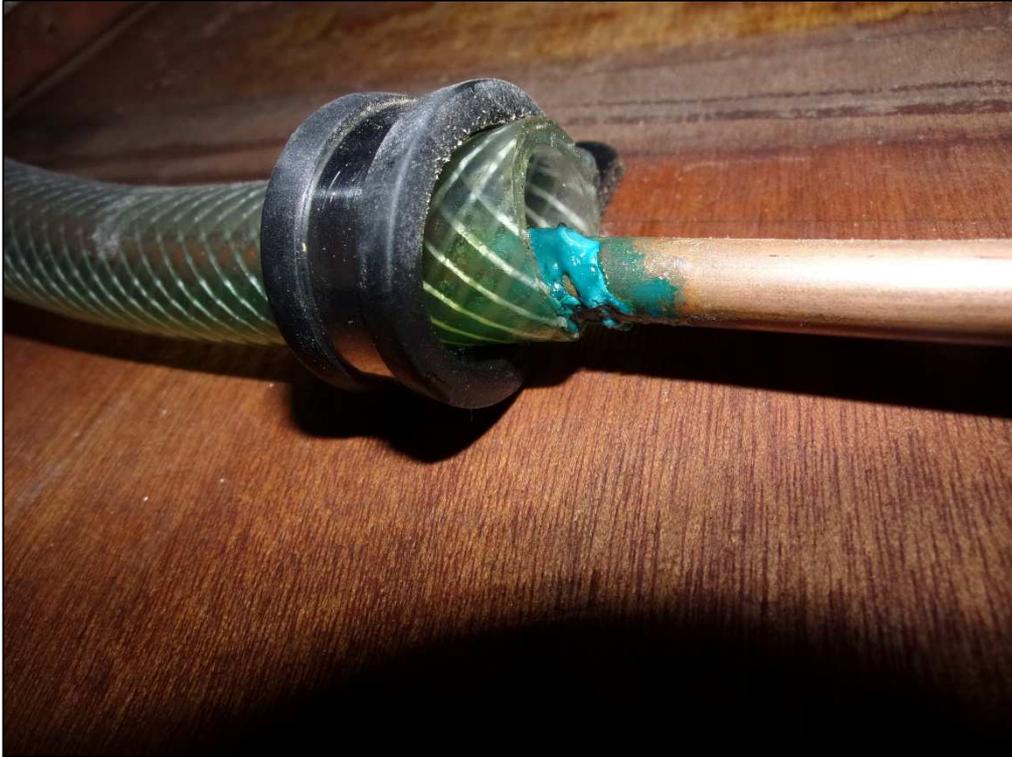
The pipe is in drawn copper and where visible is in a serviceable condition though there are areas of surface corrosion after the locker. There are twin operable gas cut off valves below the oven.

**Fig.7** – area of surface corrosion on copper gas pipe under the oven.

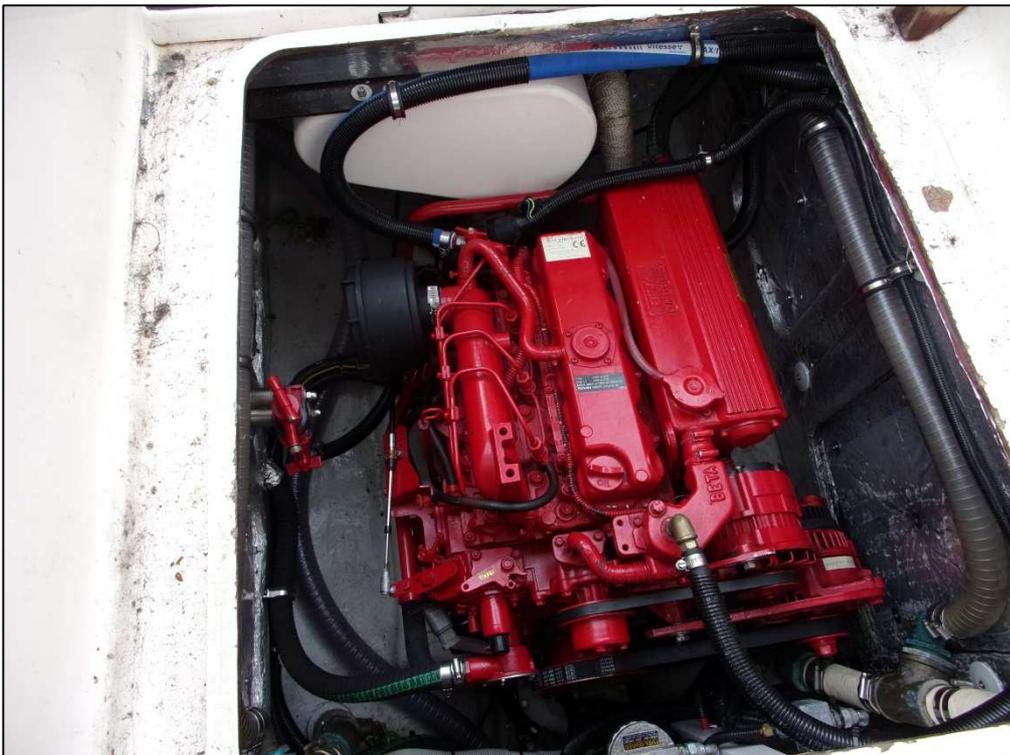
The engine is in an overall clean and good cosmetic condition and appears to be have been serviced and maintained regularly.

**Fig.8** – Beta 43 4-cylinder diesel engine.
