ANCHOR HOUSE MARINE SURVEYS

Structural Survey Report

Moody 38 CC

Thursday 6th December 2018

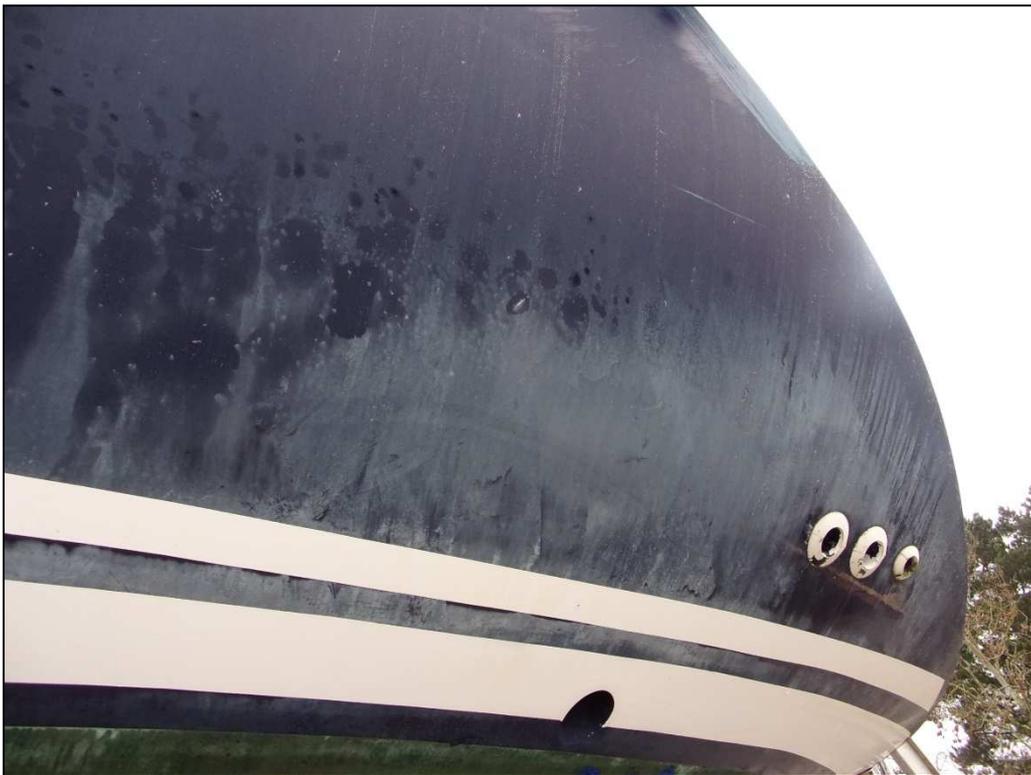
This is in navy blue painted GRP with a gold painted 'cove line' and twin white waterline stripes. The topside paint is very sun faded / damaged in various areas along its length with areas of touch up paint from burst blisters at various points along the waterline. There are various rub marks, small scratches and scuffs in areas along the topside, especially aft and aft of midships. There is a toe rail / deck edge all round fender consisting of lightly weathered teak and this is. There are no fore and aft sling tags to aid in lifting.

This is in navy blue painted GRP and is very sun faded / damaged in areas with apparent touch up patches on the outboard upper edges. There are also various small rub marks and scratches and touched up gelcoat chips on the edges.

Fig.1 – sun damage to painted topsides.

Repaint the vessel topsides and transom.

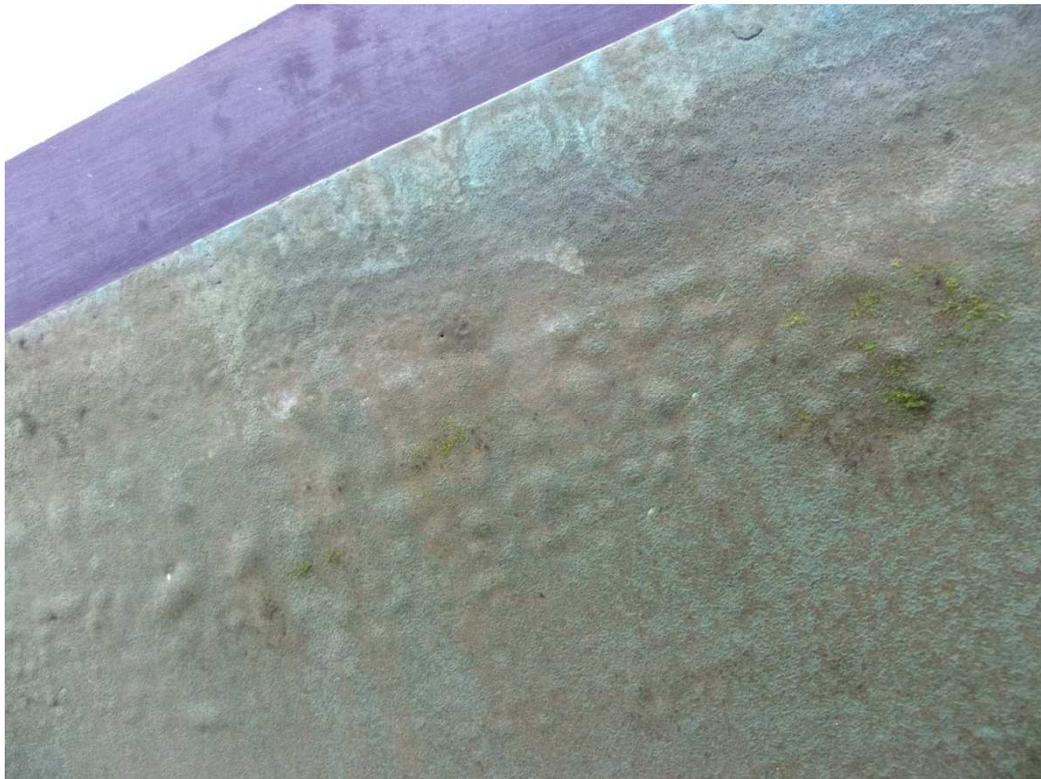
- There is a line of gelcoat blistering at the waterline and running around the stern starting from aft of midships on both sides. Closer inspection of existing and burst blisters determined that these are gelcoat deep and not further into the matting as best as can be established. Gelcoat deep only blisters suggest that this is due to imperfections / contaminants in the initial layup. In addition, given this is a consistent narrow band and not a loose collection then this gives weight to an issue created during the hull's initial layup.
- There are a handful of light blisters approximately 1cm in diameter on both sides, outboard of the forward end of the keel.

Fig.2 – line of gelcoat deep blistering around the stern from midships.

It is advised to plane off the gelcoat in way of the waterline blistering back to the matting and reinspect for any deeper cases of blistering before laying a fresh coat of gel. Regards the blisters by the keel, the gelcoat can either be removed as per the waterline or simply monitored for any worsening over time. This should all be done in concert with the removal and reapplying of the coppercoat.

Repair the hull blisters aft and consider repairing those outboard of the keel or monitor for any worsening.

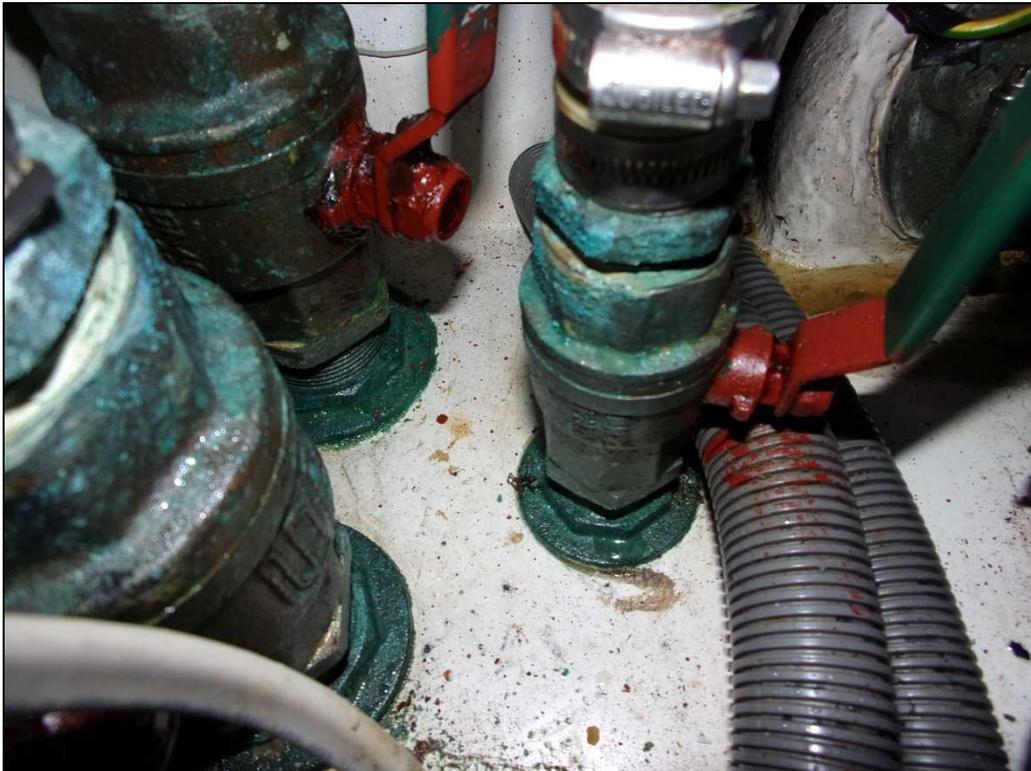
The engine coolant inlet is located aft of midships, outboard of the keel on the starboard side. The skin fitting could not be inspected due to being covered over by the lifting belt. Internally, this is fitted to a brass body seacock which operated satisfactorily but showing all over surface corrosion with red oxide painted onto the handle base. Although not seen on this seacock, adjacent ones for the water maker outlet(s) are stamped with the 'CR' marking indicating it is 'corrosion resistant'. The seacock should be cleaned off, inspected further and preserved if in good condition or it should be replaced at the next major service ashore.

Fig.3 – engine coolant seacock showing all over surface corrosion.

Free up and clean all seacocks with surface corrosion. All seacocks should either have 'CR' markings or 'CW602N' to ensure they are corrosion resistant.

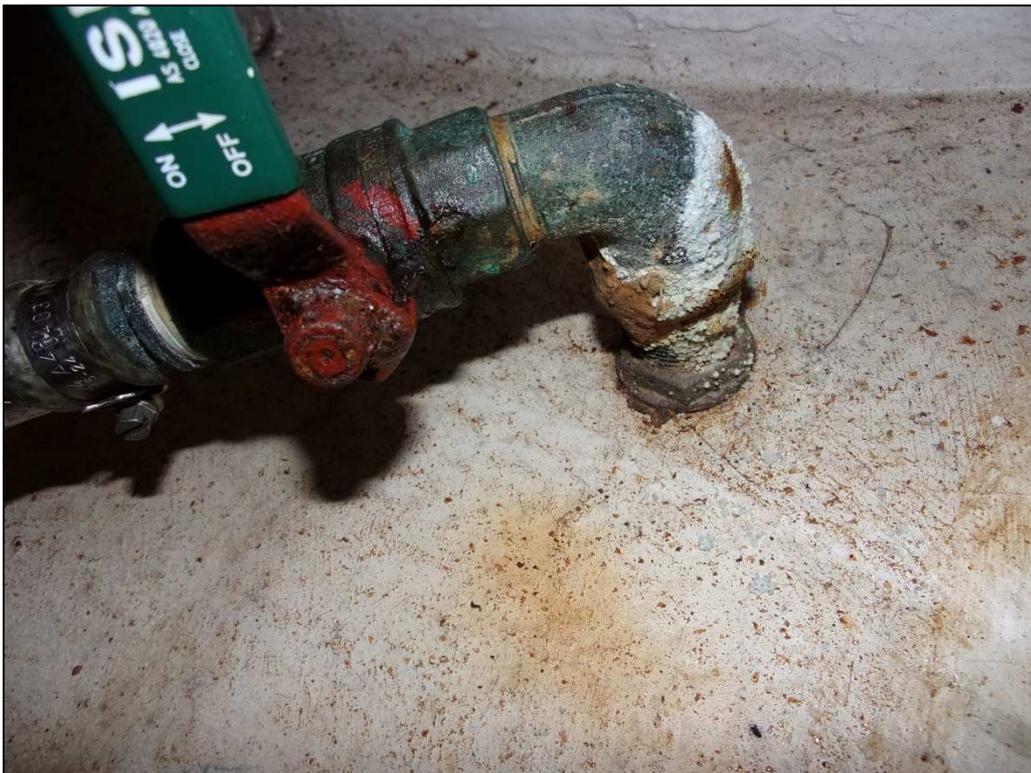
The inlet is located forward of midships by the keel on the port side and is a secure forward facing bronze scoop and showing signs of light dezincification. Internally, this is fitted to a brass body seacock which is showing signs of heavy deposits and corrosion. This was not tested and should be replaced.

Fig.4 – water maker inlet seacock showing deposits and corrosion.

Urgent Recommendation
Replace the seacock or remove and blank off.

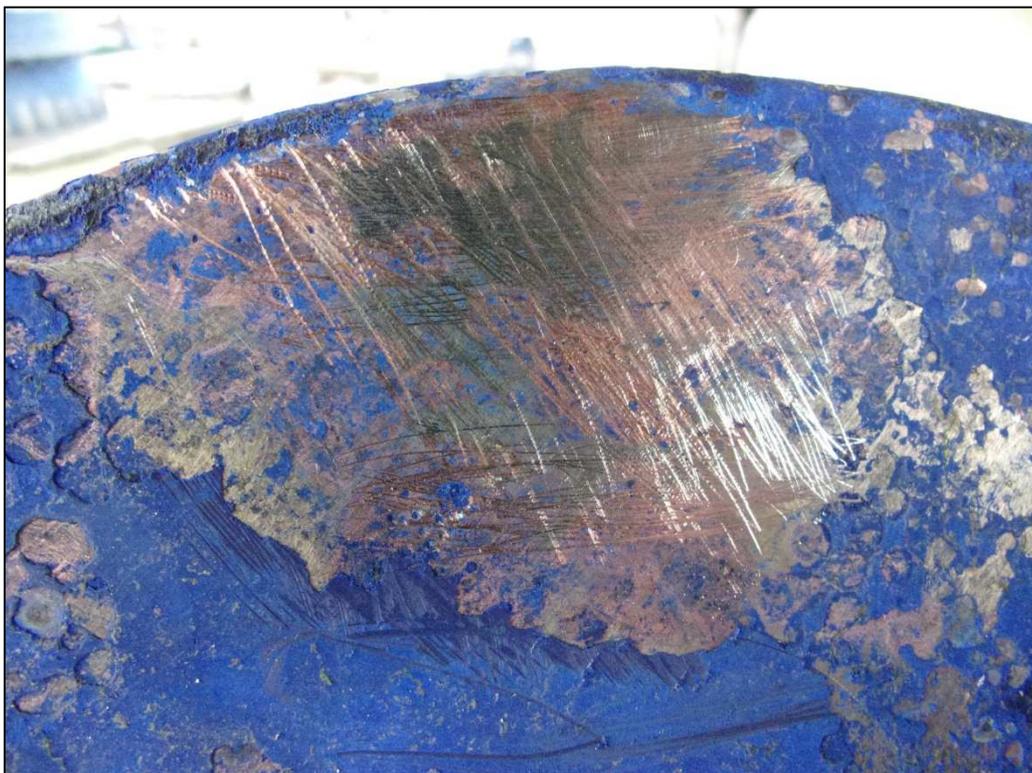
The propeller is a 'Bruntons' Autoprop of bronze construction with three blades, and in very poor condition due to heavy dezincification and this will need to be replaced along with the 'P' bracket which is heavily dezincified also

Fig.5 – signs of heavy dezincification on the propeller blades.

Urgent Recommendation
Replace the propeller and P bracket at the next available opportunity.

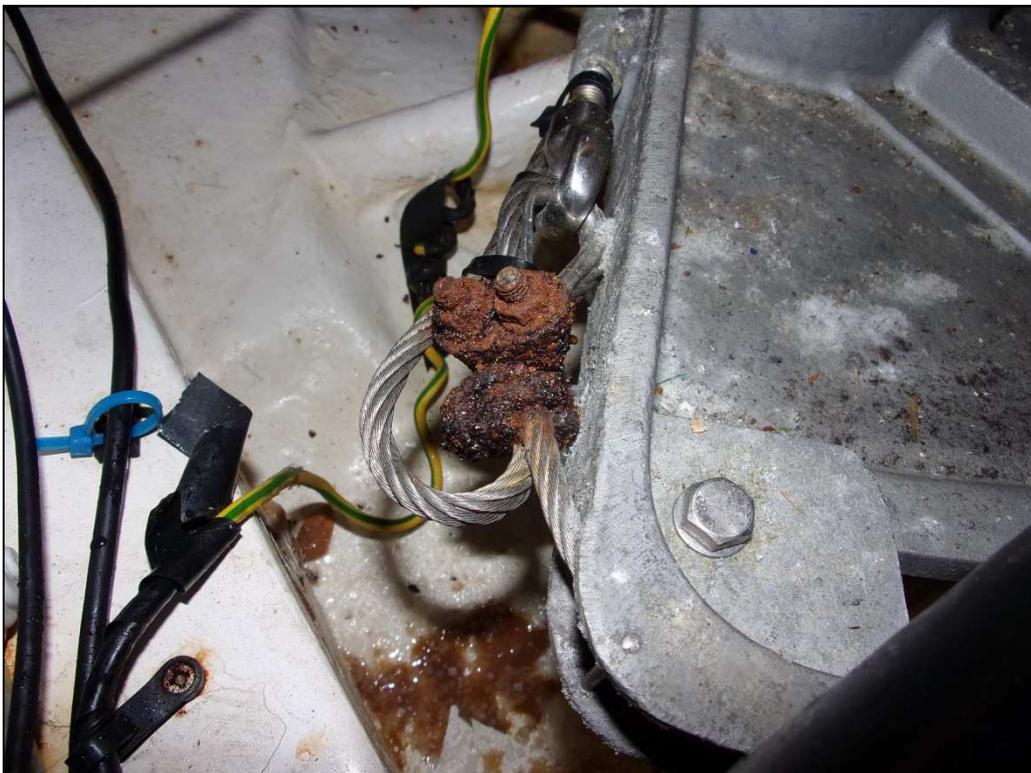
The rudder is turned via a quadrant itself rotated by a pulley and wire system connected to the helm wheel. The quadrant wires are clean and lightly greased but there is some slight slack in the wires and the wire securing shackles are heavily corroding.

Fig.6 – steering cable connecting shackles corroding.

Replace the securing shackles.

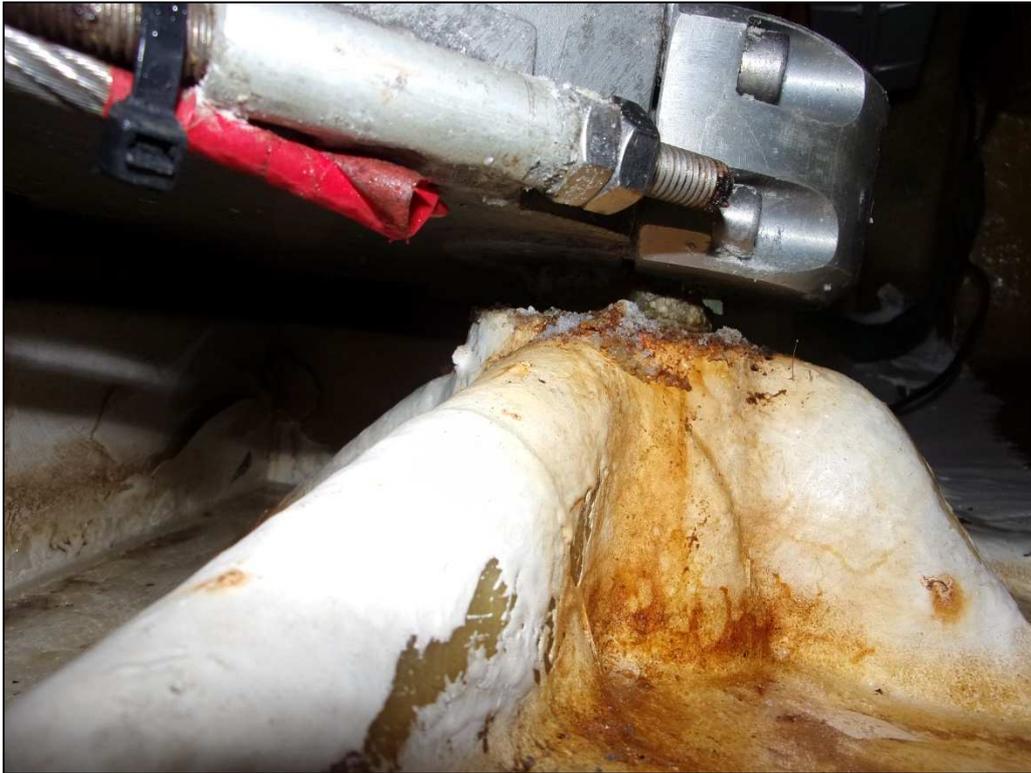
Fig.7 – rudder trunk gland showing leak and salt deposits.

The stock runs inside a supported GRP trunk with the gland located at the top. Visibility was limited but this has salt deposits noted all the way around, there is a leak 'run' down the side of the trunk and there is salt water in the bilge under the quadrant.

Replace the trunk gland and remove all standing bilge water.

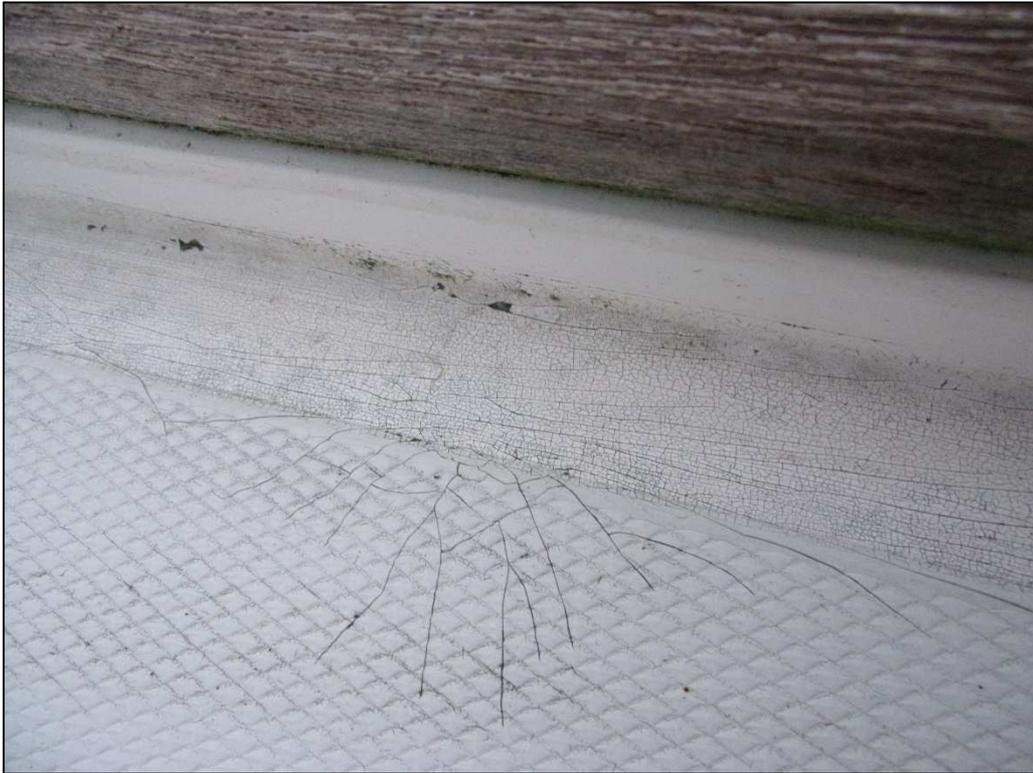
The deck is in white GRP with non-slip panels moulded into the horizontal surfaces. There are scuffs and small stress cracks at various spots around the deck edge / inboard side of the toe rail consistent with previous heavy use but nothing of any major concern and are therefore mainly cosmetic. There is a medium stress crack at the base of the cockpit moulding on both sides by the helm. The overall deck surface is dulled in appearance but there are no signs of any major damage or repair.

Fig.8 – example of minor stress cracking at the deck edge.

Repair all surface cracks on the deck or monitor for any worsening and repair when necessary.

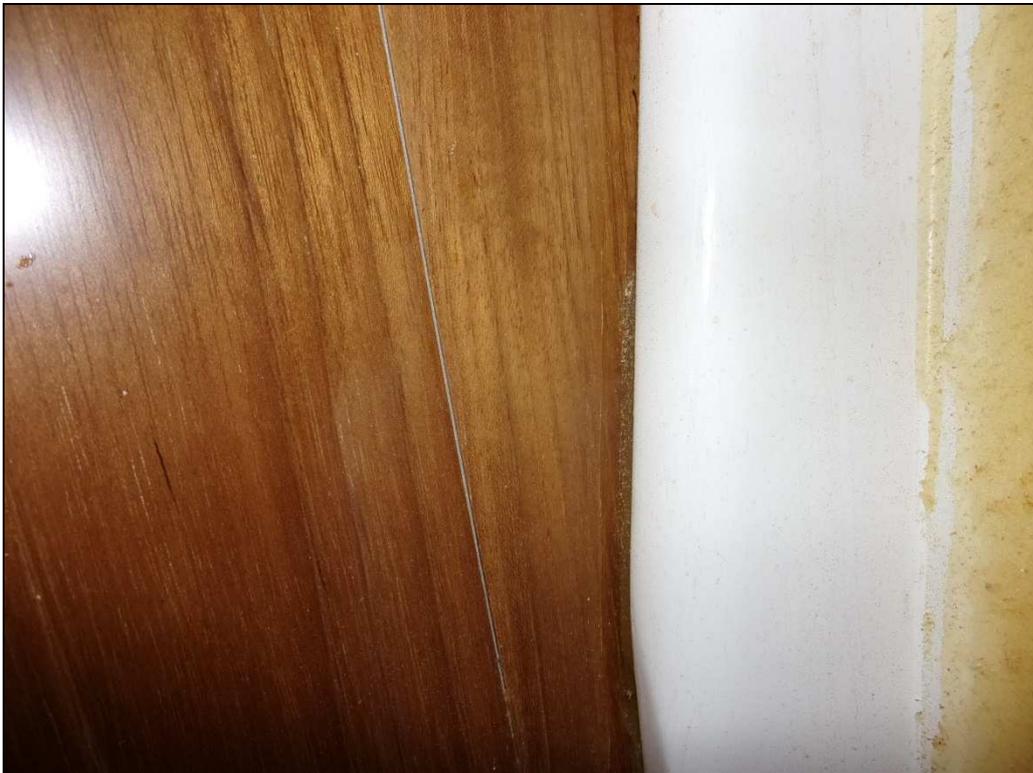
Fig.9 – bulkheads bonded / sealed to hull side mouldings.

The main and partial bulkheads are in marine ply, bonded securely to the hull mouldings and where seen, there were no signs of any movement.

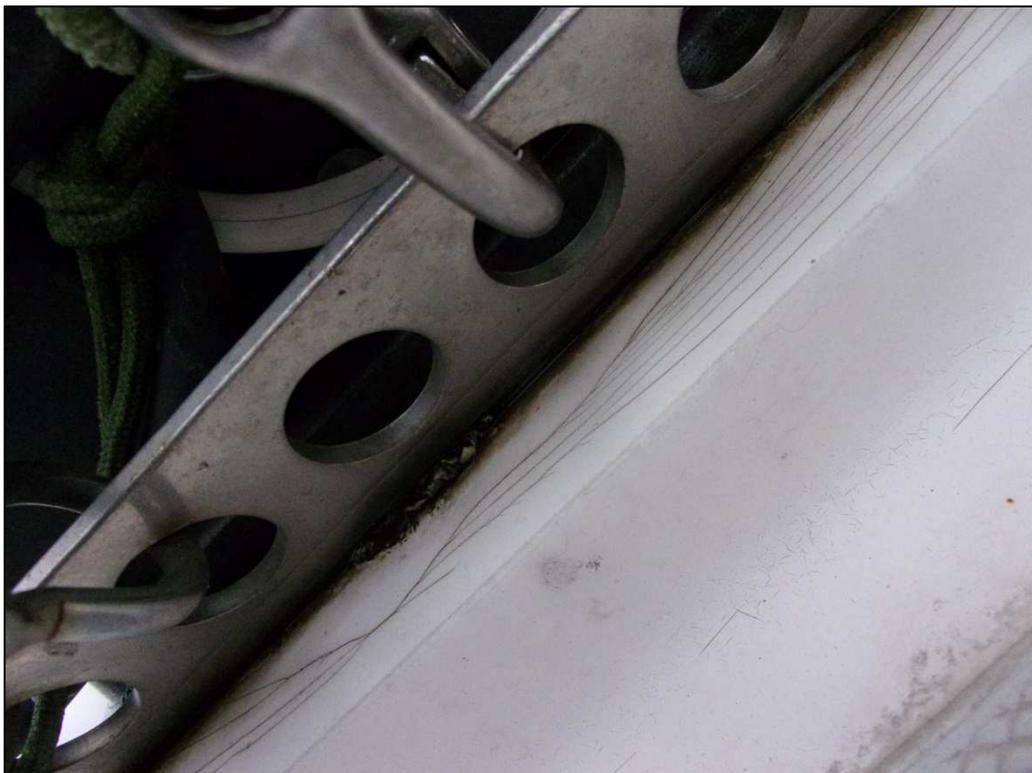
The mast is deck stepped on the coach roof moulding and a compression post is built in to the saloon and securely fitted to the keel moulding, though visibility was limited. It is securely pinned through to the foot, which in turn is securely bolted to the re-enforced deck moulding though there is a stress crack running parallel to the foot on the port side and this should be monitored for any worsening if not repaired. All through wiring is neat, watertight and internally, no evidence of leaks were noted.

Fig.10 – stress crack on the port side of the mast coach roof moulding.

Repair the stress crack and monitor.
