Structural Survey Report

Sargo 36 Fly

'Sea Buzzard'

Hamble Point Marina, Hamble, Hampshire, UK

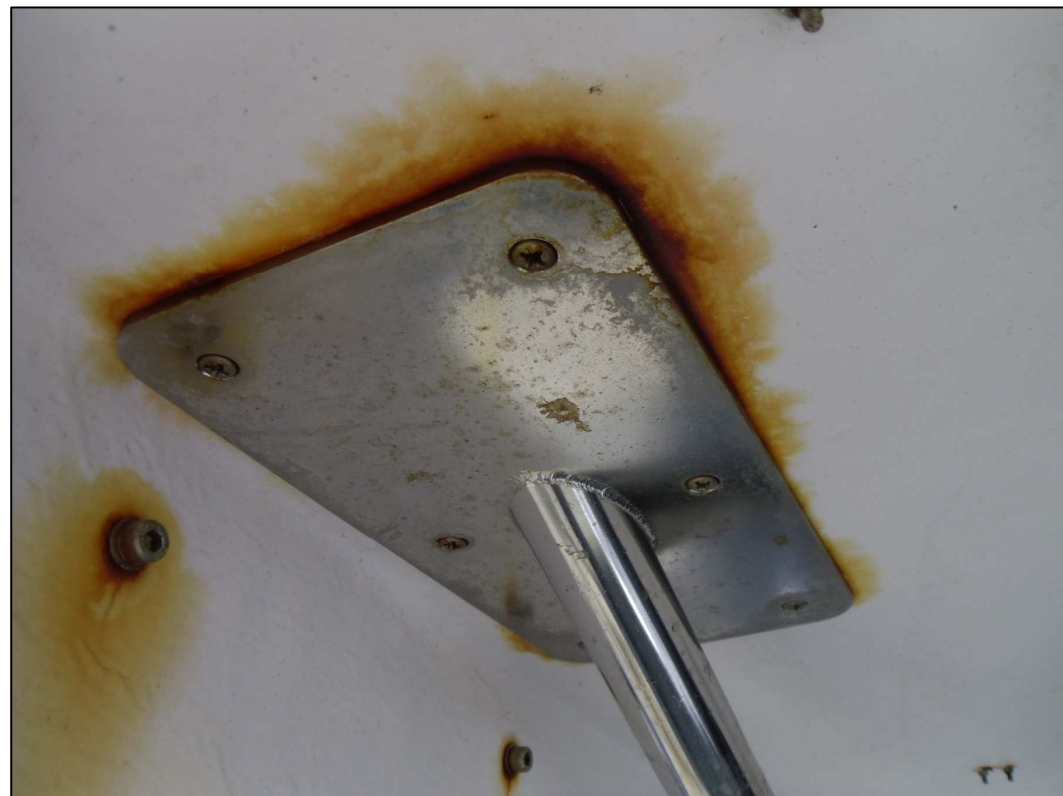
This is in blue pigmented GRP with a bolted on white GRP bathing platform and both are in a sound condition. There are teak sections fitted into the bathing platform and these are all in a sound condition and there are 4 x supports fitted to the platform underside and the hull. There is corrosion staining to most of the platform securing bolts and also to the support ends and fixing plates, but there are no signs of any movement. Internally, there are no signs of any corrosion or weeps through the bolts.

Fig.1 – corrosion staining to the platform securing bolts and support brackets.

Polish out the corrosion staining and monitor the fixings for any main corrosion.

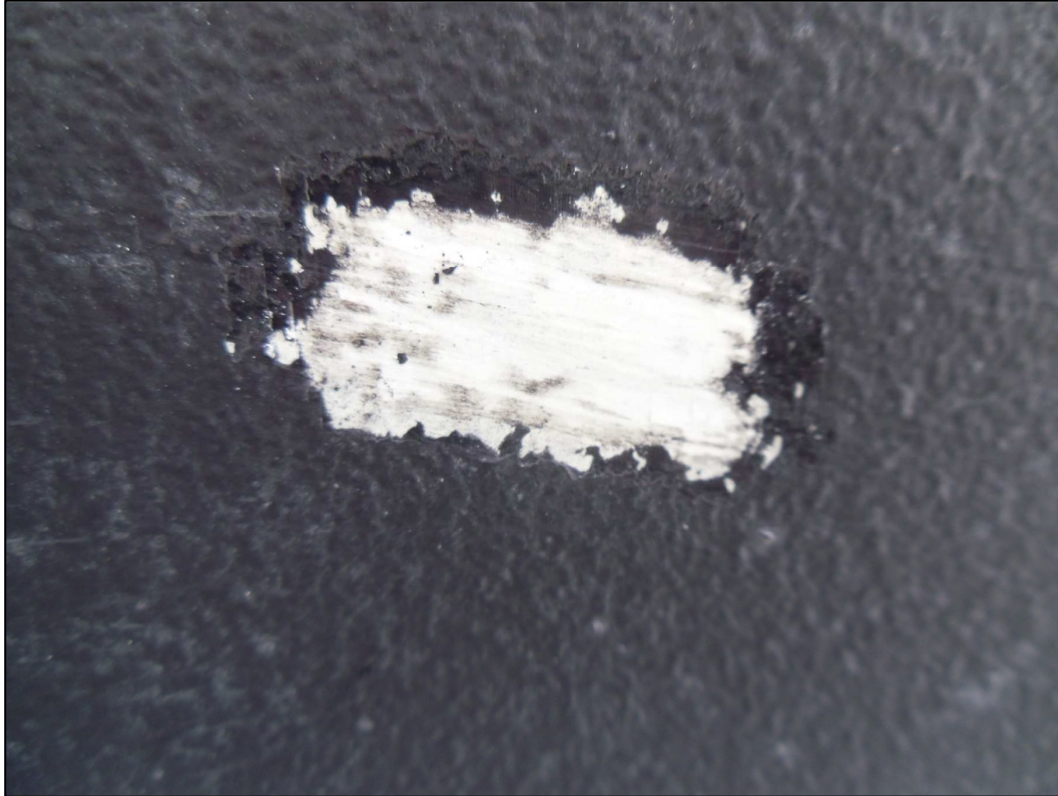
The antifoul is in black and appears to be factory applied original and is adhering well to the GRP. There is applied over a grey primer and no epoxy resin is applied.

Fig.2 – hull coatings scraping showing black antifoul over a grey primer.

At the next application of antifoul, consider the application of an epoxy resin coating to ensure prolonged hull life.

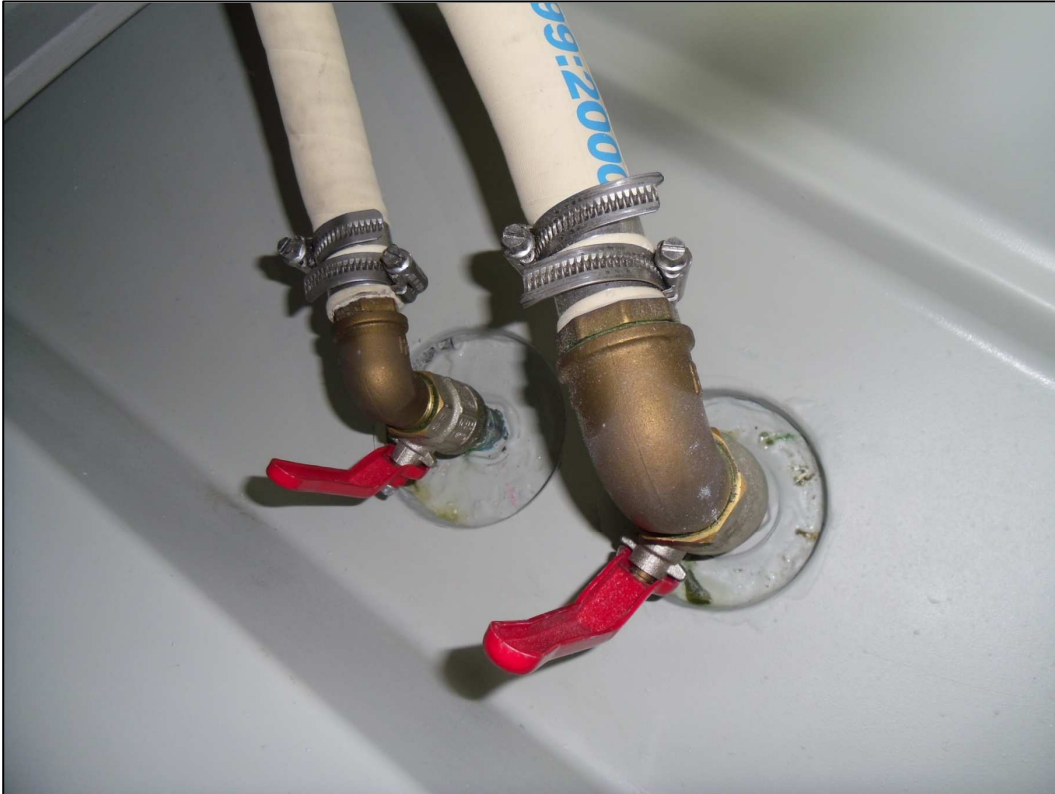
There are 2 x brass bodied ball valve seacocks located under the aft bunk in the aft lower cabin. These operated satisfactorily and are in a serviceable condition, though both handles are lightly loose and these are not 'CR' (corrosion resistant) marked. Both are fitted with brass elbows and double clipped to sanitary grade hoses. It was noted that there are some small droplets of salt water around both and the body threads are showing some surface corrosion.

Fig.3 – both toilet seacocks showing some small droplets of salt water.

Remove the droplets and monitor this area once relaunched. Investigate the cause of possible sea water leak and resolve if they return.
