ANCHOR HOUSE MARINE SURVEYS

Full Condition Survey

Prestige 450 Flybridge

'Mister Smee'

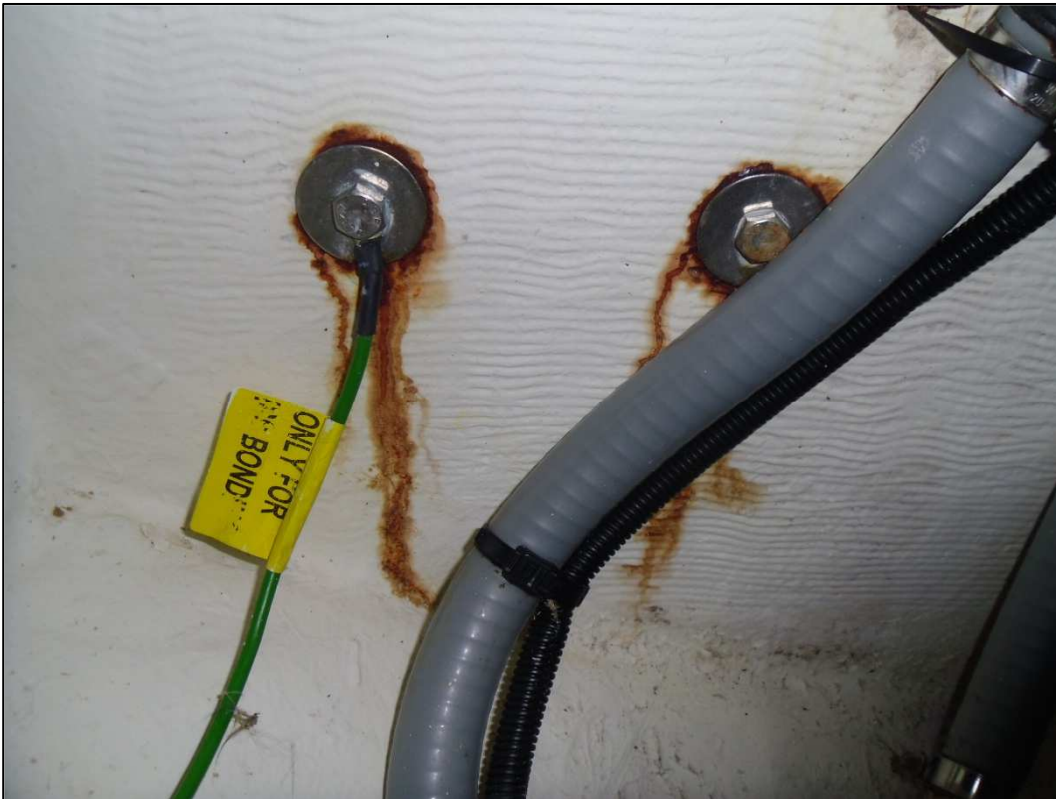
All GRP construction with a deep 'V' planing hull with a raked entry and a transom stern, carrying her maximum beam aft of amidships. This is in good condition. Internally, there is evidence of a leak through the transom starboard anode fixings, but no water was seen leaking at the time of survey.

Fig.1 – evidence of leaks through some of the transom fixings.

Ensure the connections are no longer leaking and clean up.

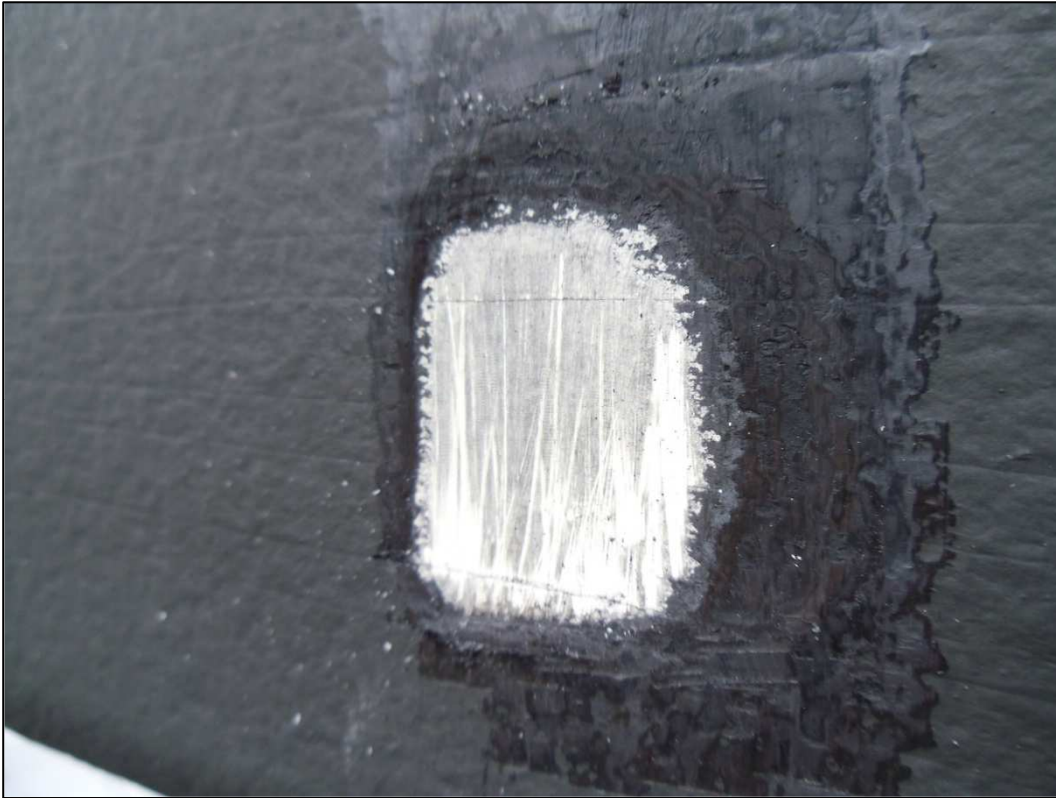
2. The antifoul has been renewed but lightly rough due to overpainting. The gel condition is good, though there is a stress crack at the chine on the starboard side. The outer bottom laminates were tested for moisture content and the resulting readings were in the dry to medium scale.

Fig.2 – stress cracks in the coatings and gelcoat.

Repair the stress crack in the chine.
