ANCHOR HOUSE MARINE SURVEYS

Full Condition Survey

Fairline Squadron 58

'Dreams to Reality'

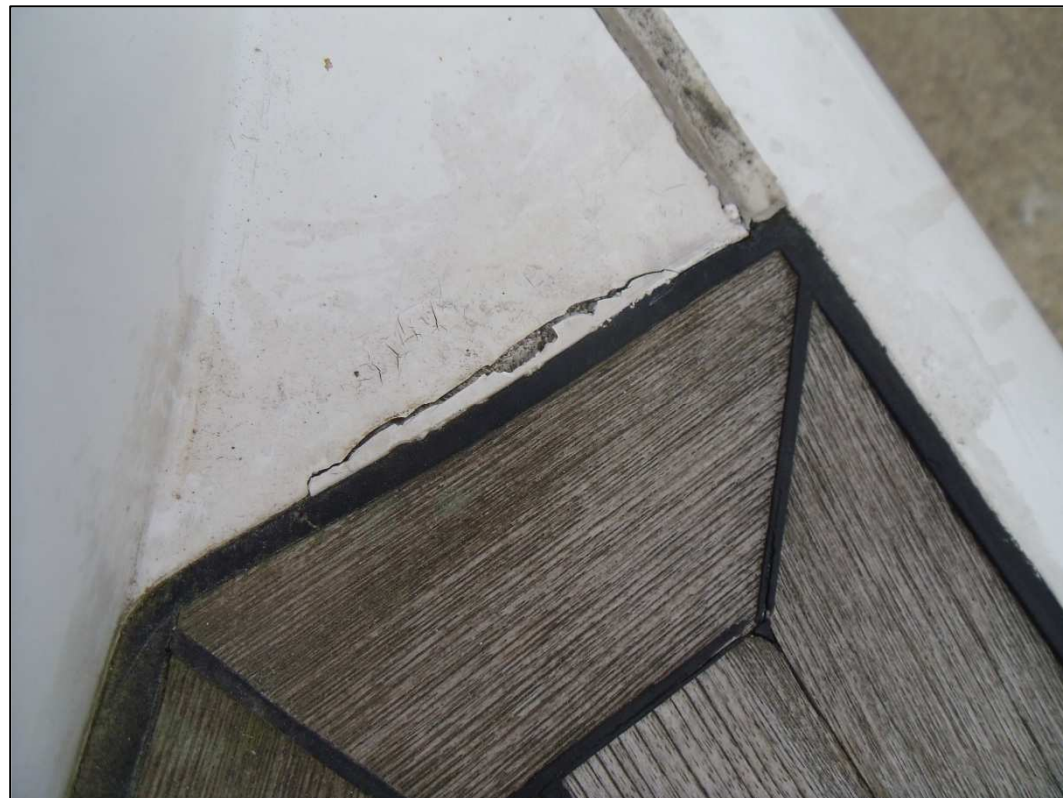
This is in white GRP with an integrated bathing platform laid with teak decking panels and a 'Williams' tender is stored here. This is generally sound but in addition to signs of normal wear and tear, there is some scuffing in the gelcoat by the transom port gate, a small stress crack in the port edge of the bathing platform, a stress crack with some gel damage in the starboard forward edge of the bathing platform and some gaps in the vertical sealant on the starboard side of the bathing platform aft edge. The teak decking, where accessible, is in a serviceable but lightly weathered condition. The bathing platform fender consists of a black rubber strip in a securely fitted stainless steel runner and this is in overall good condition, though with some light dents noted in way of the stress cracks.

Fig.1 – gelcoat cracking starboard forward on the bathing platform.

Repair the gelcoat stress cracks and damage.

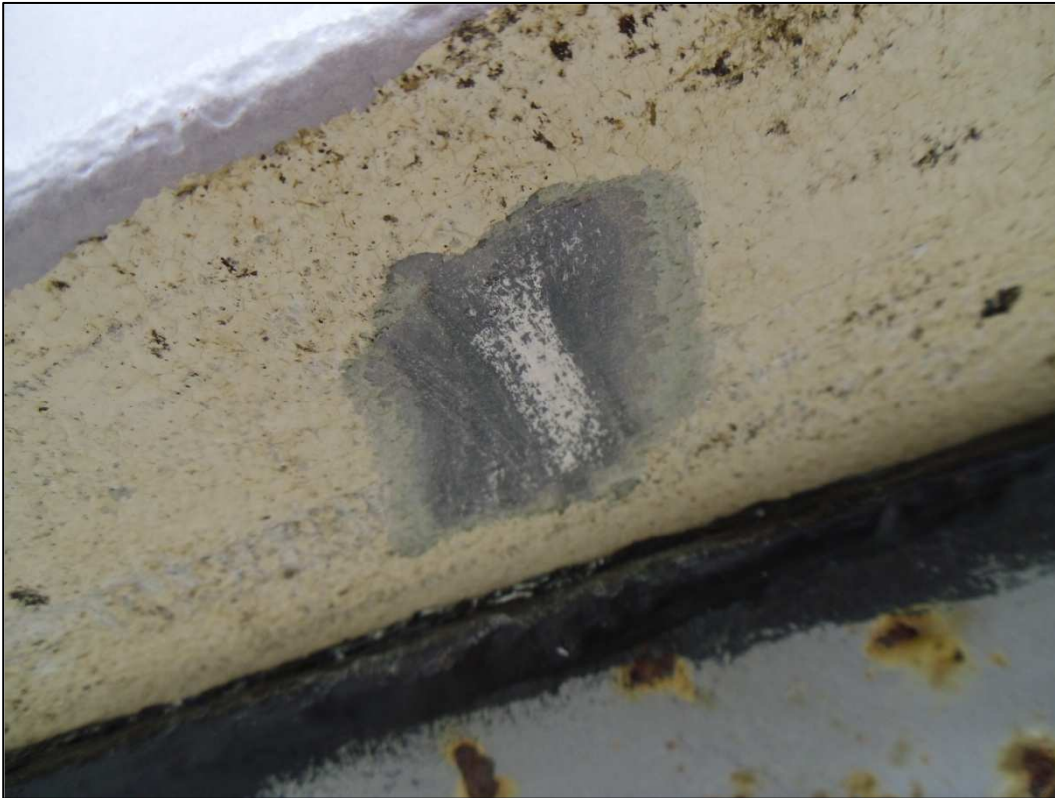
The antifoul is in recently applied grey and adhering well, though rough in some areas such as around the waterline due to overpainting. There is no epoxy resin applied and coatings consist of a various antifoul coatings with a grey base primer.

Fig.2 – coatings consisting of antifoul and primer layers.

Remove the antifoul back to GRP and replace at the next service ashore. Consider the application of an epoxy resin like 'International' Gelshield to prolong hull life.

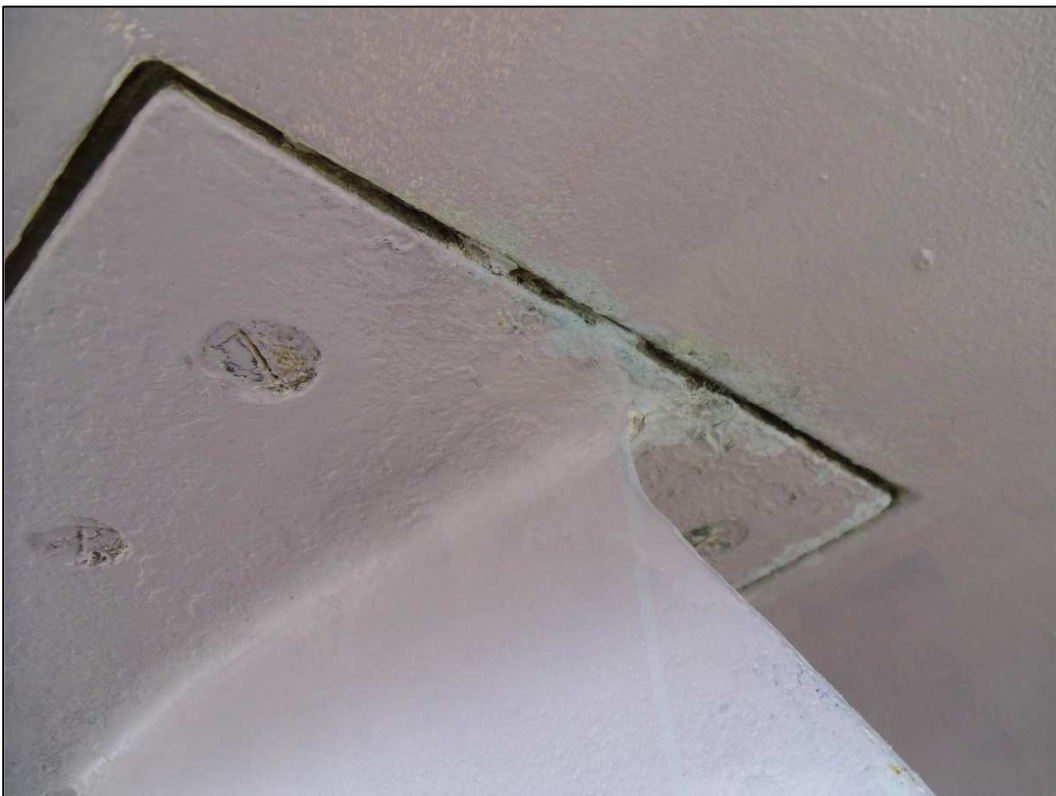
These are in bronze, secure and in a good condition. The palms are securely located but the gaps around the join on both sides are not sealed. There is some light deposit weeping from the port palm aft end, but access to the palms internally was not possible.

Fig.3 – some light weeping / deposits from the aft end of the port palm.

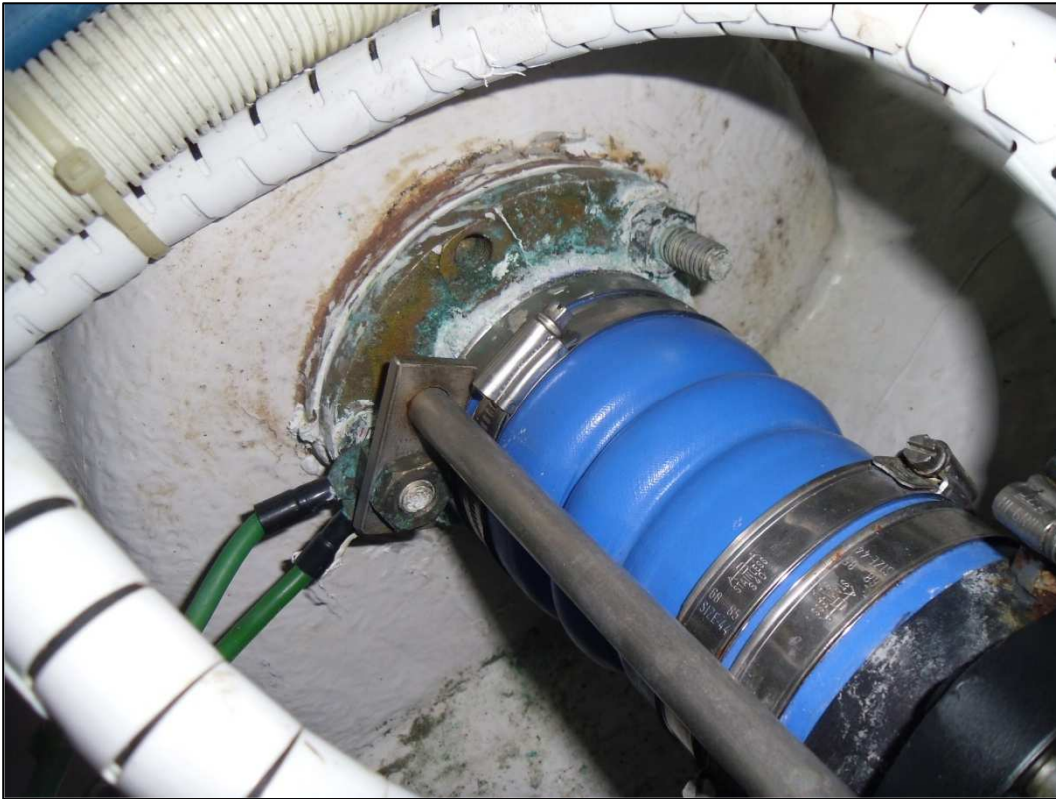
The mechanical face seal, water cooled type stern glands are in a serviceable condition, though there are salt deposits around the port stern gland to stern tube connection indicating a possible leak. Though after the sea trial, no leaks were noted.

Fig.4 – salt deposits are evidence of a leak from the port stern gland.

Clean off all salt deposits and monitor for any leaks during operation.

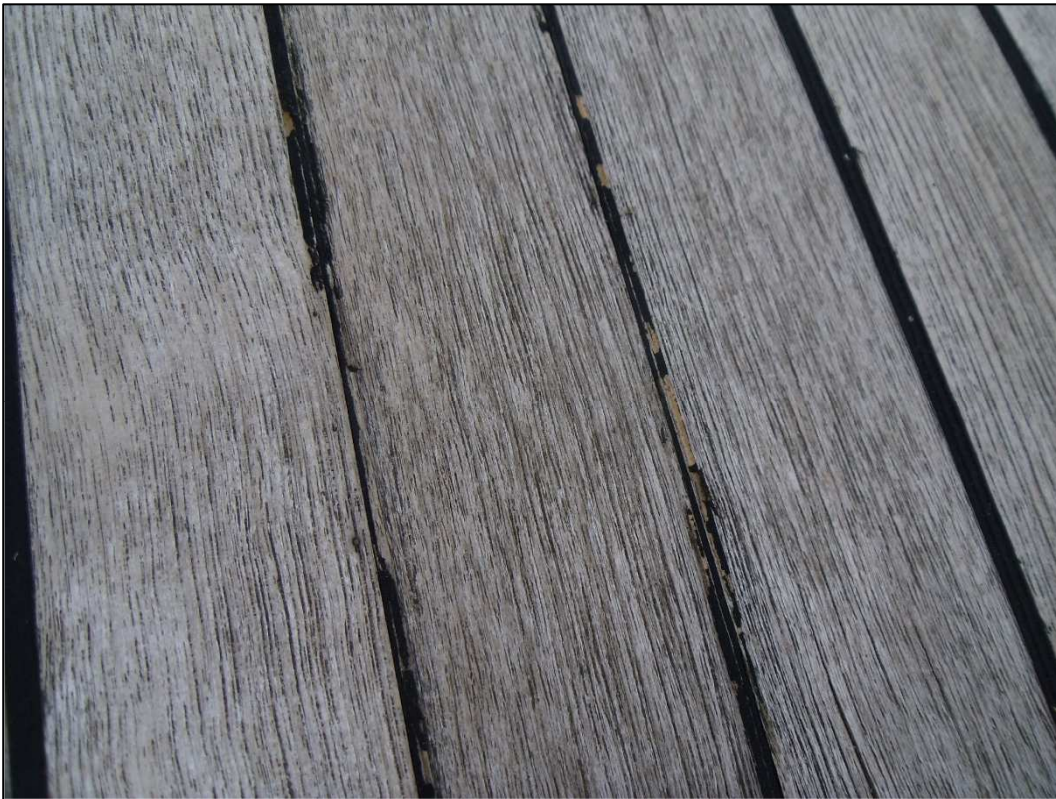
The side, cockpit, bathing platform and flybridge decks are in white GRP laid with teak throughout. This is in a sound but weathered condition overall and there are some areas of worn or missing caulking with small gaps showing, especially forward by the windlass area, though nothing of any major note. The flybridge deck has areas of staining and weathering, particularly in the aft seat lockers along with areas of mould starting due to the ongoing wetness inside. The margin board to superstructure sealant is serviceable with no clear gaps showing that would allow water to get underneath and start lifting the decking. The side decks have a moulded toe rail with gaps along its length to allow for drainage.

Fig.5 – teak decking showing areas of worn or missing caulking.

Have the teak decking cleaned and then inspected for any required repairs by a teak specialist.

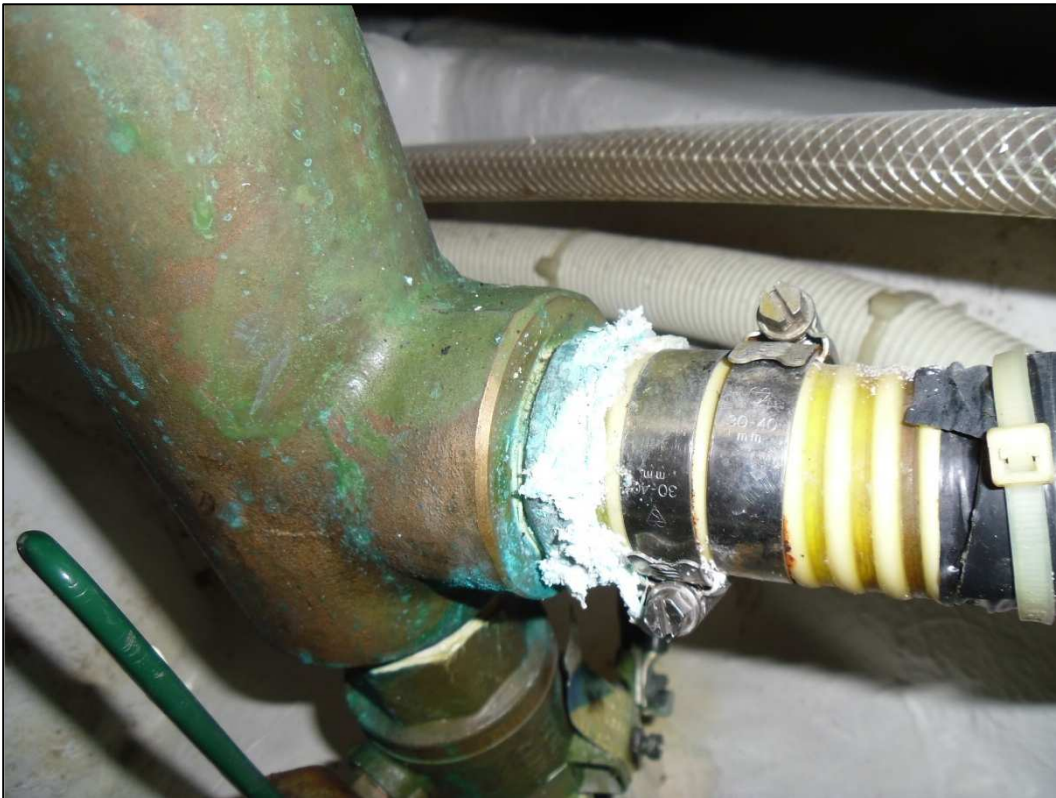
Fig.6 – air conditioning coolant seacock strainer outlet with salt deposits.

Free up any loose seacocks and remove any corrosion / patina / salt sludge as required.

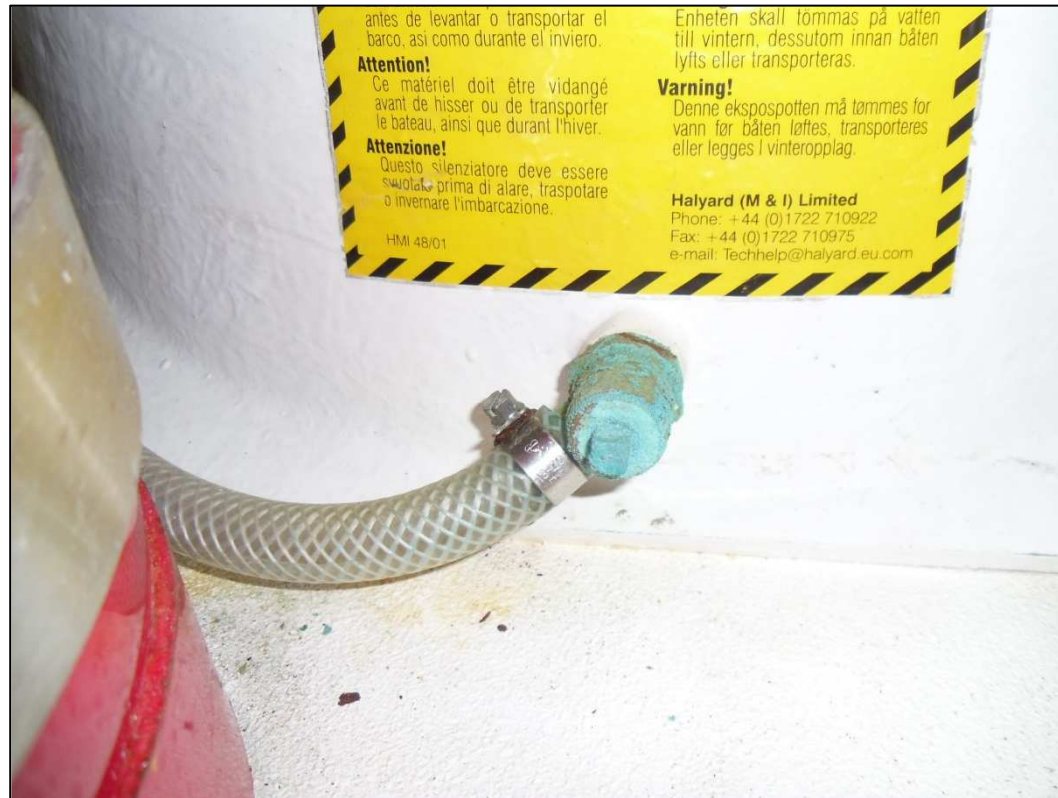
Note – the exhaust waterlock drain fixings in the engine room aft are showing signs of corrosion.

Fig.7 – corrosion to exhaust box drain connections.

Clean off all corrosion and reinspect drain tap connections for any possible leaks.
