ANCHOR HOUSE MARINE SURVEYS

Limited Outer Bottom Survey

Fairline Phantom 43AC

'Quirky Lady'

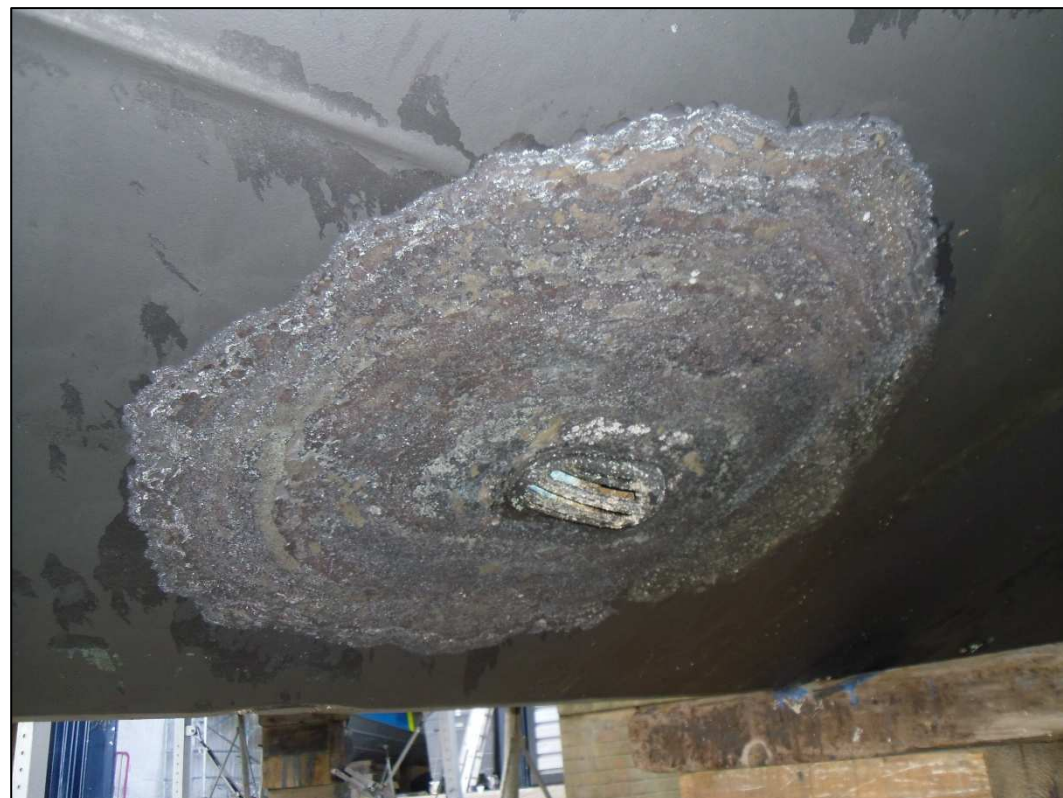
The antifoul is in 'Coppercoat', which the owner stated is 7 years old, and is overpainted with a thin black antifoul layer which is flaking and peeling in areas. However, around the various metallic skin fittings, the Coppercoat has reacted and blistered all the way around. Precisely why this has happened is unknown, but it is possible the different metals have reacted. It may also be a result of this plus the electrical bonding of the majority of the fittings all reacting as one, as the sea water acts as an electrical conductor between the various metals. Where the blistering was scraped away, the Coppercoat is still in a serviceable condition.

Fig.1 – Coppercoat blistering / reaction around skin fittings.

- Hull – this produced readings ranging from 70 to 160 which is in the dry scale, but where the meter was placed on the blistering patches, the readings were maximum. The hull around the bow thruster tunnel returned dry scale readings as well as around the stern thruster on the transom.
- Transom – readings ranged from 120 to 150 which is in the dry scale.

Remove all black antifoul. Scrape back all blistered Coppercoat back to a fresh layer. Remove the Coppercoat around all metallic components and fittings back to bare GRP, leaving around a 1" gap.

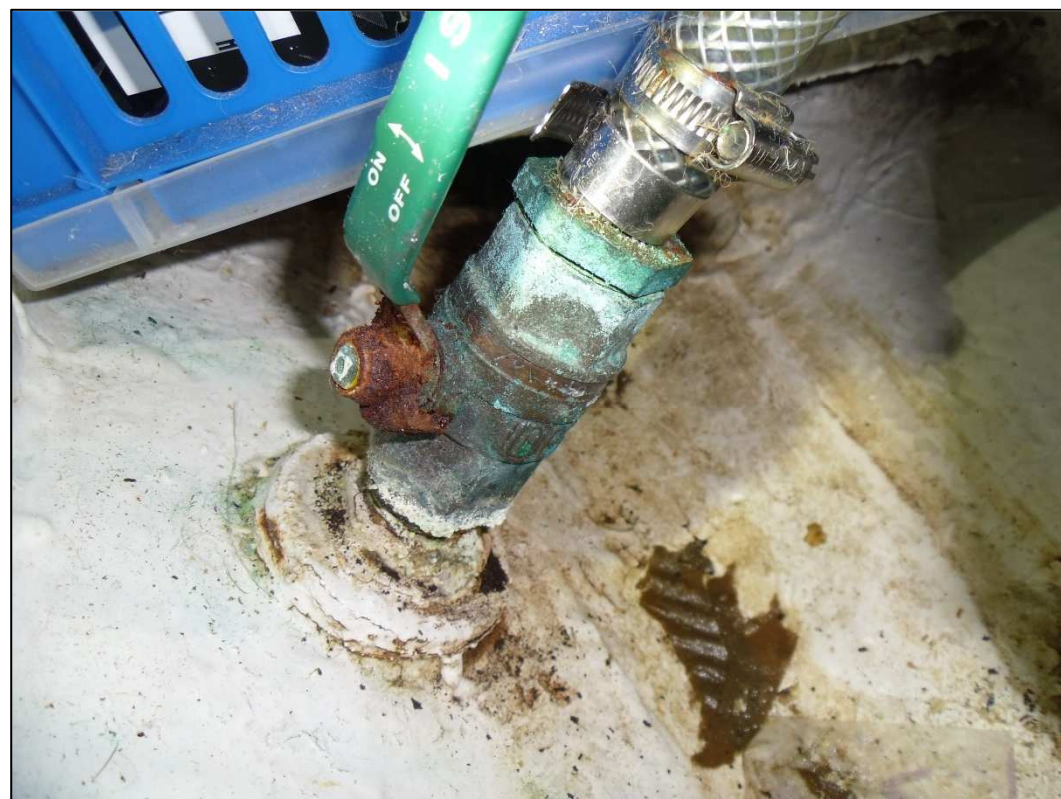
Fig.2 – salt deposits and corrosion to the forward toilet inlet seacock base and handle.

- The forward cabin toilet inlet is located aft of the bow thruster tunnel on the port side and is a secure, small bore bronze fitting in good condition. Internally, this is fitted to a 'CR' marked (corrosion resistant) brass bodied ball valve seacock which operated satisfactorily but has salt deposits and corrosion noted in areas with corrosion to the handle base. The outlet is in double clipped clear reinforced hose.

Free up any tight seacocks and service all seacocks, removing deposits and corrosion. Ensure all hoses are double clipped and where necessary, replace any poor condition seacocks.

All seacocks must be 'CR' or 'CW602N' marked types, full bronze types or 'Marelon' plastic types. Do **not** use 'CW617N' marked brass types.

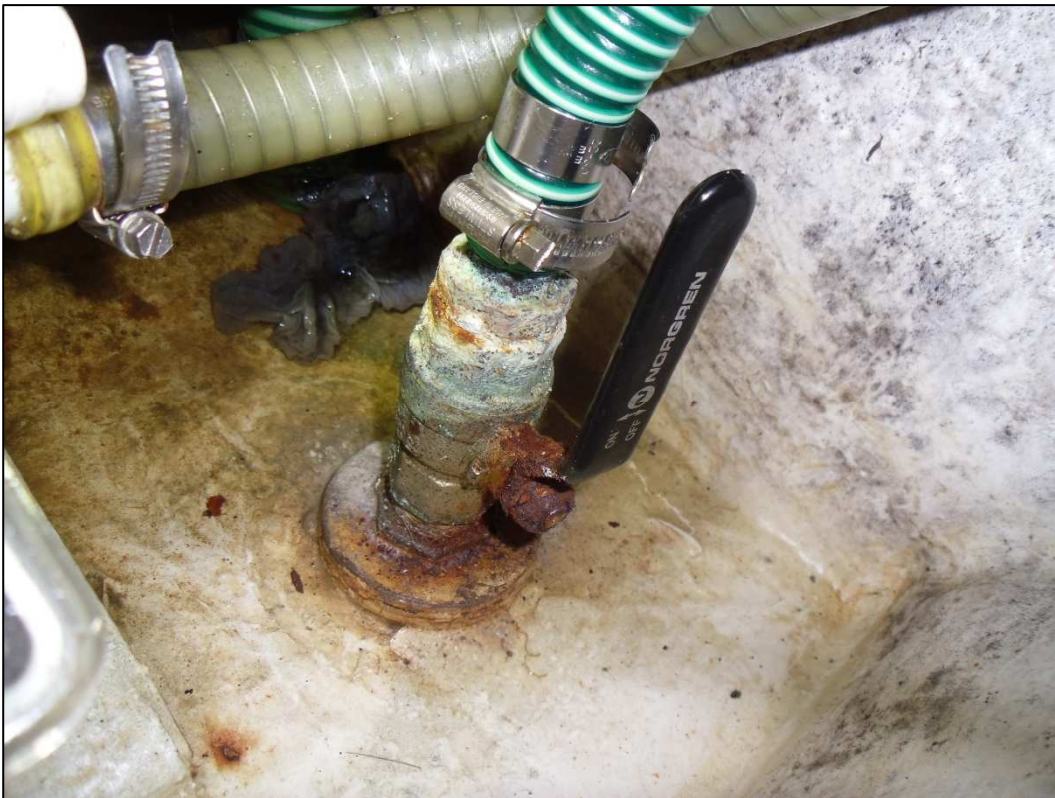
- The aft cabin toilet inlet is located forward of aft on the port side and is a secure, small bore bronze fitting in good condition. Internally, this is fitted to a brass bodied ball valve seacock which operated satisfactorily but has quite strong deposits and corrosion to the upper section with corrosion to the handle base. The outlet is in double clipped green and white reinforced hose.

Fig.3 - deposits and corrosion to the aft toilet inlet seacock and handle.

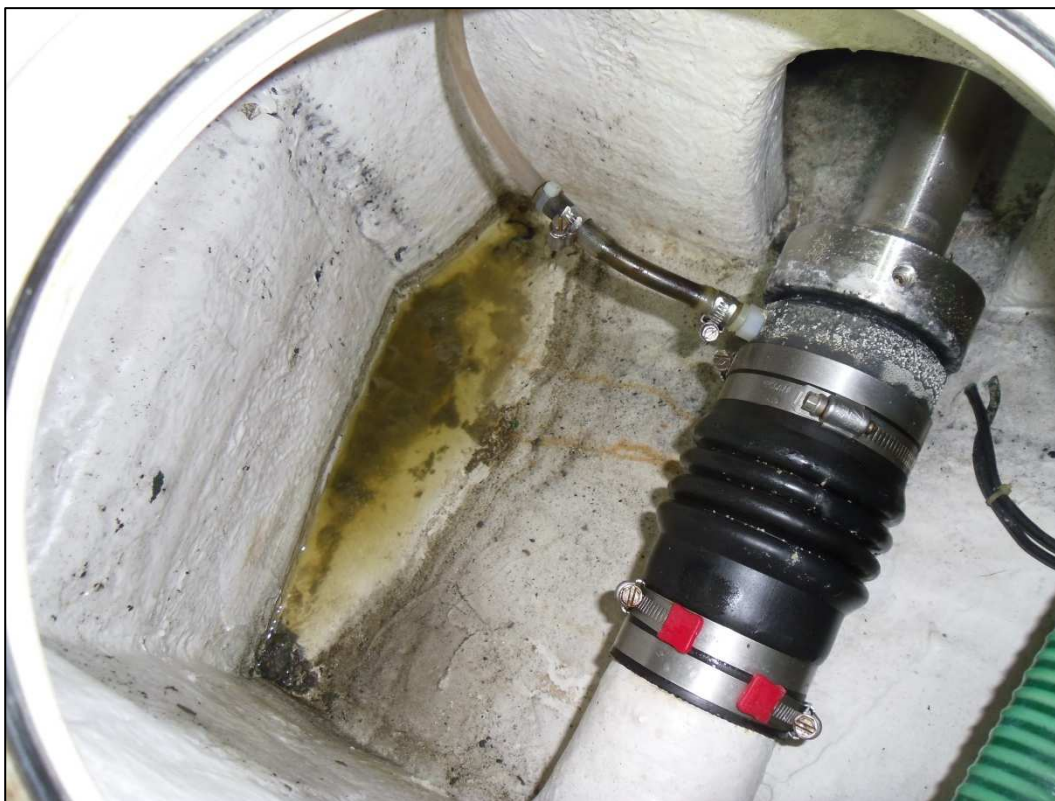
These are water cooled, mechanical face seal types with the port unit in a serviceable condition under the aft cabin deck. This is dry, though there is evidence of a previous leak. The starboard unit is located under the shower tray but this one has a leak and corrosion is starting to appear on the seal ring.

Fig.4 – starboard stern gland has a leak with long standing salt water in the bilge.

Repair or replace the starboard stern gland. Monitor both regularly.

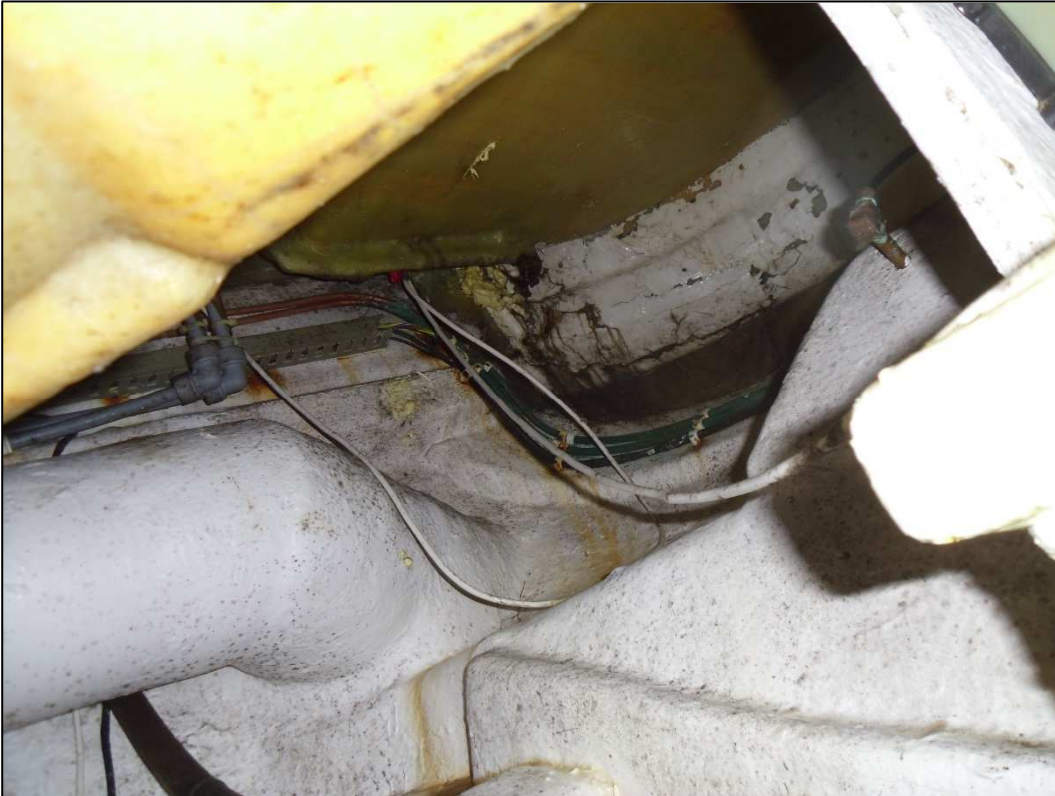
The rudders are turned via a hydraulic ram and tiller link arm installation operated from the twin helm power steering circuits. However, it was noted that the main copper lines are showing various areas of corrosion / patina along their length, heaviest in the starboard corner where seen and were all wet at the time of survey. There is a leak coming through the starboard aft end / bathing platform which is corroding the copper pipes in the area. It was noted the bathing platform rubbing strip is missing and leaks may be coming through the various fixings.

Fig.5 – various water leaks from the aft end / bathing platform on the starboard side.

Replace the copper pipes with modern hydraulic hoses as an upgrade. Resolve the leak and reinstate the missing fender strip.

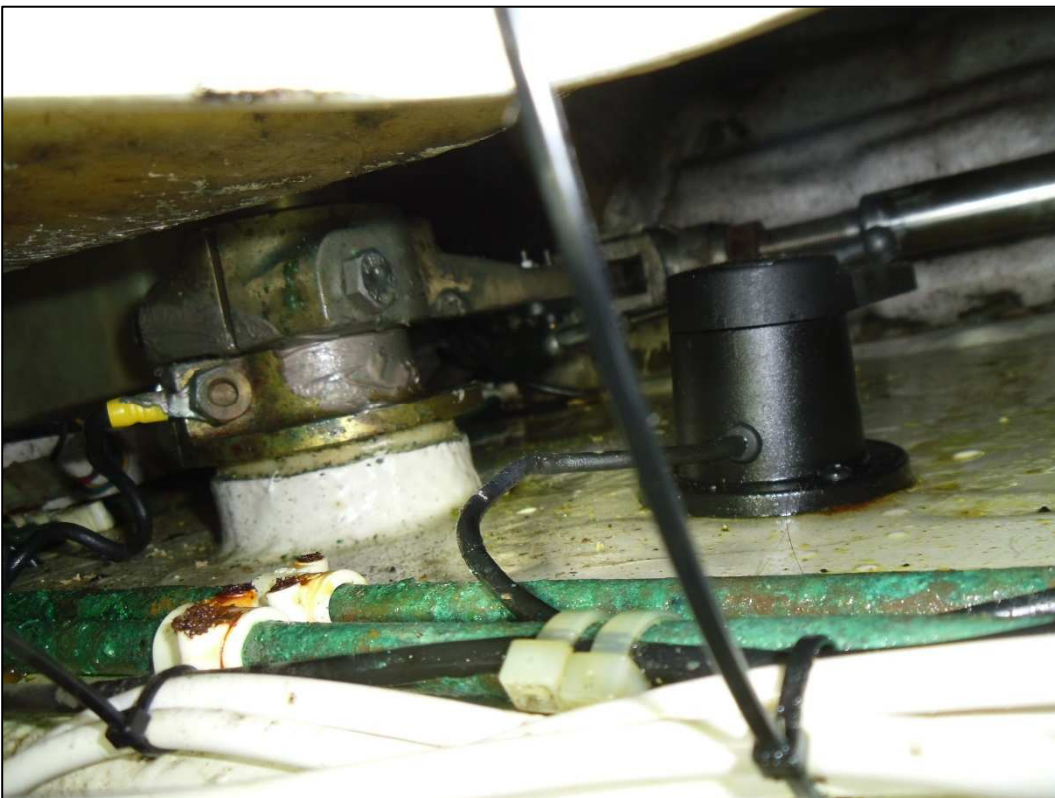
Fig. 6 – hydraulic copper pipes all showing signs of heavy patina / corrosion.

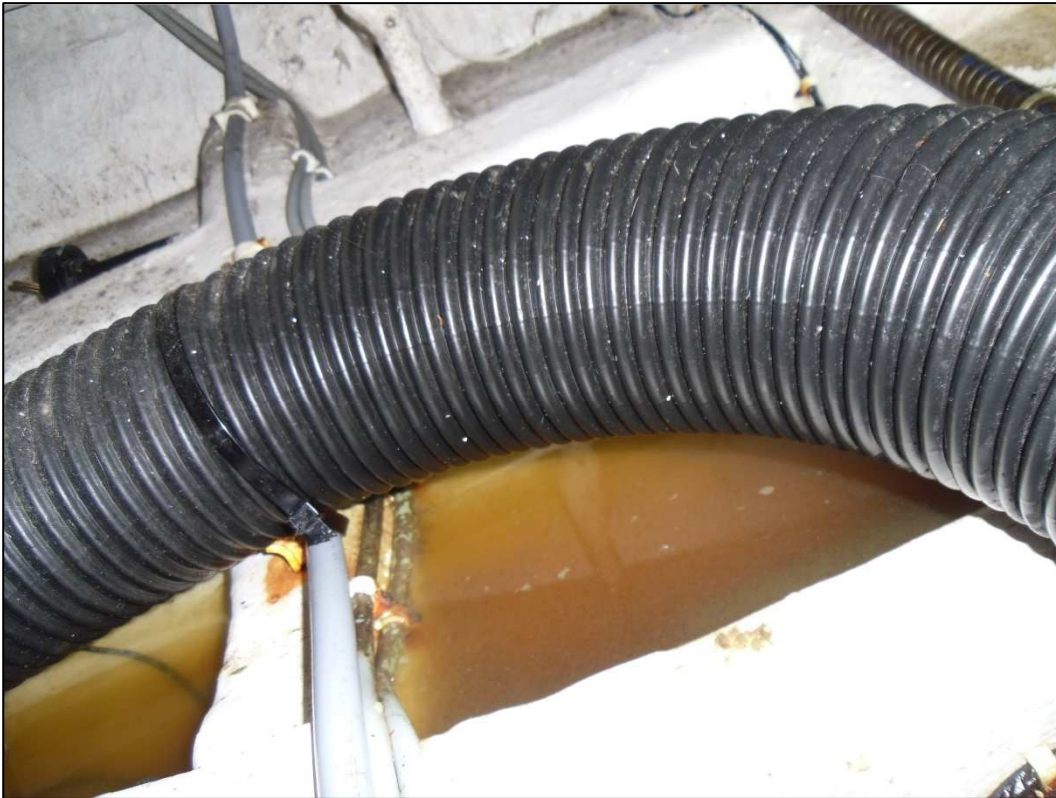
There are moulded fore and aft stringers and frame sections bonded to the hull with GRP coated, marine ply floors bonded between the hull and deck tray to give extra stiffness to the structure. Where seen, there are no clear signs of any movement but there is salt water in the bilge, particularly aft due to a leak from the starboard stern gland. The fore cabin deck access panel cannot be accessed as the carpet has been glued over the top.

Fig.7 – areas of long standing salt water extreme aft and outboard on the starboard side.
