# ANCHOR HOUSE MARINE SURVEYS

## **Limited Outer Bottom Survey Report**

**Axopar 37**

Trafalgar Wharf, Portchester, UK

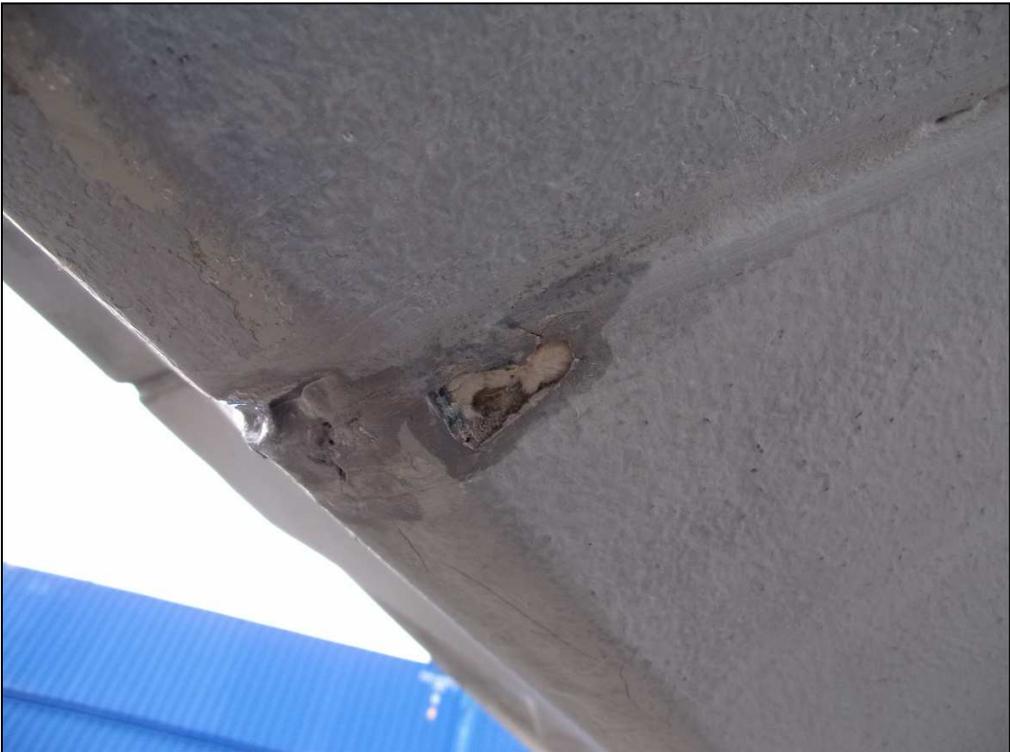
<p><b>Hull</b></p> <p><i>Hull:</i> All original GRP construction, deep ‘V’, twin stepped planing hull running into a shallow ‘V’ bilge with a shallower run aft to a transom stern. She has bilge chines and spray rails moulded at and below the water line.</p> <p><i>Hull Coatings:</i> The outer bottom is coated with grey antifoul paint and this is smooth and well adhered to the underlying GRP in general. There are some small areas forward where the antifoul is thinner and lightly detaching.</p> <p><i>Gel Condition:</i> The gel appeared smooth overall with no obvious defects or signs of any blistering or delamination. However, there is a small defect / void immediately forward of the bow thruster on the port side of the keel.</p>

<p><b>Fig.1</b> – defect / void in bow thruster base moulding.</p> <p><i>Moisture Level:</i> Moisture readings were taken with a ‘Protimeter’ Aquant 2 meter at more than 80 positions over the outer bottom area and these produced readings mainly in the low to medium scale. There were high areas recorded (around 180 – 200) around the bow thruster base moulding, especially forward and along the keel, from midships to aft. Internal inspections showed varying levels of bilge water present. The scale used is 0 – 160 (dry) / 161 – 200 (medium) / 201 – 999 (wet).</p> <p><b>Cathodic Protection</b></p> <p><i>Anodes:</i> There are the following installations:</p> <ul style="list-style-type: none"><li>• 6 x specialist anodes on the transom shield base, trim ram bases, above the cavitation plate and inset into the underside of the cavitation plates per engine.</li><li>• 2 x circular anodes bolted through the trim tabs.</li><li>• 1 x cone anode on the bow thruster propeller.</li></ul>	<p><b>Recommendation</b> Replace the antifoul at the next service ashore and give consideration to applying an epoxy coating to the GRP to ensure maximum protection from moisture ingress.</p> <p><b>Recommendation</b> Repair the defect / void in the bow thruster base moulding and investigate under paint crack for possible GRP damage.</p> <p><b>Recommendation</b> Remove all bilge water and allow the areas to dry out and monitor for any future ingress.</p> <p><b>Recommendation</b> Repair the leaking fitting on the fresh water tank as this is causing the bilge water forward.</p>

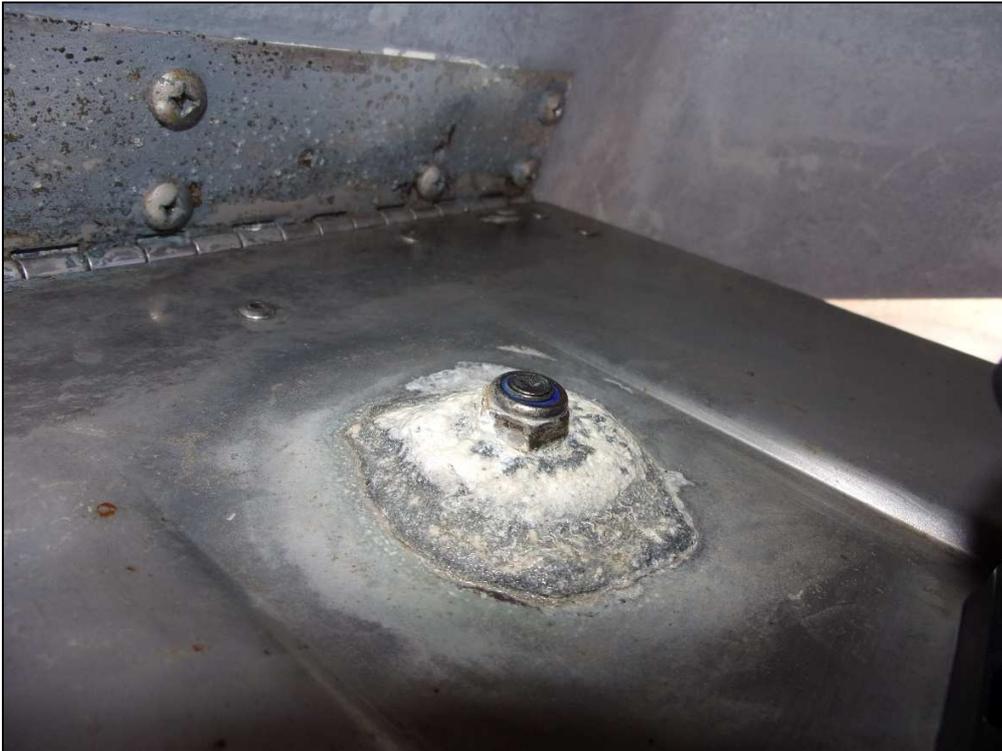
- Engine – 5% approximately.
- Trim tab – 50%+ approximately.
- Bow thruster – 15 – 20%.

**Fig.2** – trim tab anode.

**Recommendation**

Replace both trim tab anodes.
