ANCHOR HOUSE MARINE SURVEYS

Full Condition Survey Report

Hanse 455

'Ratatosk'

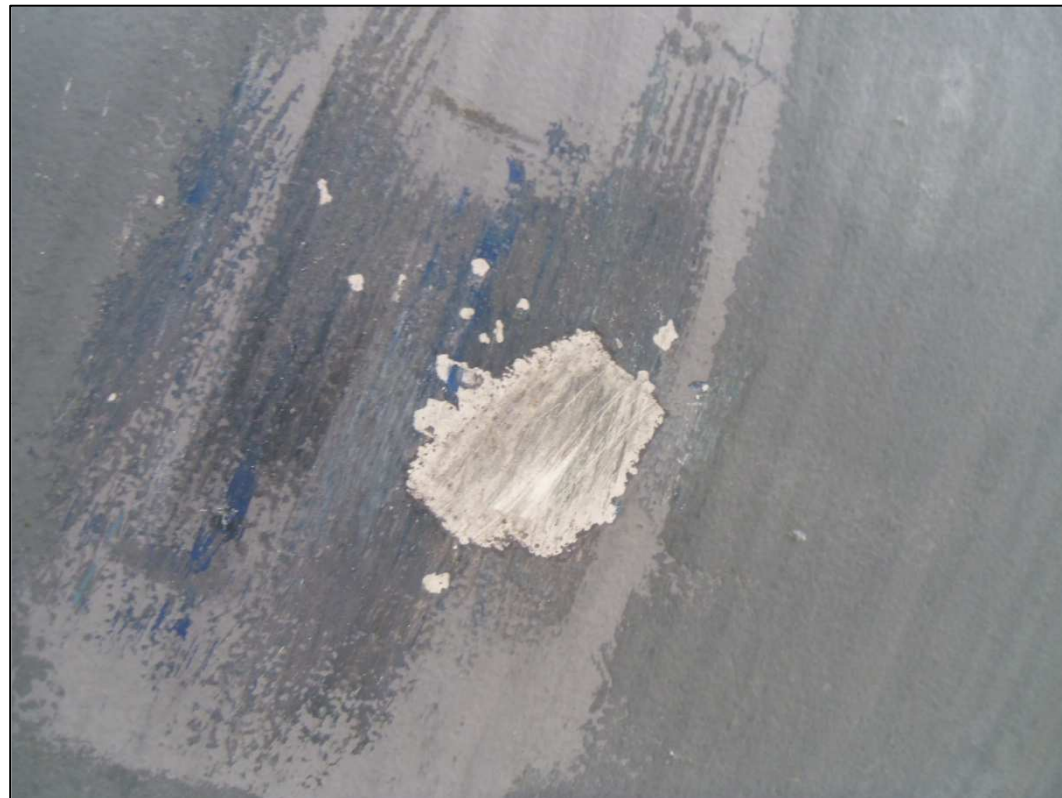
The antifoul is in grey and is adhering well to the GRP with no signs of any detachment, though there are some early signs of flaking at the waterline. A scraping confirmed coatings consist of antifoul over a grey primer, which is / was production standard, and there are no epoxy resin coatings.

Fig.1 – hull coatings consist of antifoul over a grey primer.

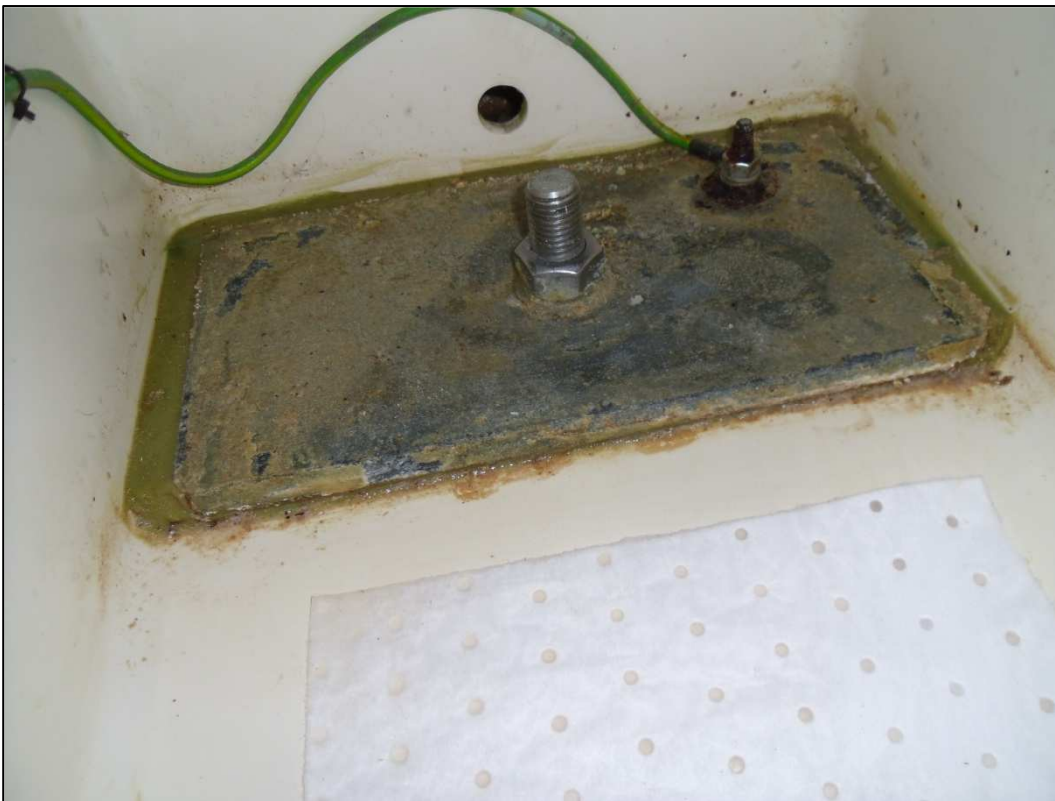
The keel is an iron fin with bulb securely fitted to the hull. This is in a serviceable condition, though there are some areas where corrosion is breaking through such as around the lower edges of the bulb. The keel to hull join is clean with no signs of any cracking, movement or corrosion weeping, though there is some very light corrosion at the palm ends breaking through. Internally, the stainless steel bolts and nuts are fitted over galvanised steel backing plates and these are all in a clean condition with no clear signs of any leaks or corrosion noted. However, due to a previous leak from the engine, the aft plate is salt scaled, the mast lightning conductor / earthing strap bolt is corroding and there are areas of salt water remaining along the plate edges.

Fig.2 – scale on the keel aft backing plate and corrosion to the earthing strap bolt.

Remove all water residue and clean off the scale and corrosion.

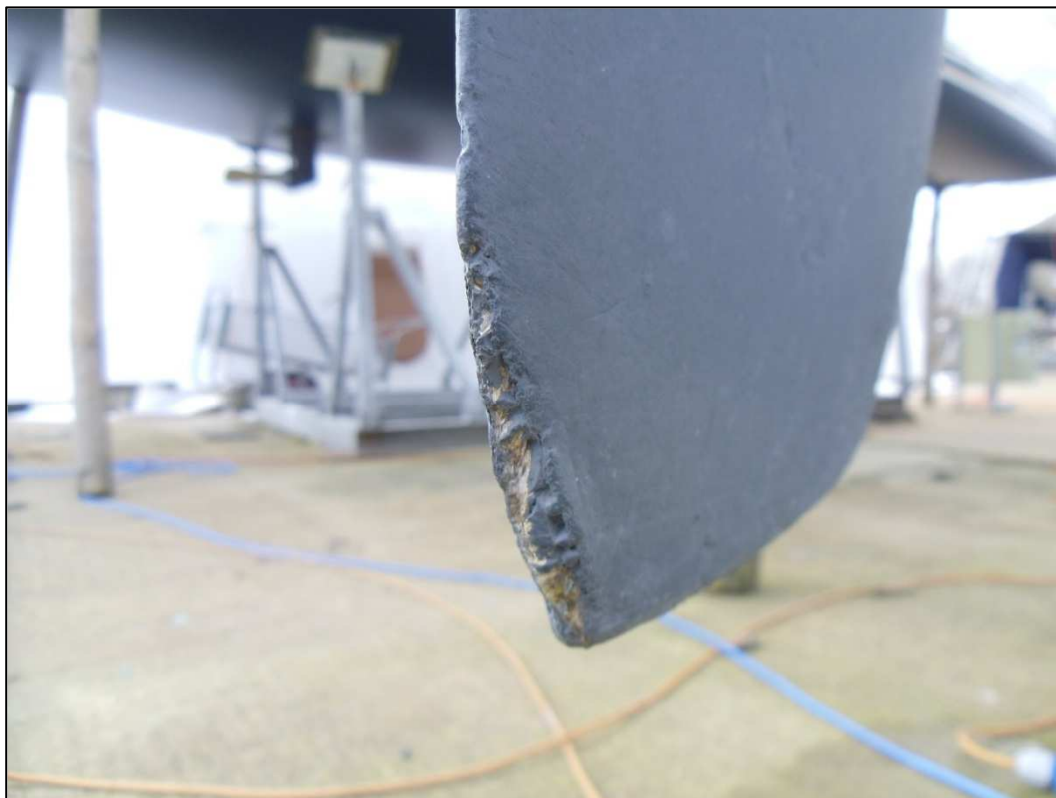
The GRP rudder is an unsupported long type of aerofoil blade design and the structure is in a serviceable condition, though there is an area of light damage to the base aft corner which is through to the laminate.

Fig.3 – damage to the rudder base end.

Repair the rudder damage.

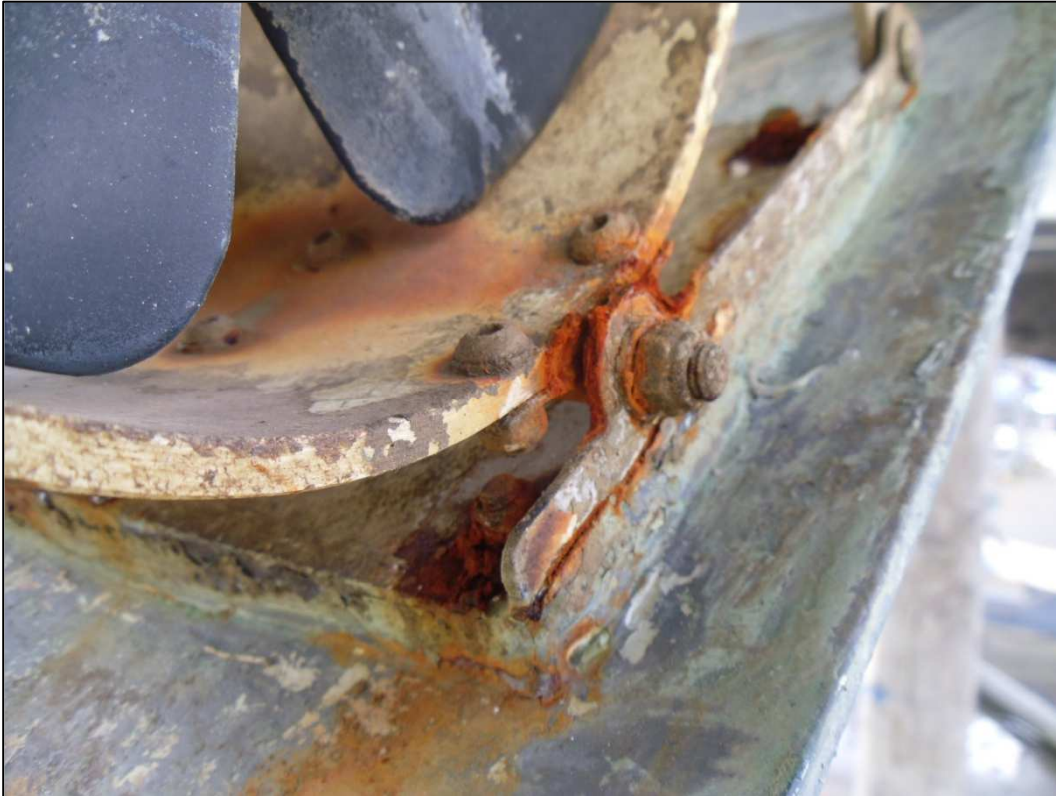
There is a 'Quick' retractable bow thruster fitted and this is in a serviceable condition, though there are some areas of corrosion noted to some of the fixings etc. The lowering mechanism is in a serviceable condition with the main connections securely pinned with some natural play noted. This is fitted with 2 x 4 plastic bladed propellers and these rotated satisfactorily without any binding against the tunnel and with minimal backlash. Internally, the motor is securely fitted to the sealing box with no leaks noted or water in the bilge and all connections to and from the local battery are clean and tight. The installation operated satisfactorily from the starboard helm control.

Fig.4 – corrosion to some of the bow thruster fixings.

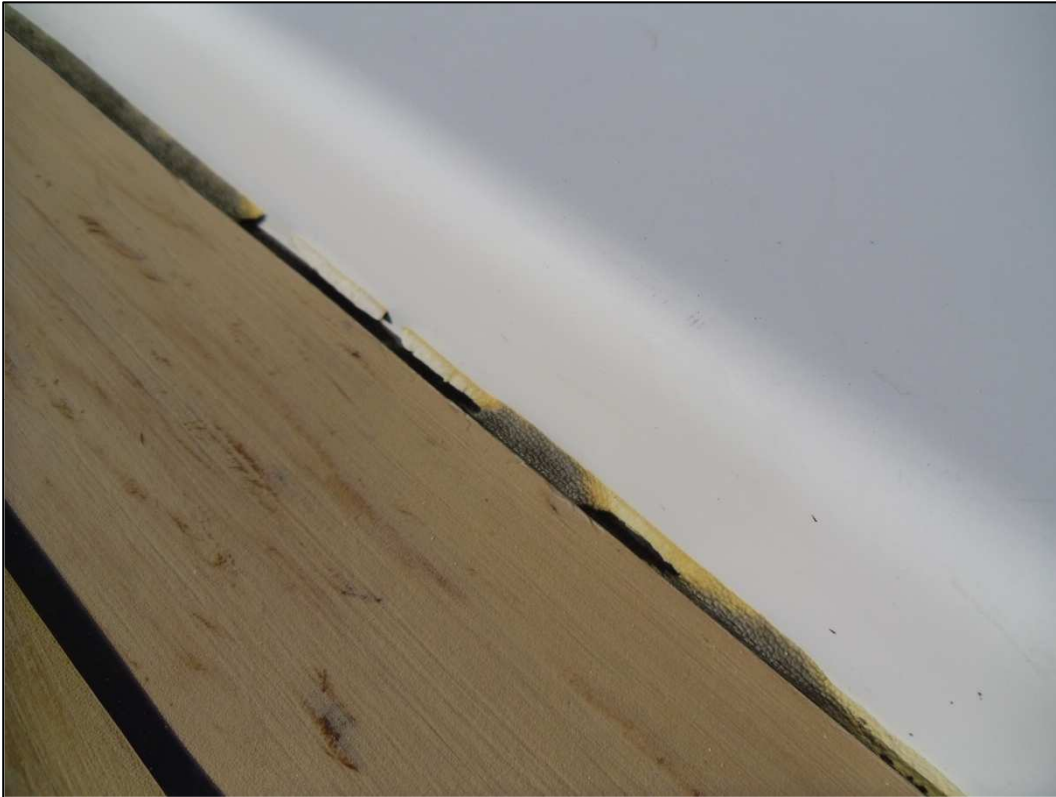
The superstructure is in white GRP with synthetic teak panels laid on the horizontal surfaces. This is in a serviceable condition but there is a small stress crack in the moulding adjacent to the hatch lid, there are some scratches and light gelcoat damage around the spray hood mounts, some scuffing in the cockpit seat backs on the starboard and the sealant at the edges of the section forward of the mast has gaps and breaks in the sealant on both side.

Fig.5 – edging sealant with gaps and breaks forward of the mast.

Repair the small gelcoat defects and replace areas of poor sealant.

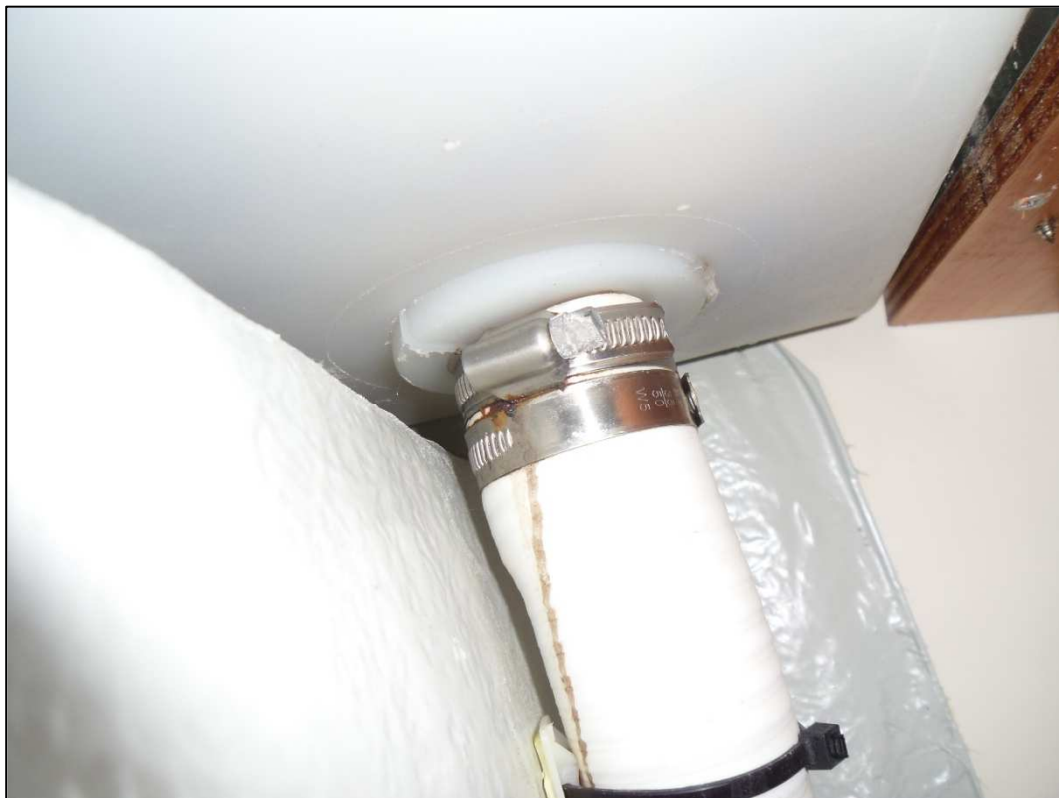
Fig.6 – corrosion and runs from the aft holding tank inlet.

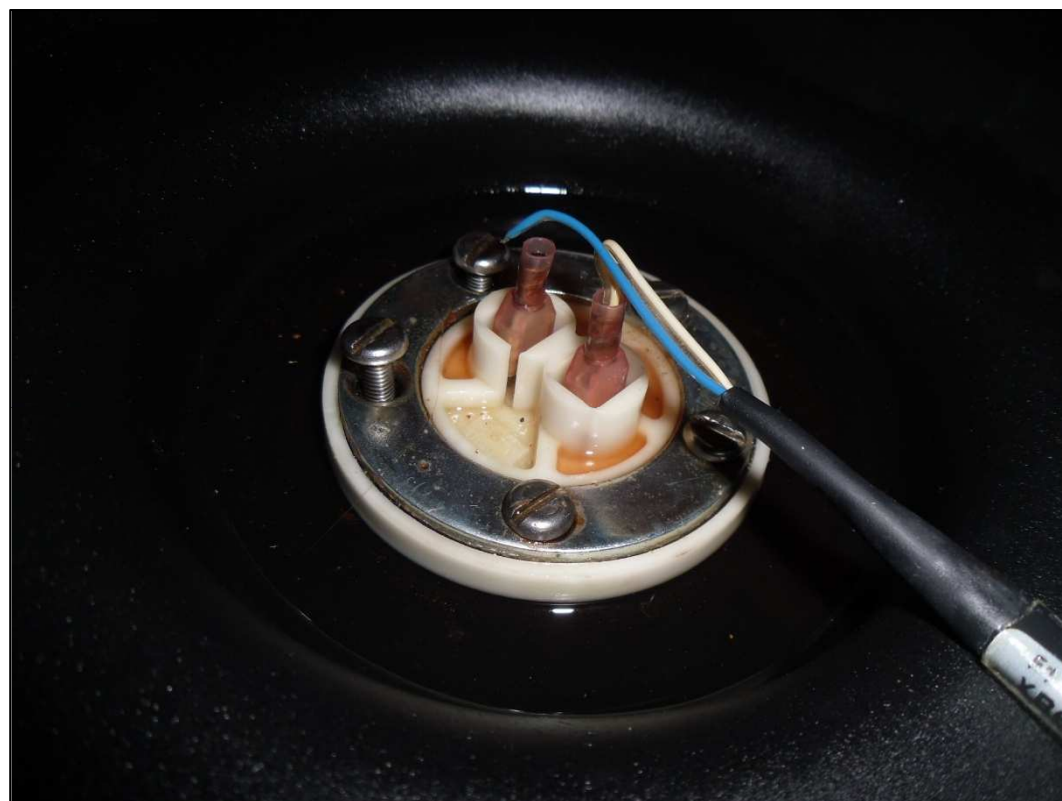
There is a plastic tank securely fitted under the starboard aft cabin bunk. The inlet and vent hoses are in ISO 7840 compliant hose and securely double clipped to the fittings and the tank. There is fuel on the tank surface and around the tank sender unit, two screws are proud and one of the sender wires is broken, explaining the switch panel tank display error.

Fig.7 – fuel leaking from sender unit with proud screws and broken sender wire.

Fix the fuel leak from the sender and reattach the wire.

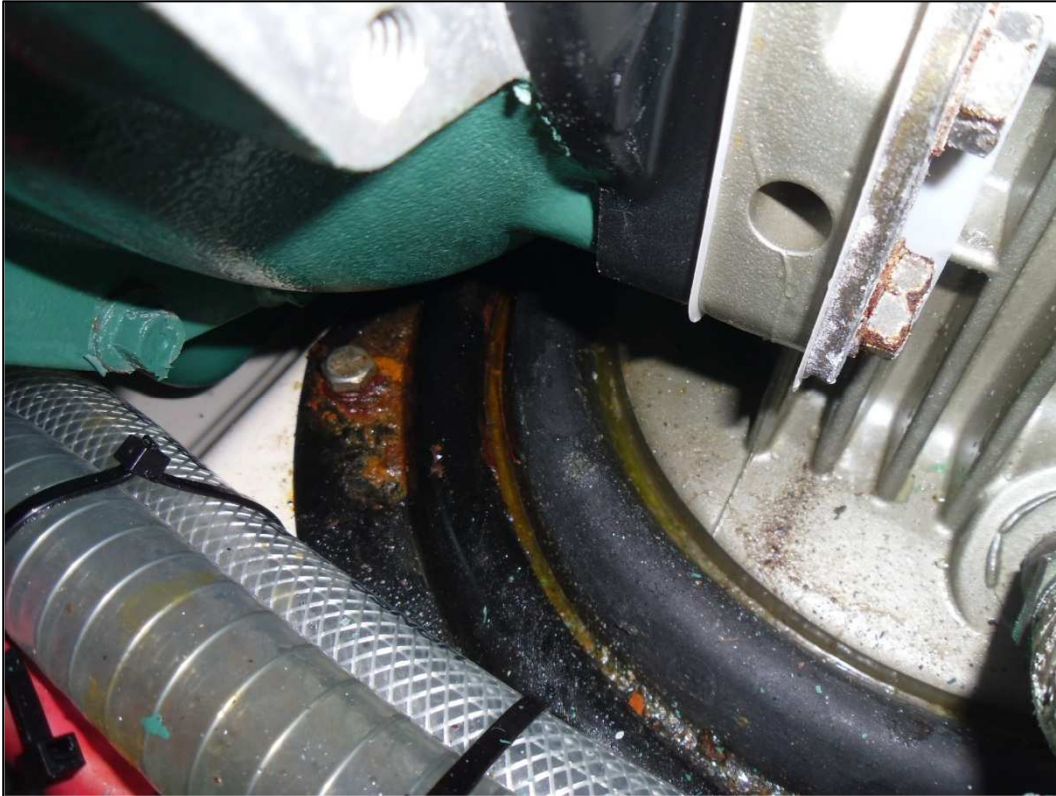
The gearbox is in good cosmetic condition, but the various attachments to it and those surrounding the aft end of the engine are showing areas of surface corrosion. The ring seal is pliable but there is oil / fuel, water and general dirt in the various grooves and there is corrosion around some of the mounting plate bolts etc. The gearbox's main details are:

Fig.9 – oil / fuel / water and dirt in the ring seal and mount bolt corrosion.

Clean up the saildrive ring and mount spaces. Clean off all fittings corrosion and preserve with 'Tectyl' or similar.
