ANCHOR HOUSE MARINE SURVEYS

Full Condition Survey

Fairline Phantom 37

Wednesday 24th October 2018

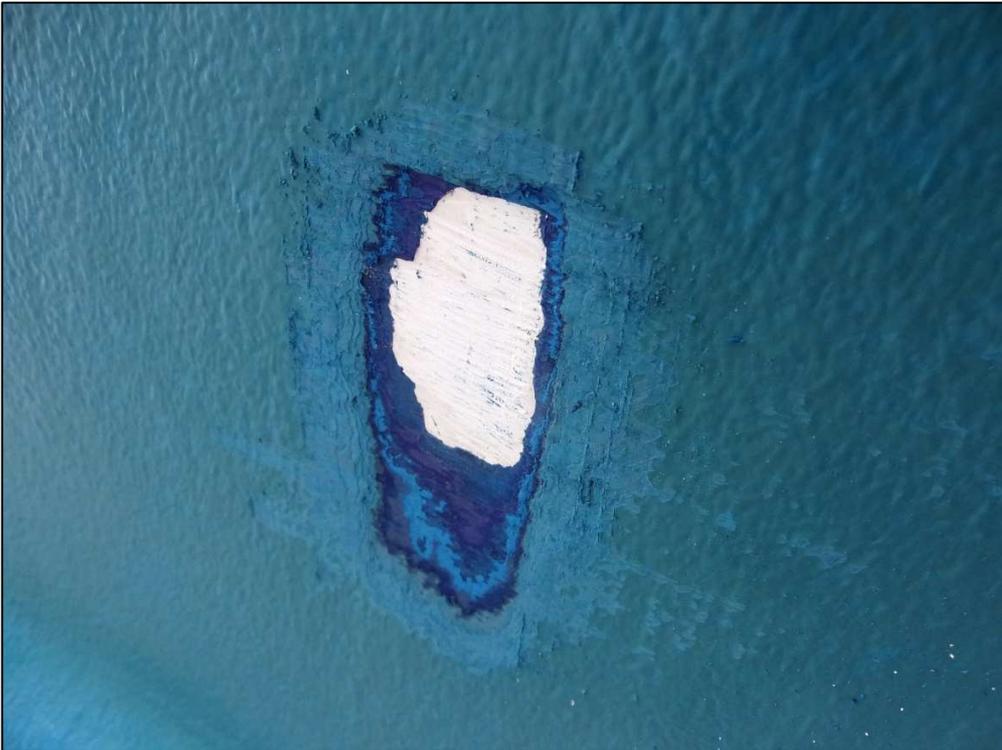
Moisture readings were taken with a 'Protimeter' Aquant 2 meter at more than 80 positions over the outer bottom area and this produced readings of 130 – 160 in the main which is in the low scale. High readings of around were obtained around the length of the keel but as this area was still wet after lift out, this is to be expected. In addition, high readings of around 350 - 400 were also obtained further outboard on both sides aft but these correspond to areas of standing bilge water in way of the engine compartment, anodes and p bracket palms. The scale used is 0 – 160 (dry) / 161 – 200 (medium) / 201 – 999 (wet).

Fig.1 – antifoul makeup showing the various layers.

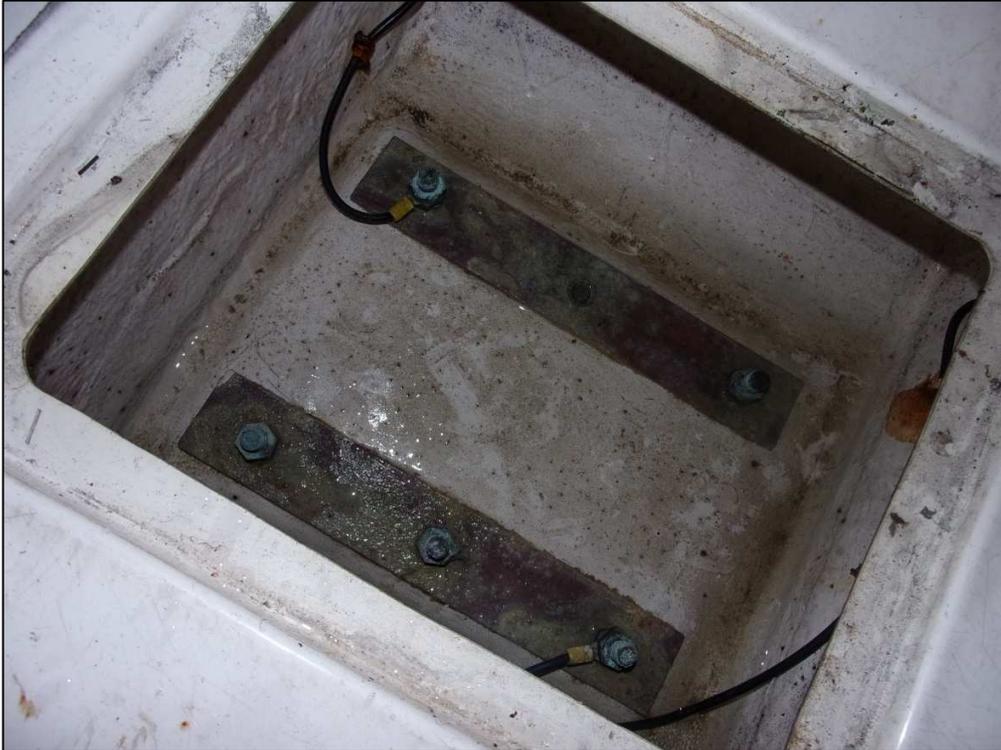
These are in bronze, secure and in a good condition where paint was scraped away. The palms are securely located but there are gap in the sealant on both units. Internally, the port palm bilge contained fresh water and the starboard palm bilge contained salt water with the fixings showing surface corrosion.

Fig.2 – water in the P bracket palm bilges.

Remove all bilge water, clean all fixings and reseal the palms externally.

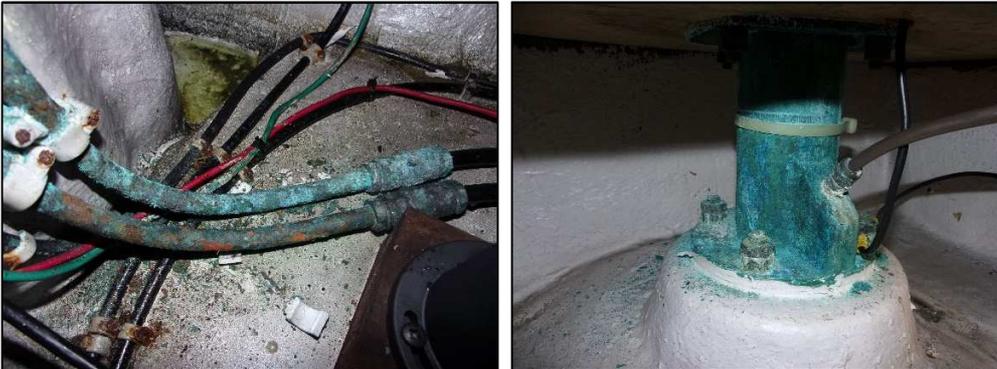
The rudders are turned via a hydraulic ram and tiller link arm operated from the twin helm power steering set up. The copper hydraulic pipes are showing heavy surface corrosion and these should be replaced at the earliest opportunity with modern hydraulic hoses.

The trunks are in bronze and showing all over surface corrosion though no leaks or salt deposits were noted. The bearings are greased via two manual pumps and these are showing signs of surface corrosion.

Fig.3 – heavy surface corrosion to hydraulic pipes and trunk / gland body.

Replace all copper hydraulic hoses with modern flexible types.

Clean up and preserve both gland bodies.

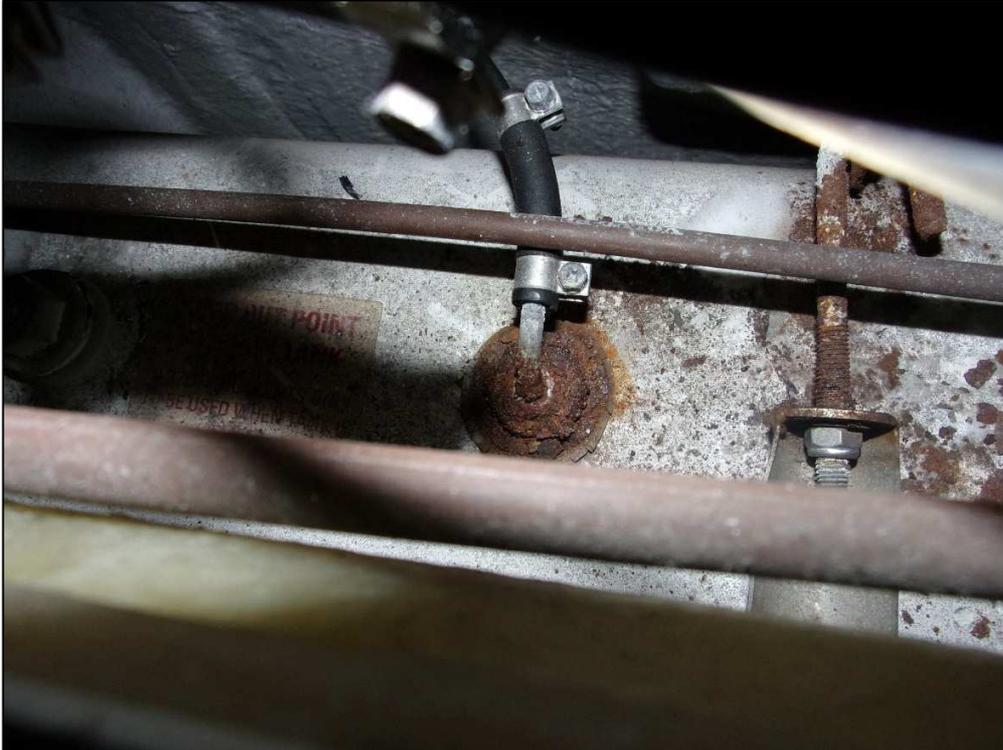
Fig.5 – the diesel heater take-off from the starboard fuel tank is heavily corroded.

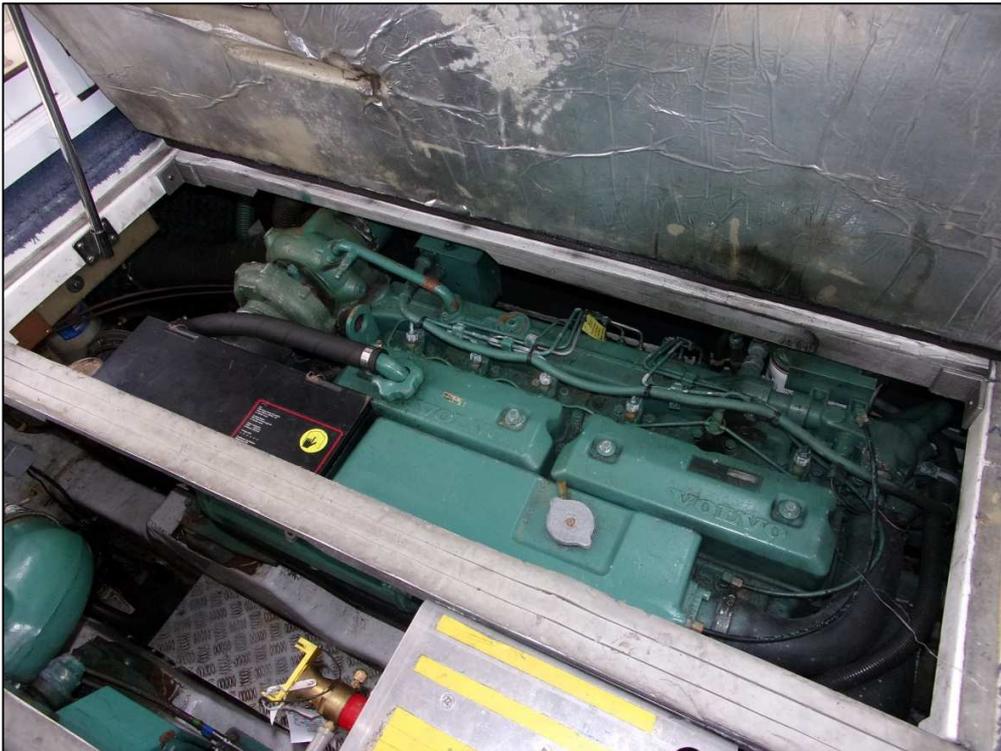
The engines are in an overall poor cosmetic condition consistent with their age. The last recorded service was in October 2017 but it is recommended that both engines and stern glands have a thorough inspection and full service full service undertaken by a competent Volvo Penta specialist at the earliest opportunity.

Fig.6 – Volvo Penta TAMD-63 6-cylinder turbo diesel engines.

Undertake a full inspection and servicing of both engines.
