ANCHOR HOUSE MARINE SURVEYS

Full Condition Survey Report

Westerly Fulmar

'Keromi'

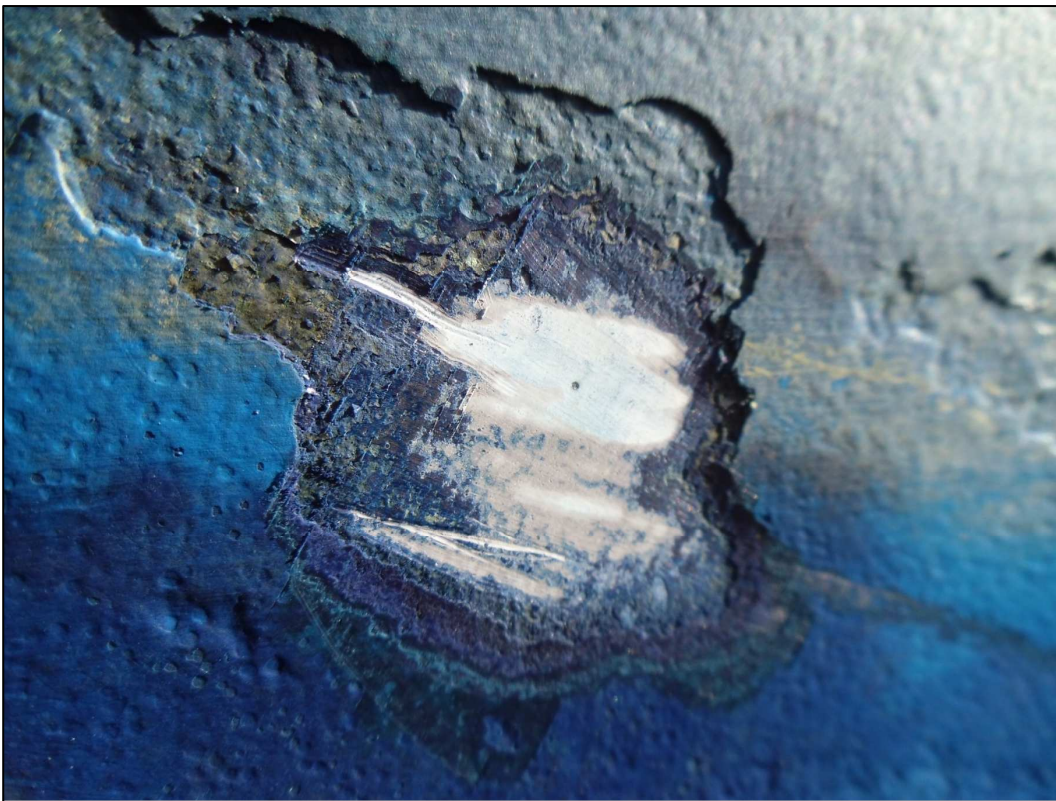
The antifoul is in blue and rough in appearance due to overpainting but adhering generally well. The seller states that a 'Blakes' epoxy resin was last applied in 2003.

Fig.1 – hull scraping showing epoxy resin, primer and antifoul coatings.

At the next service ashore, remove and reapply the antifoul or remove all coatings back to bare GRP and reapply new epoxy resin and new antifoul after a thorough inspection and moisture reading recheck of the hull.

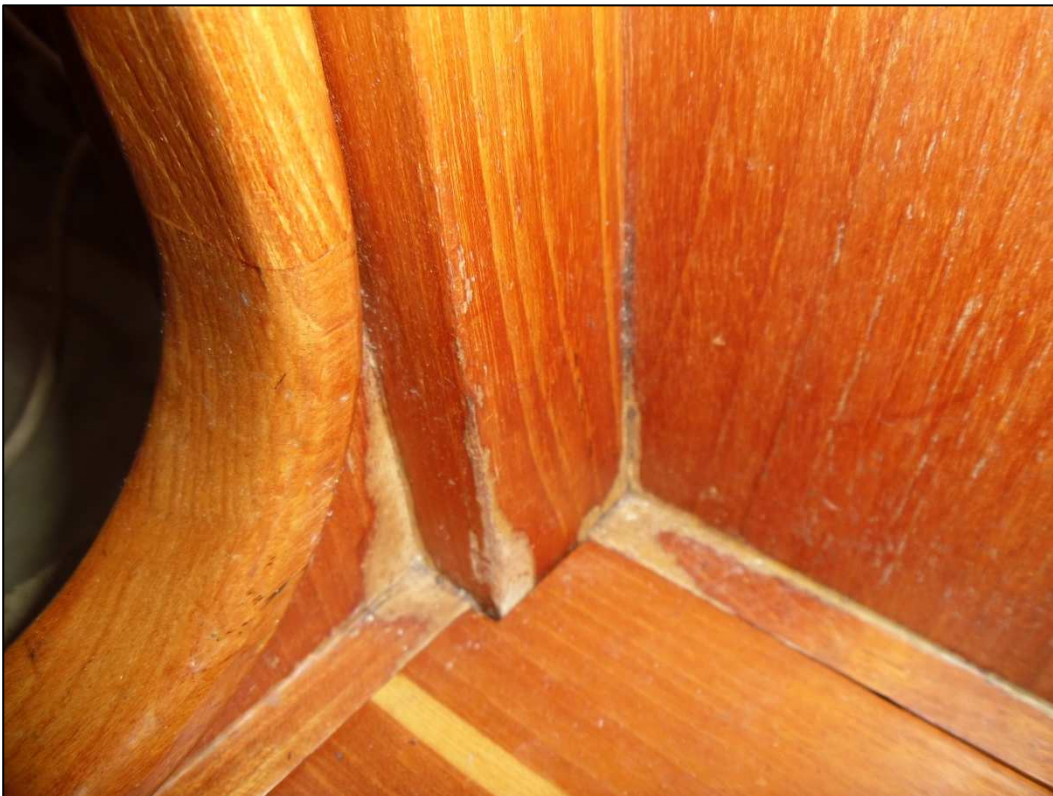
The main and partial bulkheads are in varnished / painted timber and bonded to the hull via GRP tabbing and where seen, there were no clear signs of any movement. There are some light areas of water staining at the base of the heads bulkhead / compression post and some salt water / crystals just aft of the compression post in the bilge.

Fig.2 – areas of water staining at the base of the compression post.

Remove all water remnants and salt crystals and monitor for any return to locate the source.

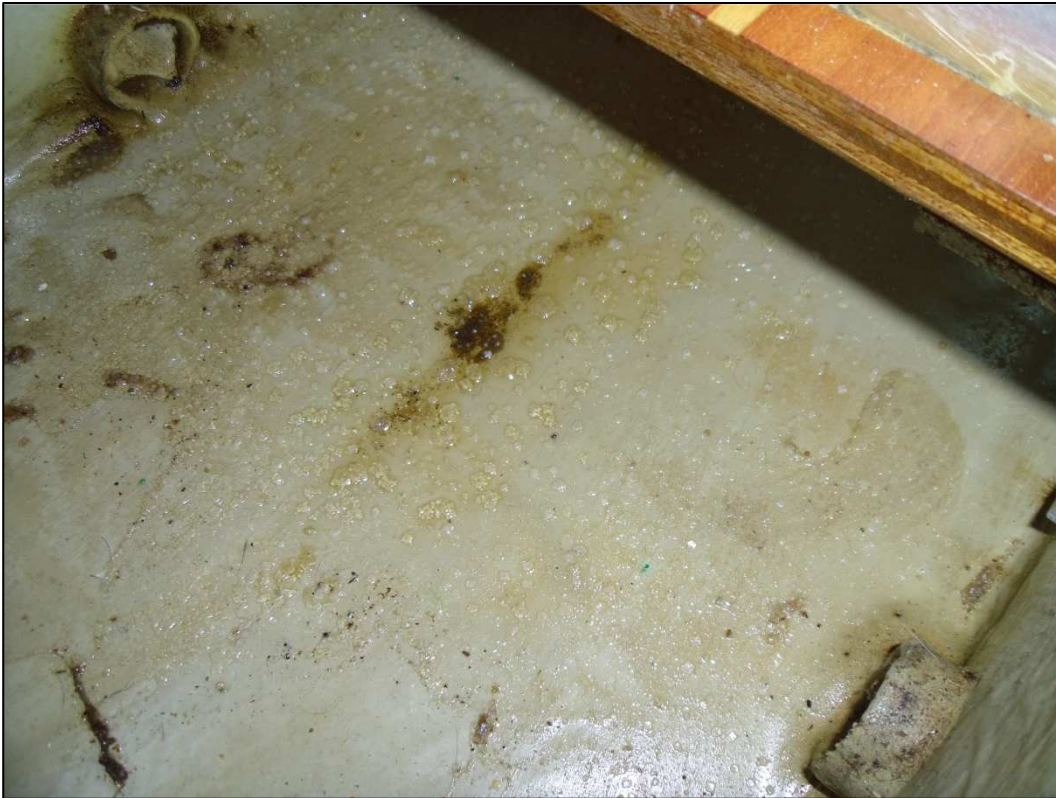
The 'Selden' anodised aluminium mast is in a serviceable condition as seen from the deck. The fittings and plates are in a serviceable condition. There is a wooden compression post securely fitted in the saloon as part of the heads aft bulkhead, but there are some light areas of water staining around the base, the copper lightning strip has all over patina / corrosion and there is an area of salt crystals and water remnants in the bilge.

Fig.3 – area of salt crystals and water remnants aft of the compression post in the bilge.

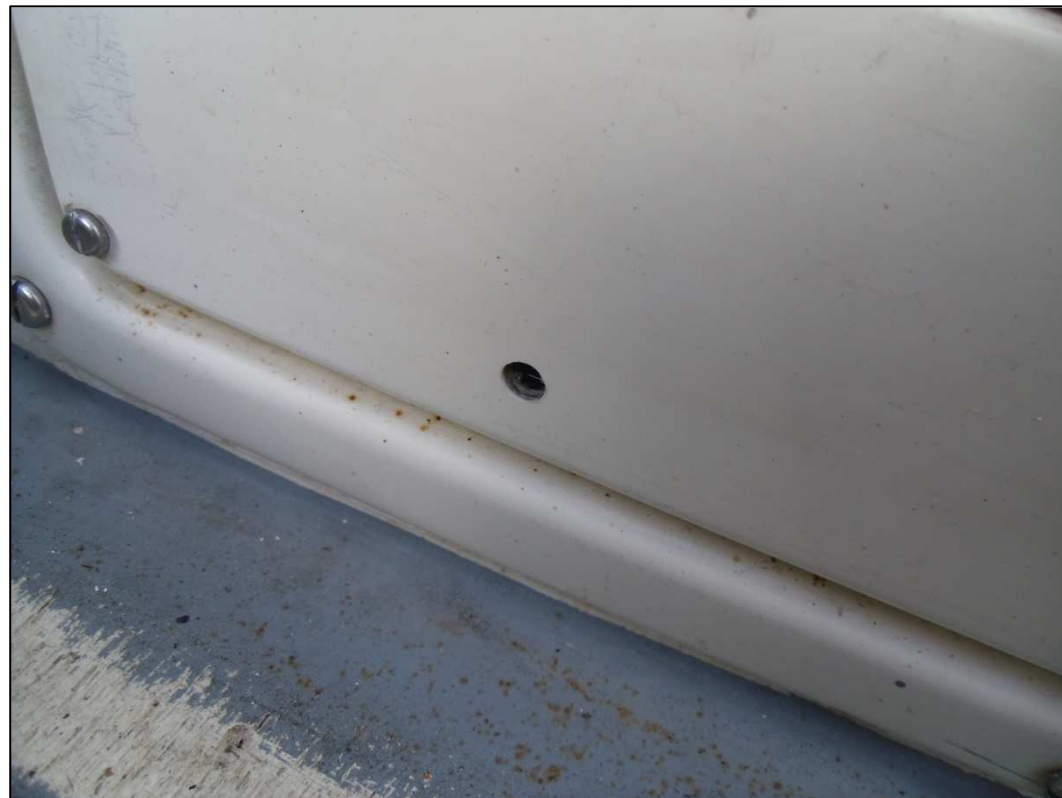
This is located in a moulded locker under the cockpit starboard forward seat. This contains a 2 x 2.75kg 'Campingaz' butane gas bottles which are in good condition but not secured. The forward bottle is connected up but the outlet fitting has surface corrosion present. The bottles sit in a shaped wooden base, but this is breaking up and the drain holes discharge into the cockpit under the tread boards. The drain should go directly overboard.

Fig.4 – drain hole is not sufficient nor is it directly overboard.

Add a drain that discharges any leaking gas directly overboard, rather than into the cockpit deck where it could pool and potentially ignite.

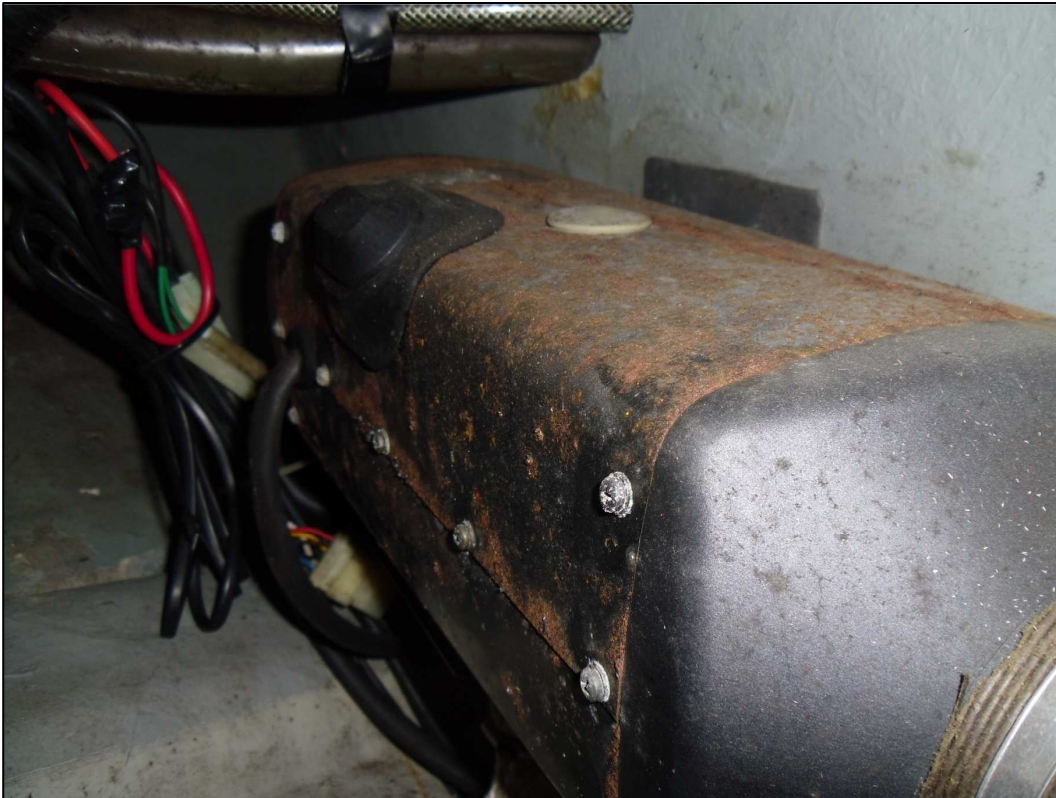
Fig.5 – diesel heater does not work and the casing is showing all over corrosion.

Replace the diesel heater and control panel with a modern one.

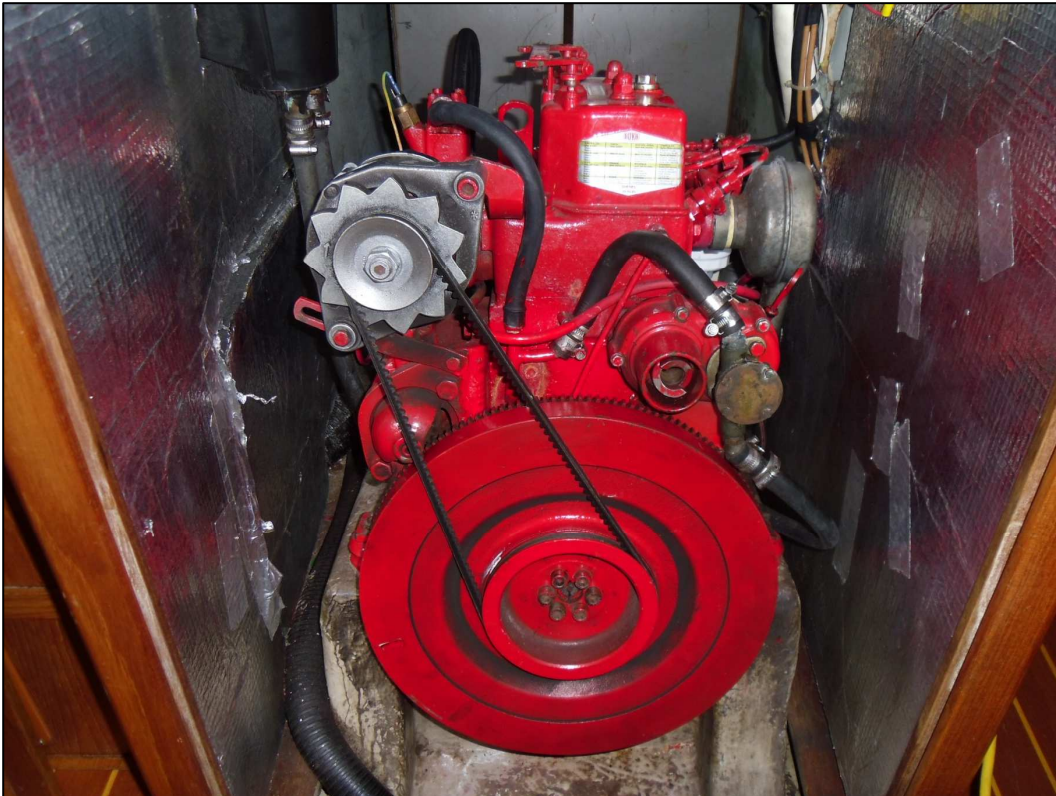
The engine is in an overall good cosmetic condition with no clear signs of any corrosion or major leaks noted and the compartment sides are lined with sound deadening insulation. There is a towel wrapped around certain aspects of the engine aft, so it is recommended the complete powertrain is inspected and serviced by a competent 'Bukh' specialist. The engine was started and ran satisfactorily during the trip to the lift out and the main specifications are.

Fig.6 – Bukh DV20 2-cylinder diesel engine.

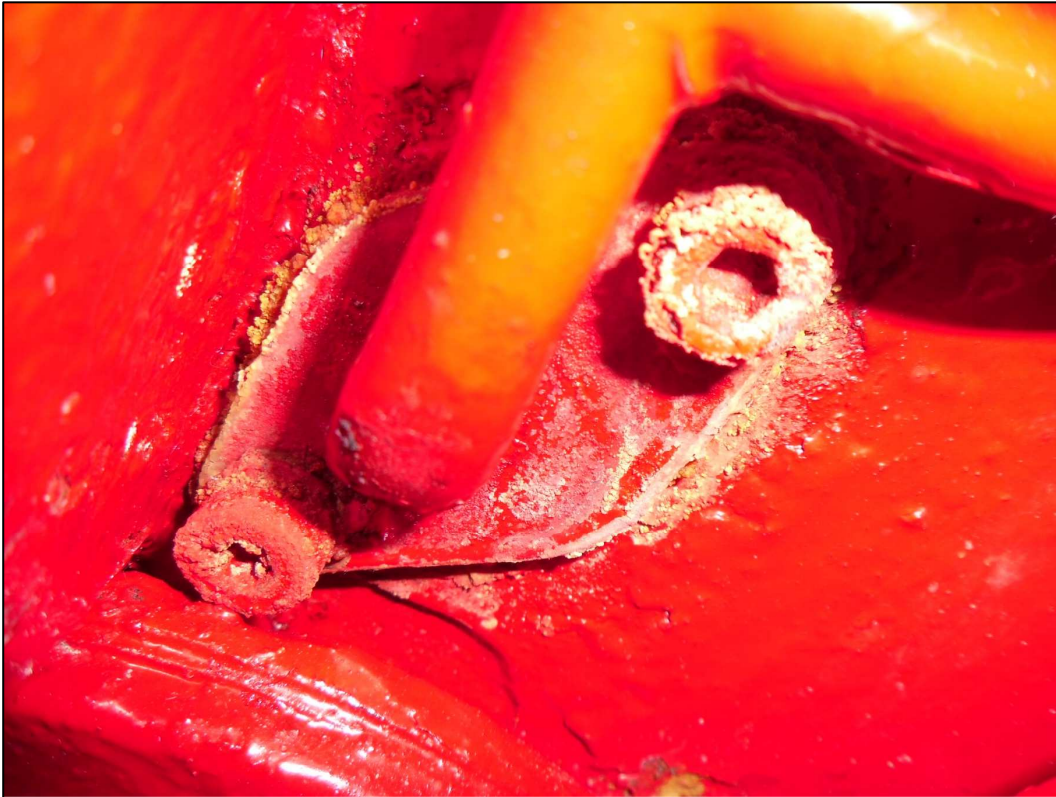
The engine is cooled directly by seawater supplied by an engine driven impeller type pump which is in a serviceable condition, though there are some areas of corrosion and possible salt deposits around the outlet fitting. However, there is a diamond outlet take-off fitted to the forward face of the engine which has corrosion and deposits around the edges and fixings and there are salt deposits around the forward cylinder manifold outlet.

Fig.7 – corrosion and deposits around the forward take-off.

Clean off all deposits and monitor for any leaks when the engine is running and resolve as required.
