ANCHOR HOUSE MARINE SURVEYS

Full Condition Survey Report

Berthon 8 Tonne Gauntlet

'Nausikaa'

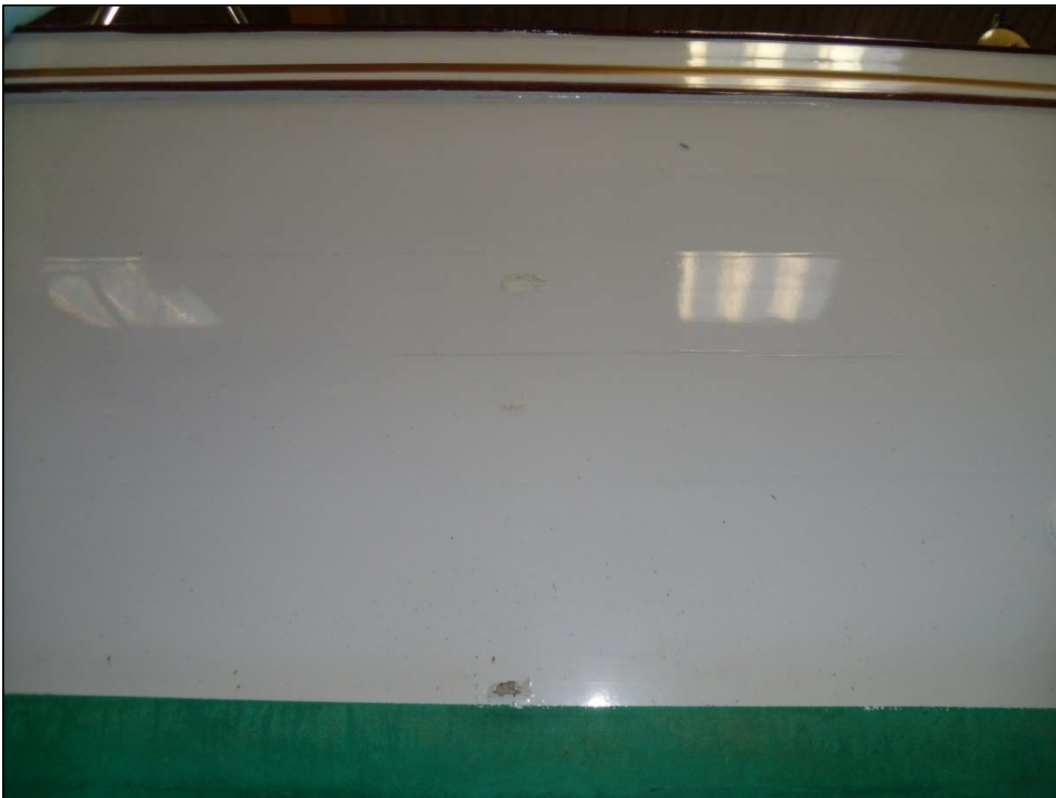
This is in white painted, carvel laid teak planking with a gold painted cove line above the varnished teak fender. The topside is generally clean but there are some minor areas of paint bubbling / detachment as well as some light caulking line protrusion in the paintwork along the yacht's length but there are no signs of any major damage or repair. There are no fore and aft sling tags fitted.

This is in white painted, carvel laid teak planking with a gold painted cove line above the varnished teak fender. The topside is generally clean but there are some areas of paint bubbling / detachment aft of midships as well as some light caulking line protrusion in the paintwork along the yacht's length but there are no signs of any major damage or repair. There are no fore and aft sling tags fitted.

Fig.1 – some light defects and plank caulking line protrusion in the paintwork.

Repair the topside defects.

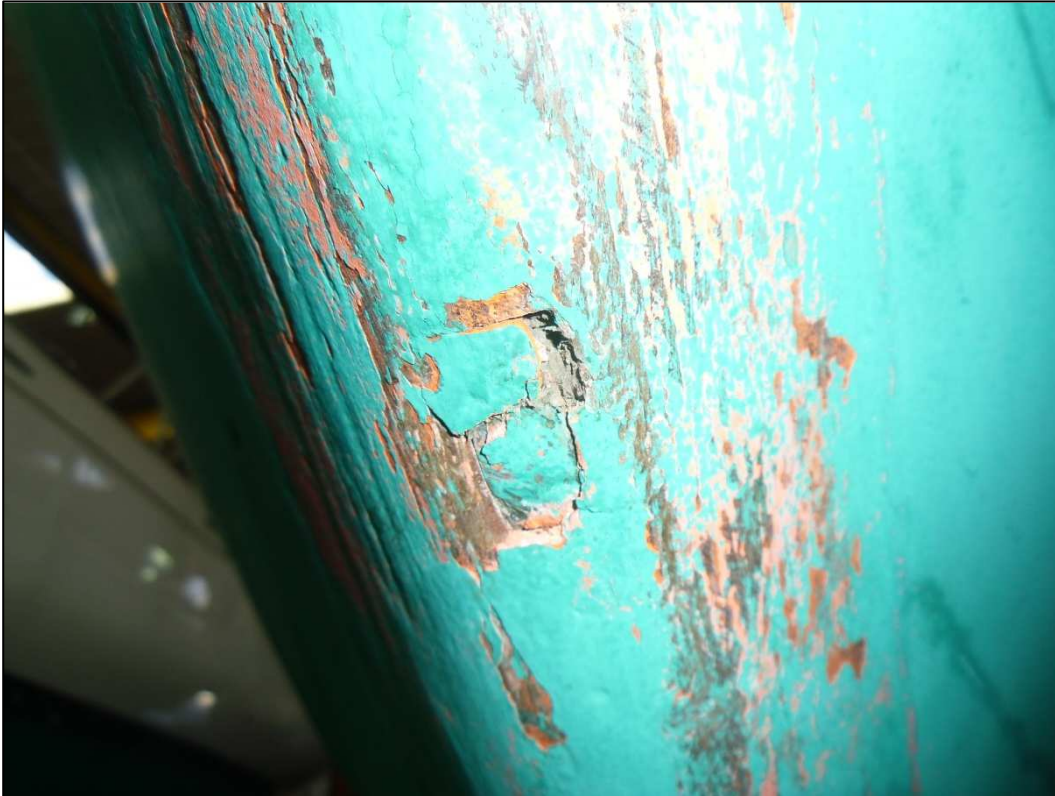
There are some minor chips and scuffs in the paintwork above the waterline but no signs of any major damage or repair. Below the waterline there is some heavy wear / rubbing, scuffing marks as well as some apparent circular impressions noted with surface wood damage, which may be in way of the connecting bolts. The damp seam / caulking lines can be lightly seen in the antifoul but there are no signs of any obvious internal issues.

Fig.2 – small area of damage to the bow stem below the waterline.

Repair the areas of wear along the stem / forefoot.

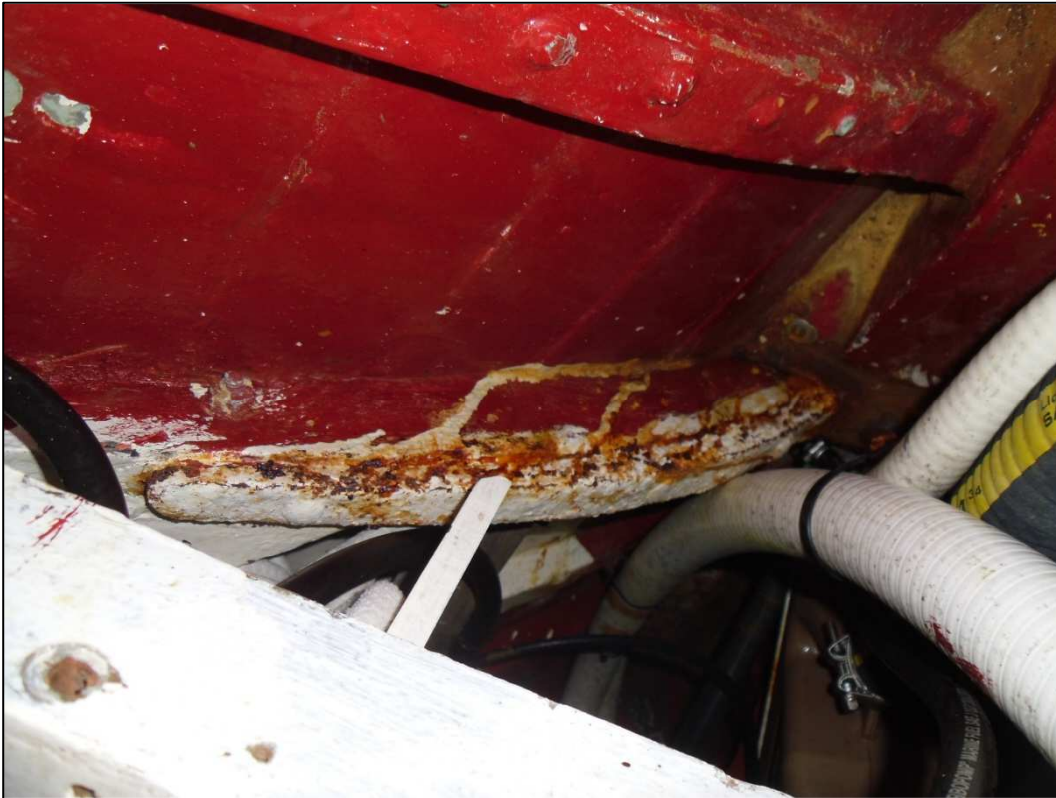
These are securely fitted to the hull frames and elm keelson via bronze bolts and coated in red bilge paint but in the bilge where the sea water is, there is surface corrosion noted particularly to the submerged sections. In the cockpit and aft, these are showing a fair bit of corrosion and weeping though access is difficult to properly inspect.

These are securely fitted to the deck beams and hull frames via bronze bolts and painted white but the aft knees particularly in the cockpit and lazarette section are showing some signs of corrosion and weeping.

Fig.4 – signs of corrosion and weeping from the lazarette iron floors.

Clean off all corrosion from the floors and knees where seen and repaint.

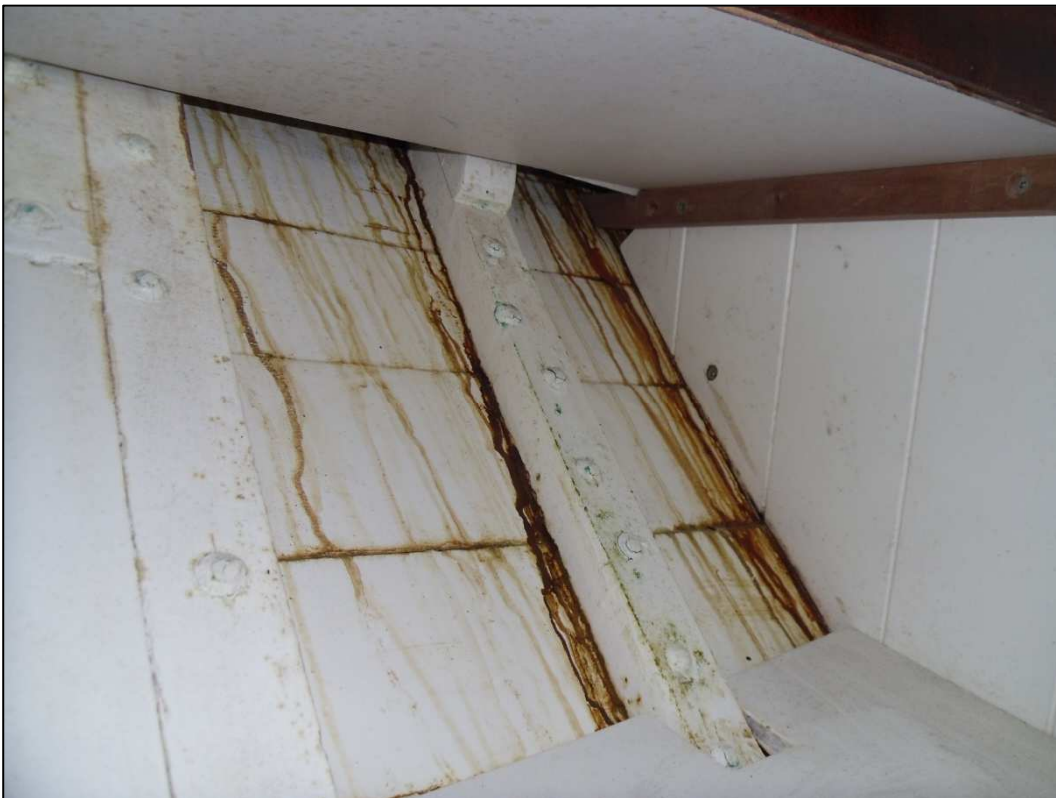
The oak frames are in a serviceable condition and securely fitted where seen without any clear signs of separation from the teak planking noted, though some of the copper clench nail heads have patina. There is a leak underneath the water pipework noted around the port side frame under the forward bunk space and there are various leaks and deposits around frame and deck fixings.

Fig.5 – example of weeping from the structure / planking.

Clean up all weep runs and shore up / stop the various leaks where possible.

Resolve all areas of weeping.

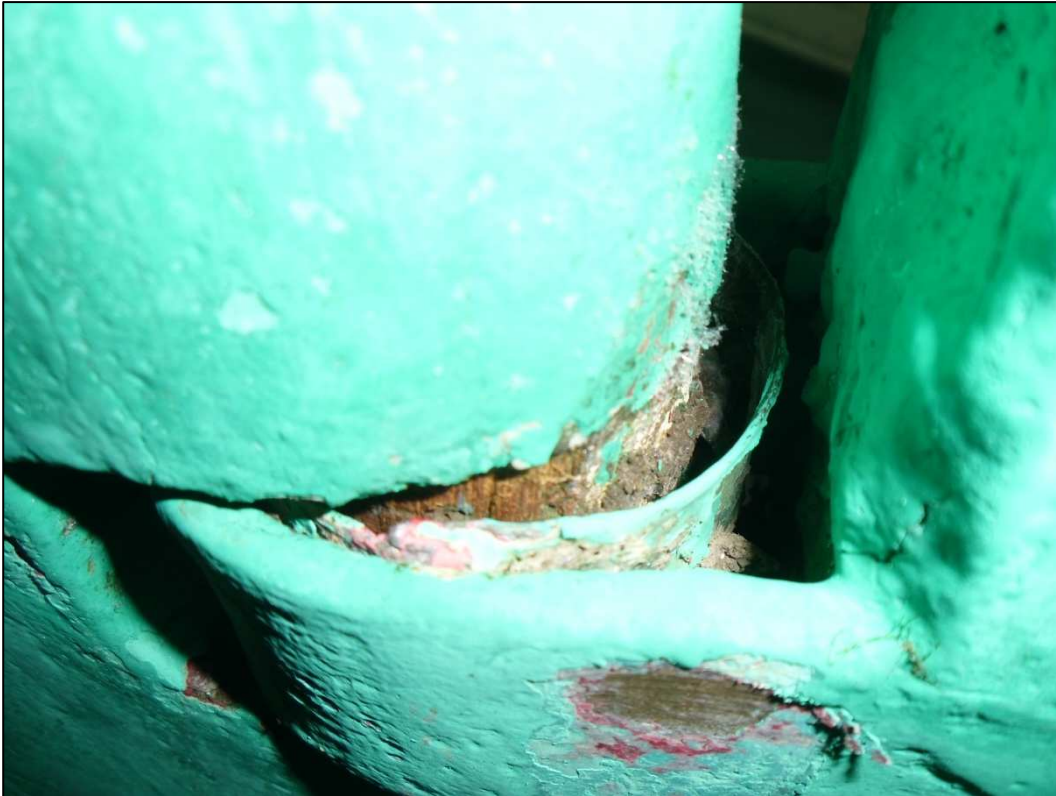
Fig.6 – rudder dudgeon inner sleeve has detached and is corroding.

There is medium to heavy play in the bronze base bearing and centre gudgeon hinge. The gudgeon hinge is securely fitted but the inner lining has detached and is corroding and the 'wooden stock' section appears quite worn, though visibility was limited.

Remove the play in the various bearings and service the gudgeon inner lining.

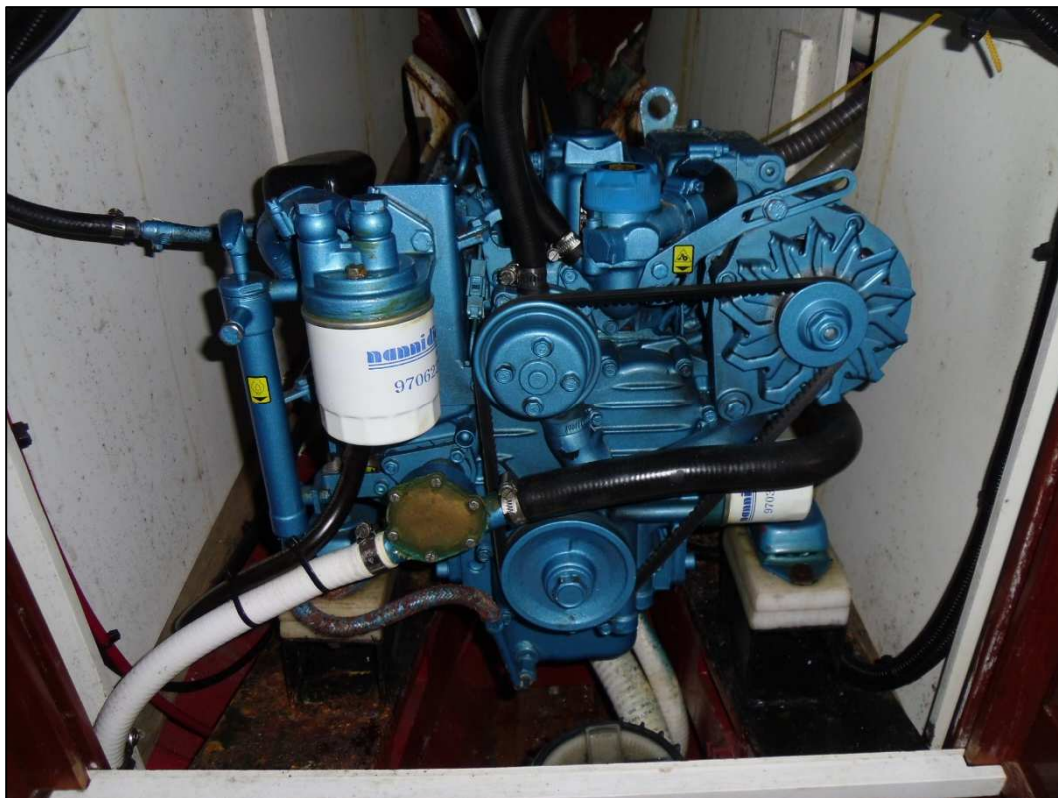
The engine is in good cosmetic condition overall and is in a condition proportionate to being serviced and maintained regularly. However, the oil extraction flexible hose has surface corrosion. The engine identification plate could not be read. The engine details are:

Fig.8 – Nanni N2.14 2-cylinder diesel engine.
