Insurance Survey Report

Sadler 32

Hayling Island Sailing Club, Hayling Island, UK

Tuesday 19th February 2019

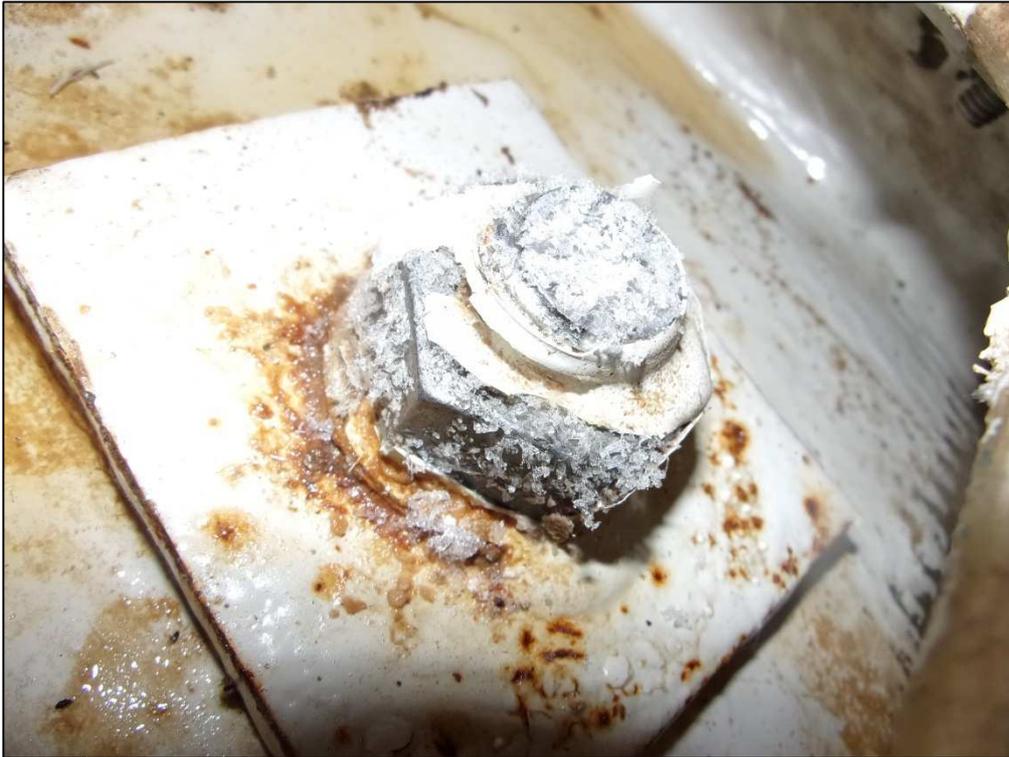
Fig.1 – keel bolt and securing plate showing surface corrosion.

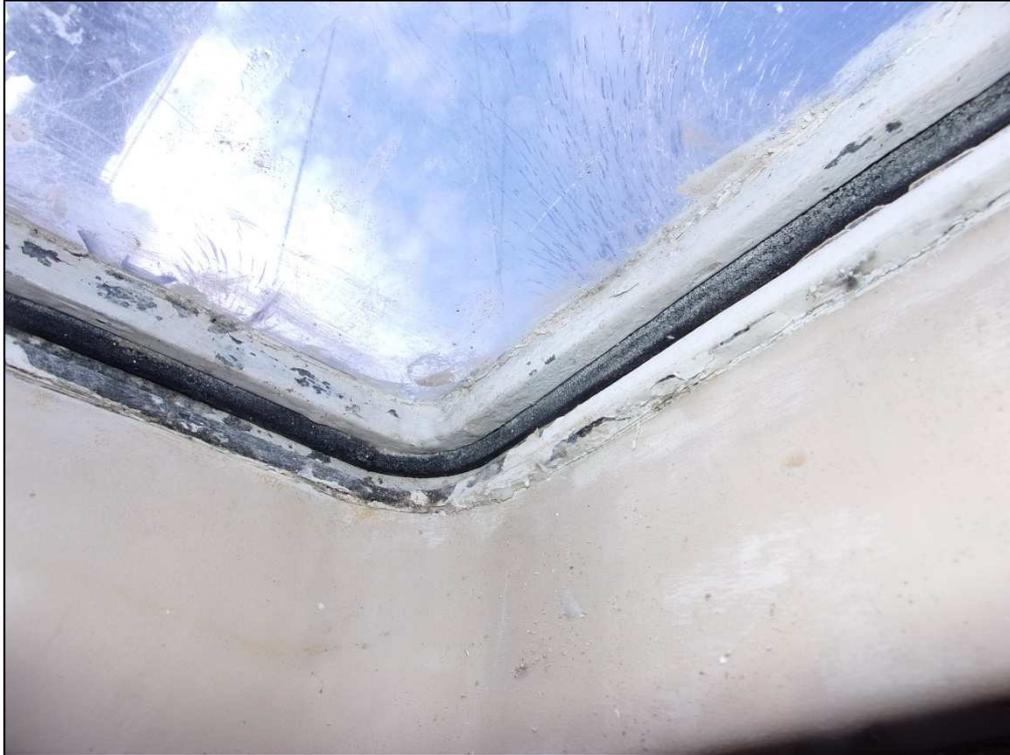
There is a 480mm x 340mm rectangular, forward friction hinged, painted aluminium framed fore hatch with heavily crazed acrylic glazing securely fitted over the saloon. The lid has a good seal and has two internal rotary handles but the glazing to frame sealant and the frame to deckhead sealant is poor which is also showing signs of leaks or condensation runs.

Fig.2 – poor hatch to deck head sealant showing leaks.

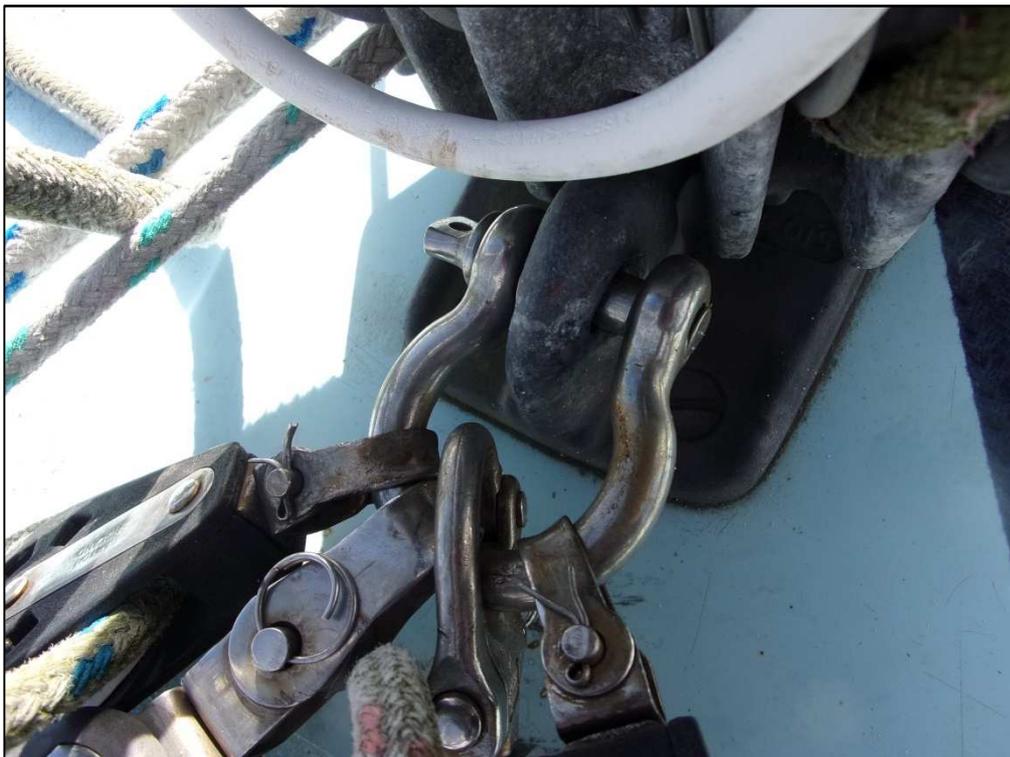
- The 'Selden' anodised aluminium boom is in a serviceable condition with a securely pinned and secured bracket. The bracket base split pin needs to be opened out.
- The 'Main' block and rope rodkicker is in a serviceable condition but the mast foot tensioner shackle pin is not wired to protect from accidental unscrewing.

Fig.3 – main shackle securing pin not wired against accidental unscrewing.

Recommendation

Ensure all rigging shackle pins are wired against unscrewing.

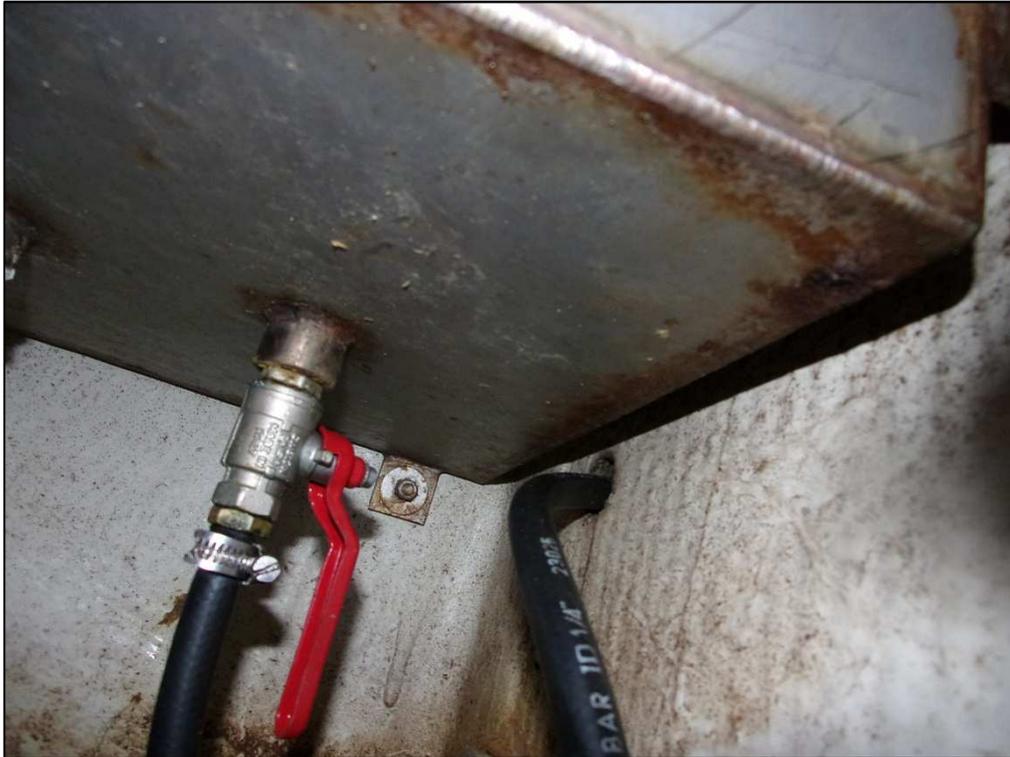
There is a single and operable fuel cut off valve for the engine fuel line but located underneath the tank where access is almost impossible. The diesel heater take off is very corroded and no shut off valve was noted.

Fig.4 – the fuel tank cut off valve is very inaccessible in an emergency.

Recommendation

Move the shut off valve to an easily accessible area.

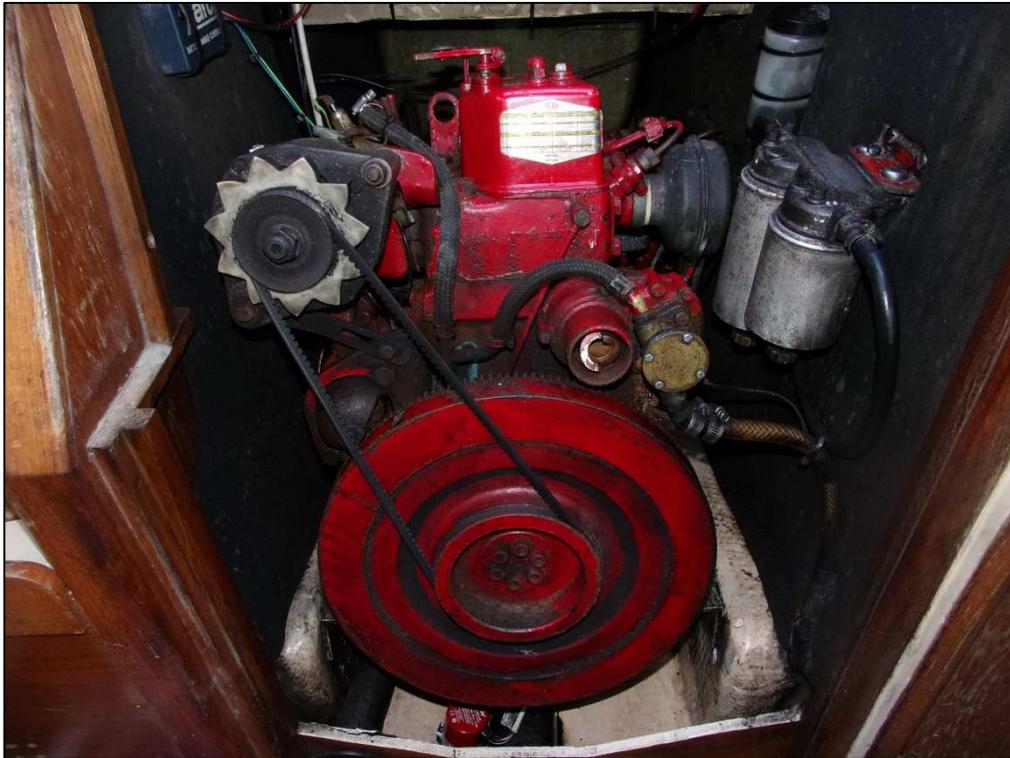
The engine is in poor cosmetic condition overall and there are areas, especially on the aft end, that have heavy surface corrosion and salt deposits present. There are components under the manifold that have heavy surface corrosion present and it is advised to have the whole engine and gearbox assembly inspected and serviced by a 'Bukh' specialist.

Fig.5 – Bukh DV20 2-cylinder diesel engine.

Recommendation

Have the engine and gearbox installation fully inspected and serviced by a 'Bukh' specialist to ensure the engine remains in a serviceable condition.
