# ANCHOR HOUSE MARINE SURVEYS

## **Structural Survey Report**

**Elan E4**

**2023 Demonstrator**

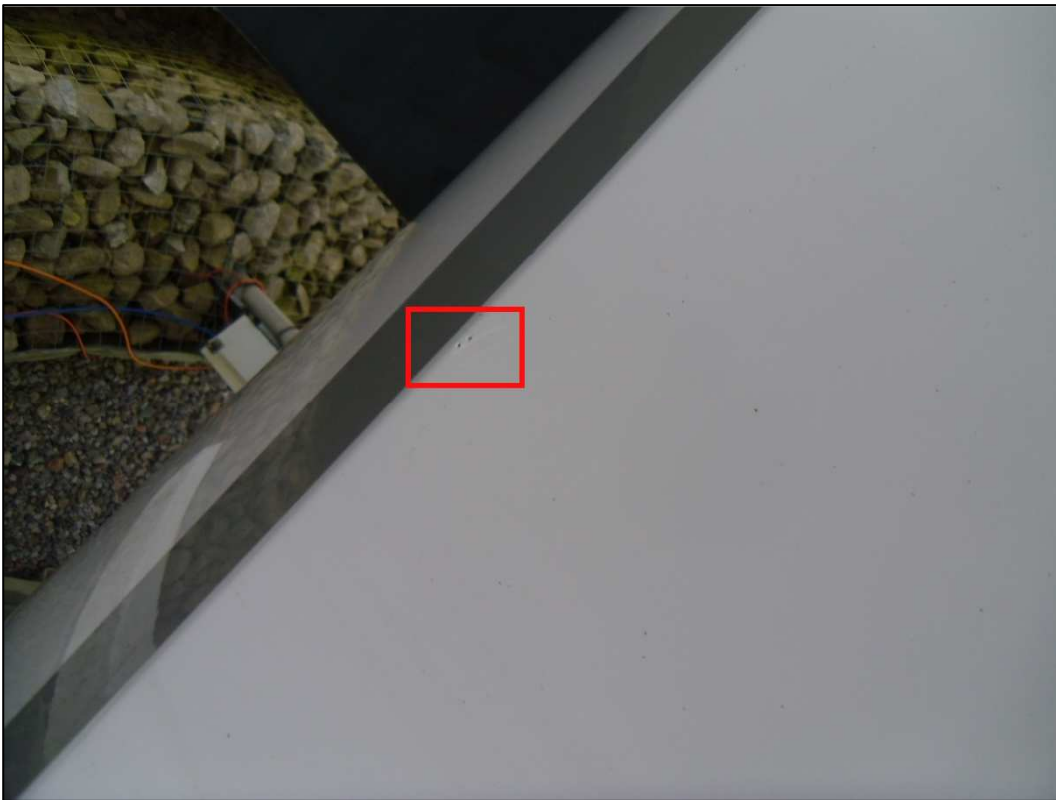
1. The topsides, deck and superstructure are in a sound condition structurally, though there is a small area of scuffing / gelcoat damage extreme starboard aft. The internal structure where seen is sound with no evidence of any movement, though there are areas of old salt water in various bilge sections.

This is in white GRP with an angled turn from midships running to aft and a black decal waterline stripe. The topside is generally sound but there is an apparent small scuff and some gelcoat damage at the angled turn extreme aft, though access and visibility was very limited, but there are no clear signs of any major damage or repair. There is no fender and there are factory and Gosport Marina fore and aft sling tags fitted below and at the deck edge, though these do not line up with each other.

**Fig.1** – small area of gelcoat damage and scuffing extreme starboard aft.

Repair the gelcoat damage / scuff.

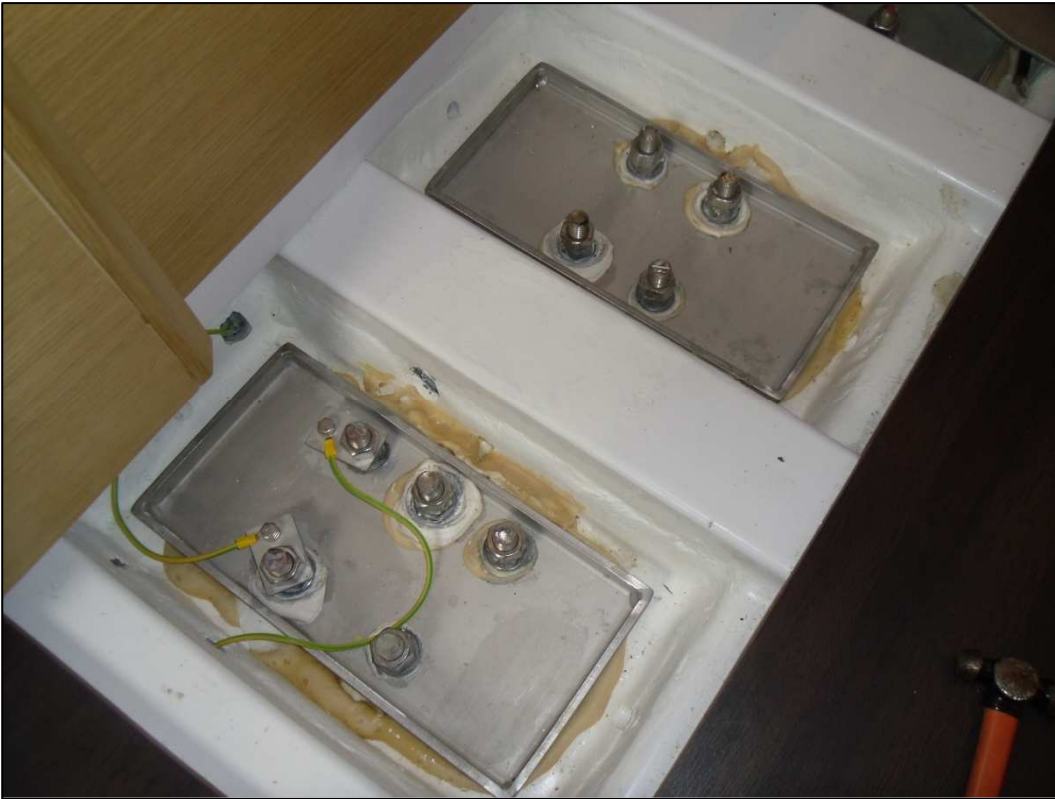
There is an iron fin and bulb keel securely bolted to the hull and this is in a sound condition bar a couple of small corrosion spots at the base of the bulb aft on both sides. The keel to hull join is flush, with no signs of any cracking or weeps and the sealant is clean, though some of the paint along the sealant line has detached. Internally all the stainless steel bolts, fixings and backing plates are clean and dry and hammer sounding returned good readings.

**Fig.2** – keel bolts, fixings and backing plates.
