ANCHOR HOUSE MARINE SURVEYS

Full Condition Survey Report

Berthon 8 Tonne Gauntlet

'Nausikaa'

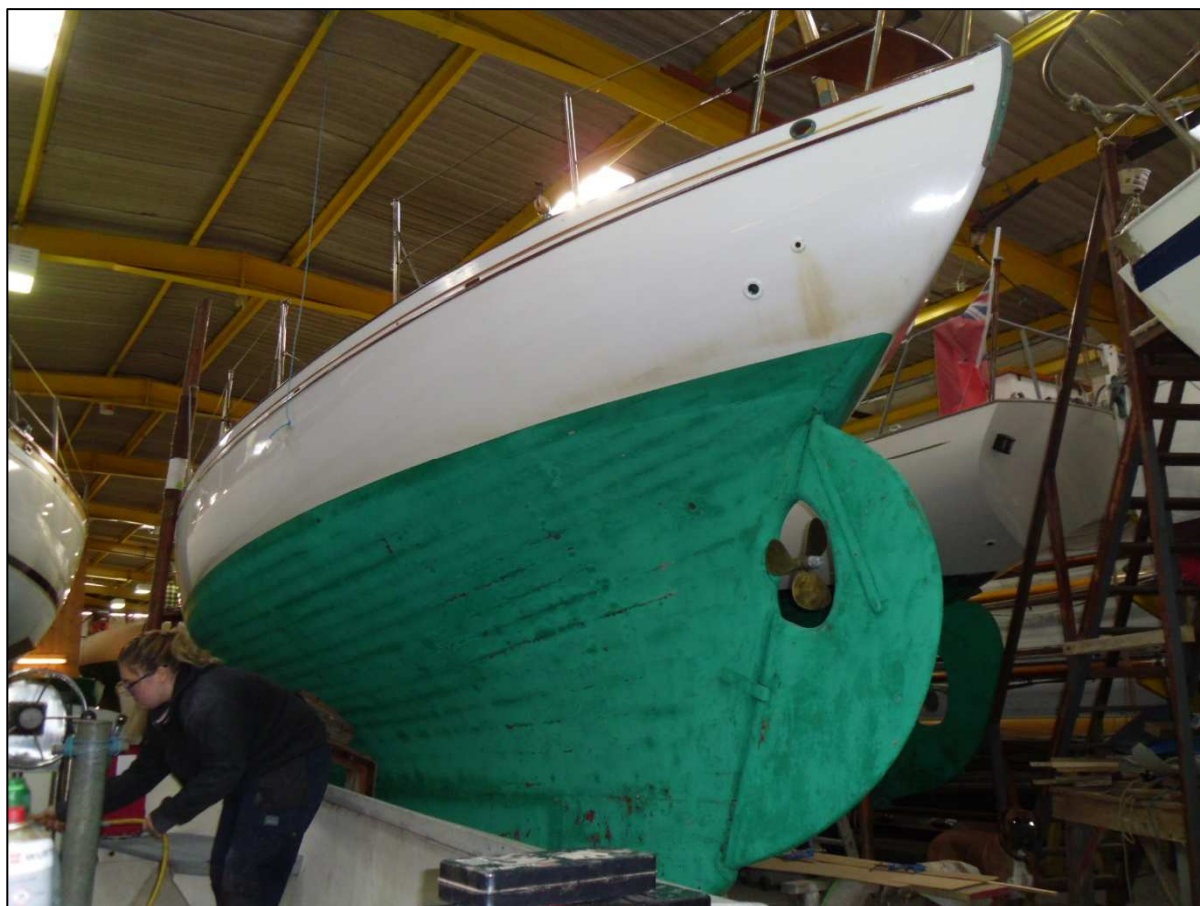
This is in white painted, carvel laid teak planking with a gold painted cove line above the varnished teak fender. The topside is generally clean but there are some minor areas of paint bubbling / detachment as well as some light caulking line protrusion in the paintwork along the yacht's length but there are no signs of any major damage or repair. There are no fore and aft sling tags fitted.

This is in white painted, carvel laid teak planking with a gold painted cove line above the varnished teak fender. The topside is generally clean but there are some areas of paint bubbling / detachment aft of midships as well as some light caulking line protrusion in the paintwork along the yacht's length but there are no signs of any major damage or repair. There are no fore and aft sling tags fitted.

Fig.1 – some light defects and plank caulking line protrusion in the paintwork.

Recommendation

Repair the topside defects.
