ANCHOR HOUSE MARINE SURVEYS

Full Condition Survey

Fairline Squadron 58

'Dreams to Reality'

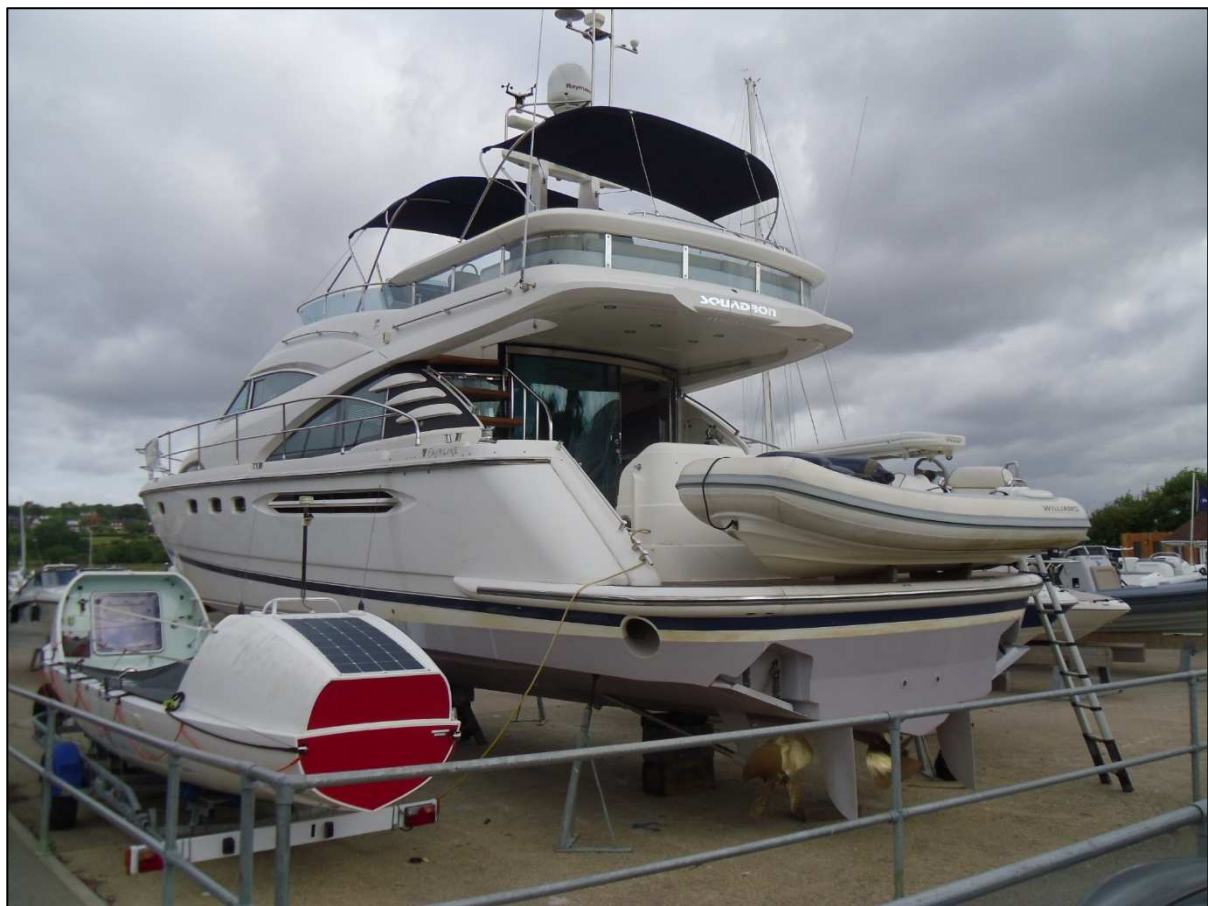
This is in white GRP with an integrated bathing platform laid with teak decking panels and a 'Williams' tender is stored here. This is generally sound but in addition to signs of normal wear and tear, there is some scuffing in the gelcoat by the transom port gate, a small stress crack in the port edge of the bathing platform, a stress crack with some gel damage in the starboard forward edge of the bathing platform and some gaps in the vertical sealant on the starboard side of the bathing platform aft edge. The teak decking, where accessible, is in a serviceable but lightly weathered condition. The bathing platform fender consists of a black rubber strip in a securely fitted stainless steel runner and this is in overall good condition, though with some light dents noted in way of the stress cracks.

Fig.1 – gelcoat cracking starboard forward on the bathing platform.

Repair the gelcoat stress cracks and damage.
