ANCHOR HOUSE MARINE SURVEYS

Full Condition Survey Report

Hanse 455

'Ratatosk'

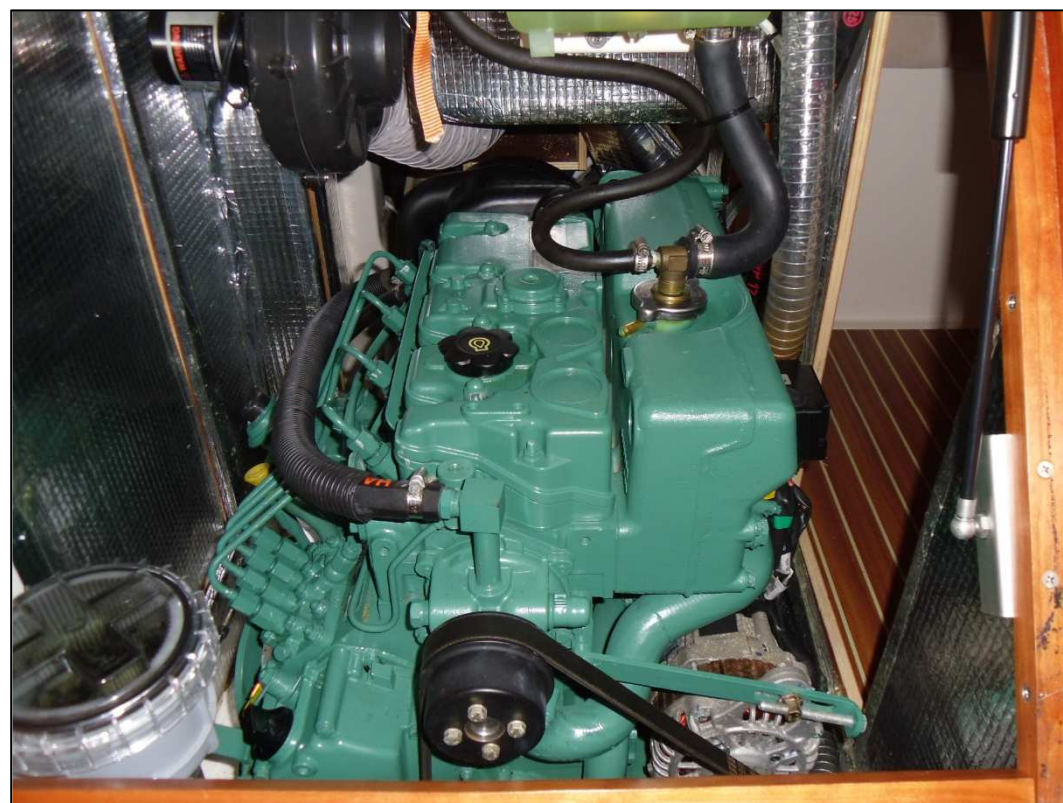
Fig.8 – Volvo Penta D2-55 4-cylinder diesel engine.

The engine is in good cosmetic condition with no clear signs of any corrosion or leaks, though the earthing bolt on the port side of the block is corroding and there was water in the air filter sponge cover at the time of survey. The compartment is lined with insulation panels but is collapsing in areas and the engine's main details are:
