ANCHOR HOUSE MARINE SURVEYS

Full Condition Survey

Fairline Phantom 37

Wednesday 24th October 2018

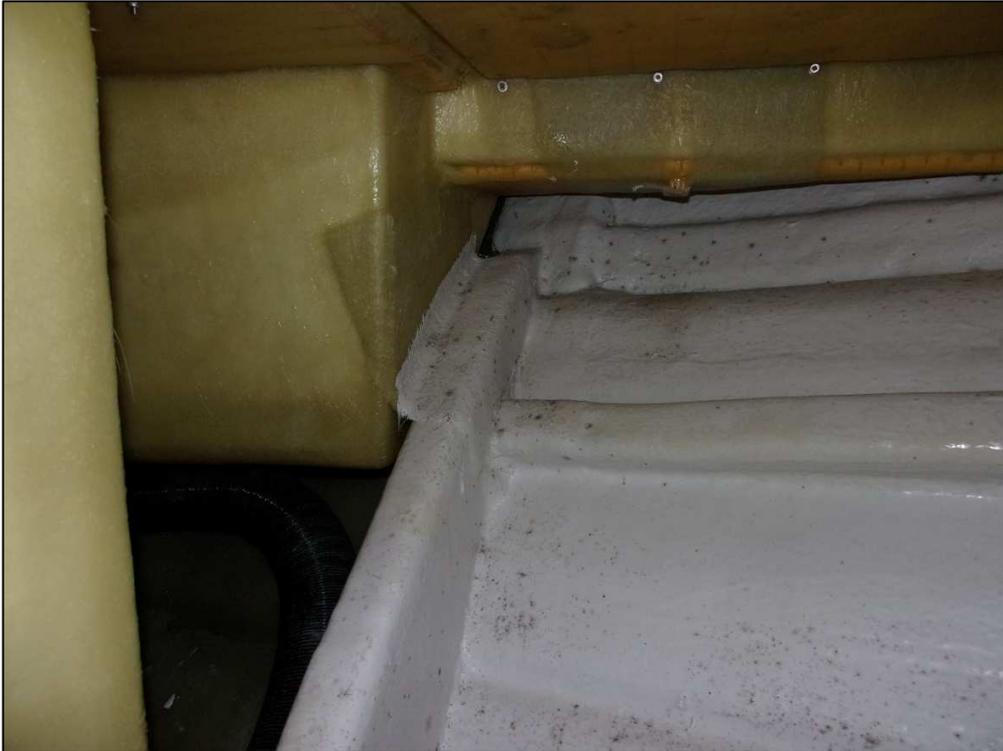
There are GRP floors, moulded stringers and various supports bonded to the hull and deck tray to give extra stiffness to the structure. Where seen, there were no signs of any movement.

Fig.4 - structure showing deck tray, stringers, floors and extra supports bonded.
